# **Derailment of freight train 82P7 and subsequent collision with coal train 9F02**

3 km east of Marmor, Queensland, on 29 January 2023

Rail Occurrence Investigation (Systemic)

RO-2023-001

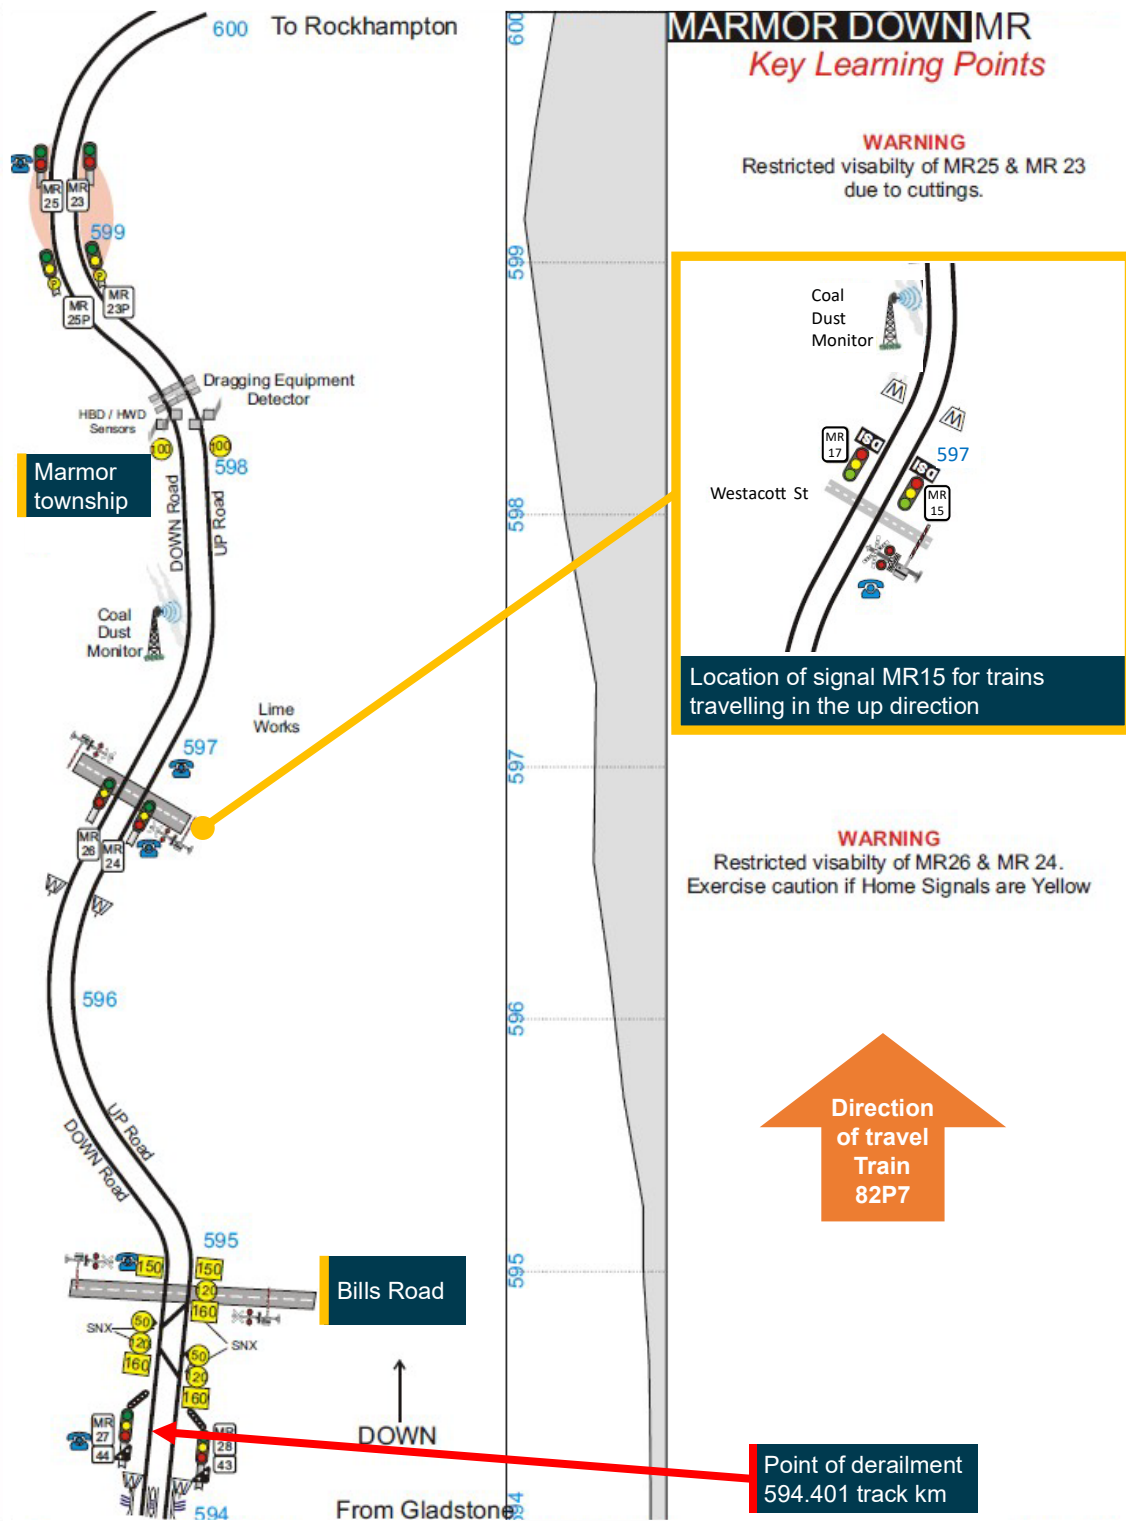
Figure 3: Schematic of the track section near Marmor, Queensland

82P7, which was fouling the up line. Train 9F02 stopped adjacent to a different container (Figure 2). It did not reach the main wreckage of train 82P7, located near the Bills Road level crossing (Figure 3). Train 9F02 sustained significant impact damage to the driver's side of the cab on the lead locomotive and along the side of the train.

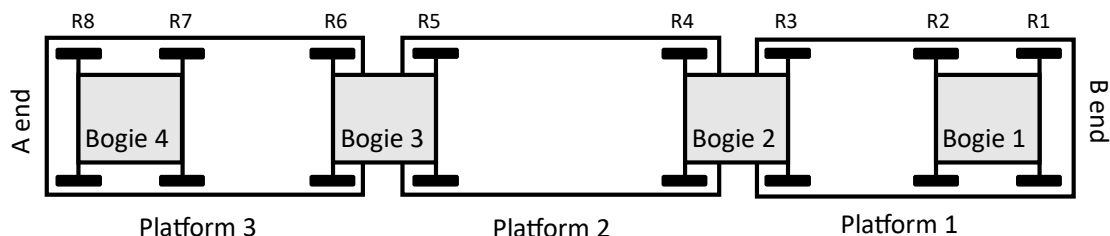
**Figure 6: Schematic of a triple-pack wagon on train 82P7**

The recovered fractured axle was identified as an NB axle with serial number 7L7NB4726. This was the leading axle on the 3rd bogie of the 6th wagon behind the locomotive (axle labelled R5 in Figure 6). Pacific National completed a post-derailment inspection of the fractured axle, the sibling axle, and the bogie, which was observed by the ATSB. While the wheels and bogie were significantly damaged from the derailment, no pre-existing concerns were identified with these components, other than the axle fracture. Paint had eroded from the surface of the barrel of both the fractured axle and its sibling axle.

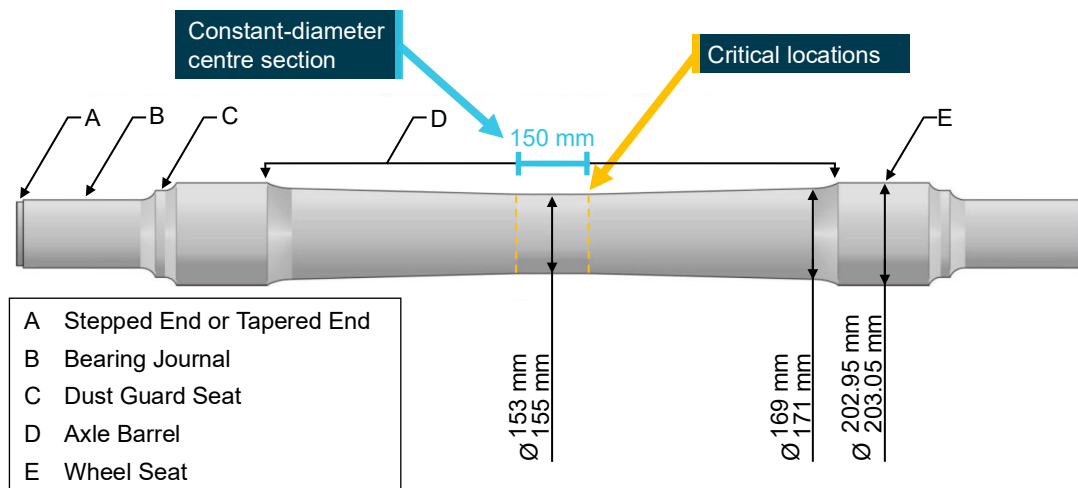
**Figure 7: Schematic of 7L7NB (NB) axle**

The design drawing for the NB axle (Figure 7), listed the diameter of the centre section of the axle as  $154 \pm 1$  mm. This constant-diameter centre section was 150 mm long. The axle then tapered out to a diameter of  $170 \pm 1$  mm over 366 mm, followed by a radius to transition to the wheel seat, which had a diameter of  $203 + 0.05$  mm (Figure 7 'E'). The total axle length was 1,816 mm. In contrast, the 7L7N axle had a greater diameter of  $165 \pm 1$  mm for a 152 mm long constant-diameter centre section, tapering out to  $181 \pm 1$  mm near the wheel seat. The critical location of the NB axle barrel, where the margin of safety<sup>6</sup> was smallest, was located at the transition between the constant-diameter centre section and the taper.

The evaluation reported that the critical location, described as the ‘most highly stressed’ location, was the transition between the constant diameter centre section and the outward taper (Figure 7). The stress calculated at this location was 154 MPa and corresponded to the location with the lowest margin of safety, 1.17. In comparison, the calculated stress at this location for the 7L7N design was 125 MPa and the margin of safety was 1.44, when calculated using the same maximum allowable stress value.

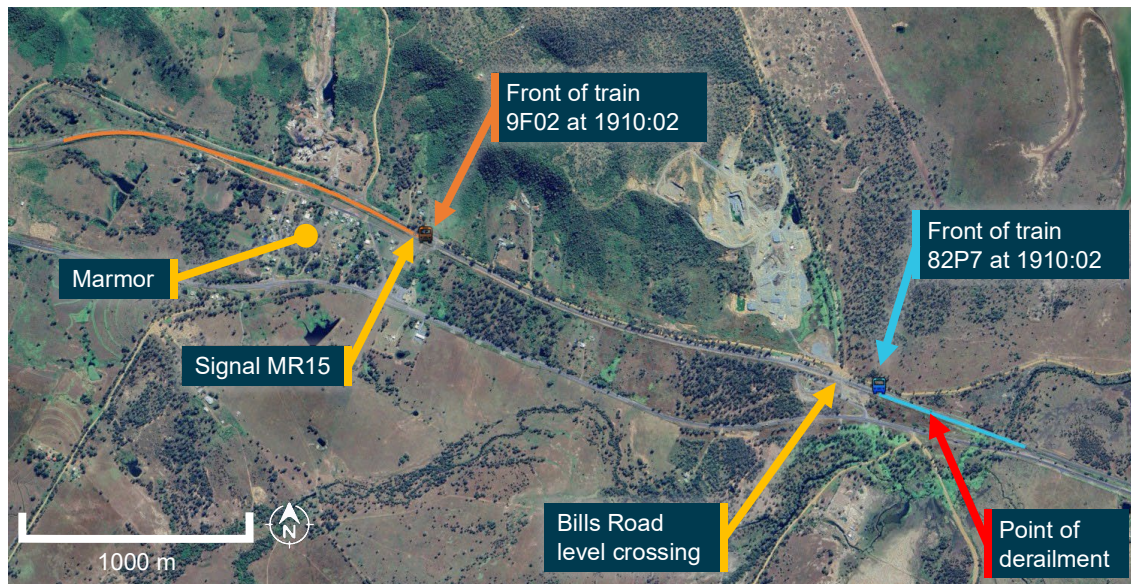
**Figure 8: Location of train 82P7 and train 9F02 when signal MR15 restored to red**

The universal traffic control system also recorded the status of signal MR15, the last signal for train 9F02 before it encountered the wreckage of train 82P7. When passed by train 9F02 at 1910:00, signal MR15 indicated a green proceed signal. Two seconds later, following the passage of train 9F02, the signal restored to a red (stop) indication, as designed. Figure 8 shows the locations of both trains at the time when MR15 restored to a red indication.

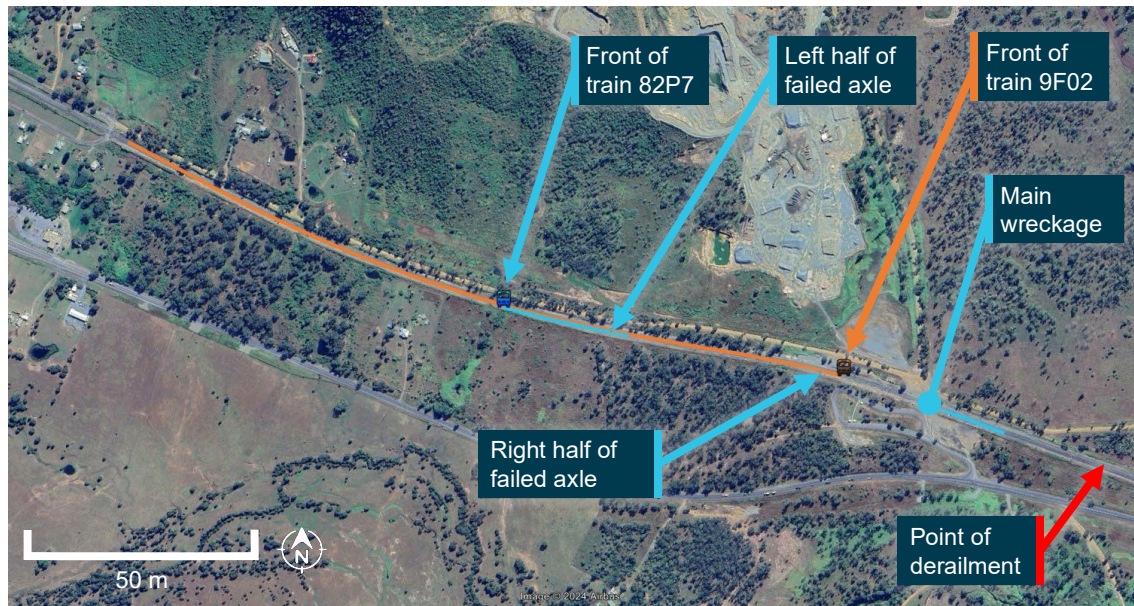
**Figure 9: Overview of accident site**

The accident site extended over 2.5 km from the point of derailment, around 400 m east of the Bills Road level crossing, to the trailing end of train 9F02 (Figure 9). The ATSB's onsite examination identified the point of derailment to be at 594.401 track km<sup>8</sup> (Figure 3). For the Raglan to Marmor section of track, no relevant track faults were identified during the inspection following the accident. Furthermore, the track cant<sup>9</sup> and gauge measurements were within specification.

The track infrastructure sustained extensive damage from 594.401 track km to 595.510 track km, including damage to the points, level crossing equipment, and overhead line equipment. The main wreckage site (Figure 1), including the derailed rear 8 wagons of train 82P7, was located near the Bills Road level crossing at 596.710 track km.

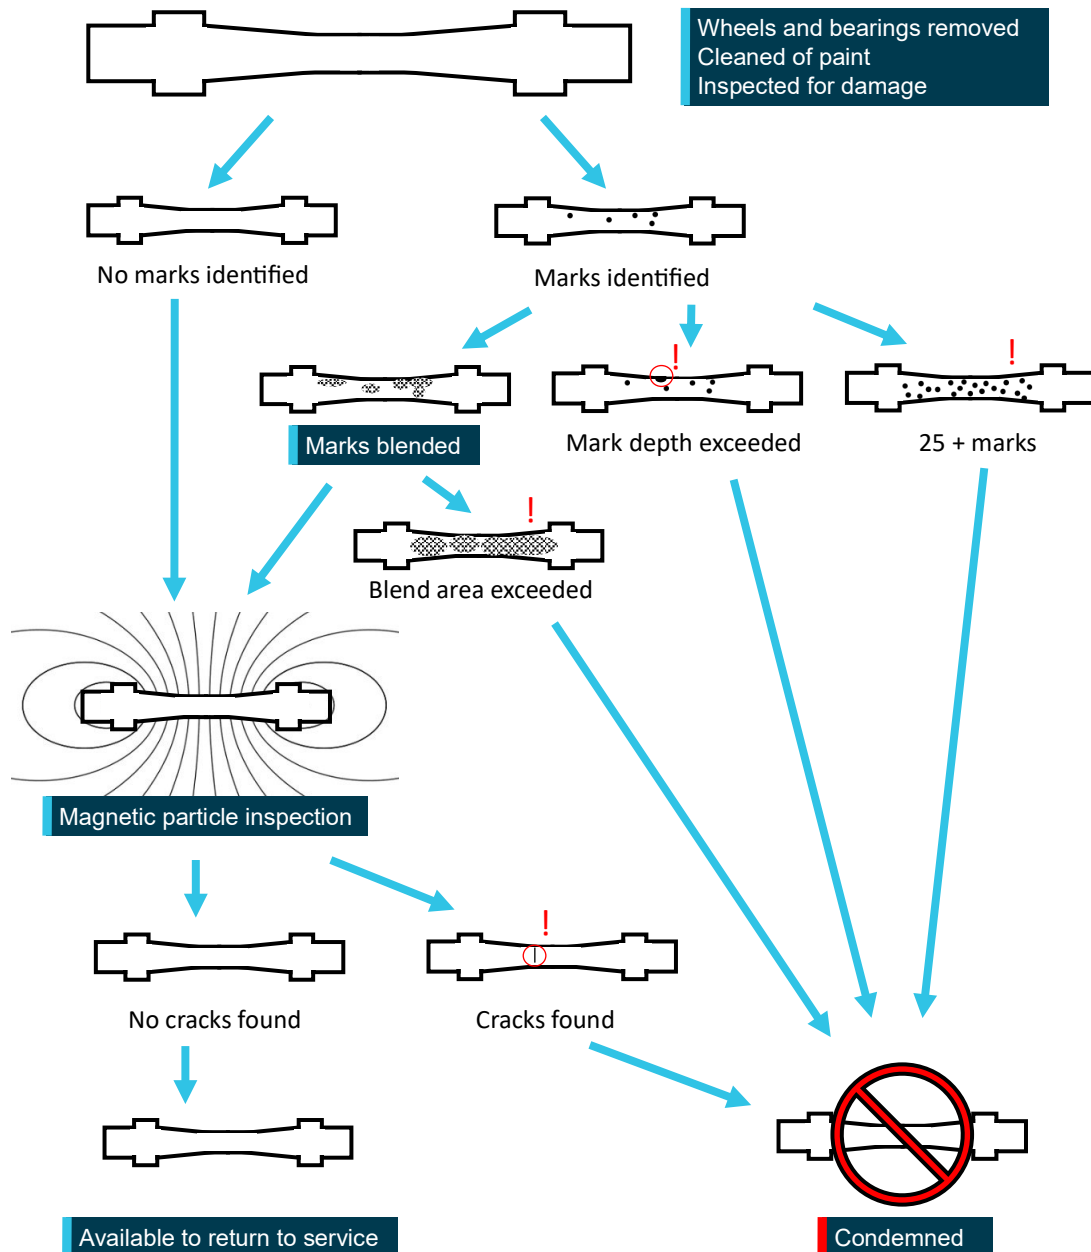
**Figure 12: Diagram illustrating the barrel-related action during axle overhaul**

One overhauler advised the ATSB that they performed a dimensional tolerance check following blending repair to ensure the constant-diameter centre section of the axle was not thinned beyond the tolerance of the design drawing. Following blending, the axle would be checked for the presence of cracks with magnetic particle inspection. Figure 12 shows a diagram summarising the barrel-related actions during overhaul. There were also many non-barrel-related criteria, not described in this report, that needed to be satisfied for an axle to be returned to service.
