# **Level crossing collision between passenger train DB09 and a B-double truck**

Runcorn, Queensland, on 14 August 2025

Rail Occurrence Investigation (Short)

RO-2025-006

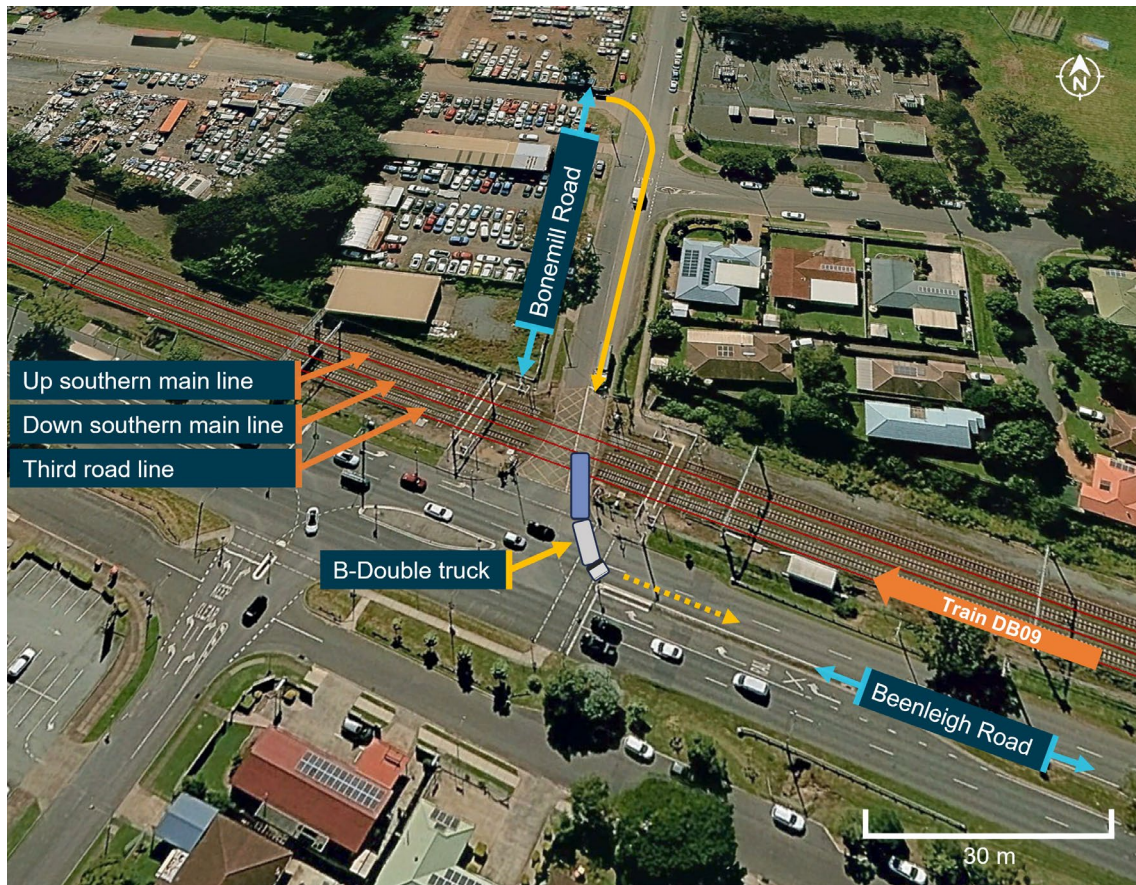
**Figure 1: Bonemill Road level crossing and vehicle directions of travel**

The B-trailer obstructed the Third road line and the Down southern main line.<sup>3</sup> The prime mover and A-trailer (first trailer) had cleared the rail corridor but were obstructing road traffic on Beenleigh Road heading east (Figure 1). The CCTV recorded the truck lurching, as the truck driver attempted to move the vehicle. The driver then exited the truck and went to inspect the area between the A- and B-trailer (Figure 2). There were other motor vehicles overtaking the truck, and some pedestrians in the area at that time.

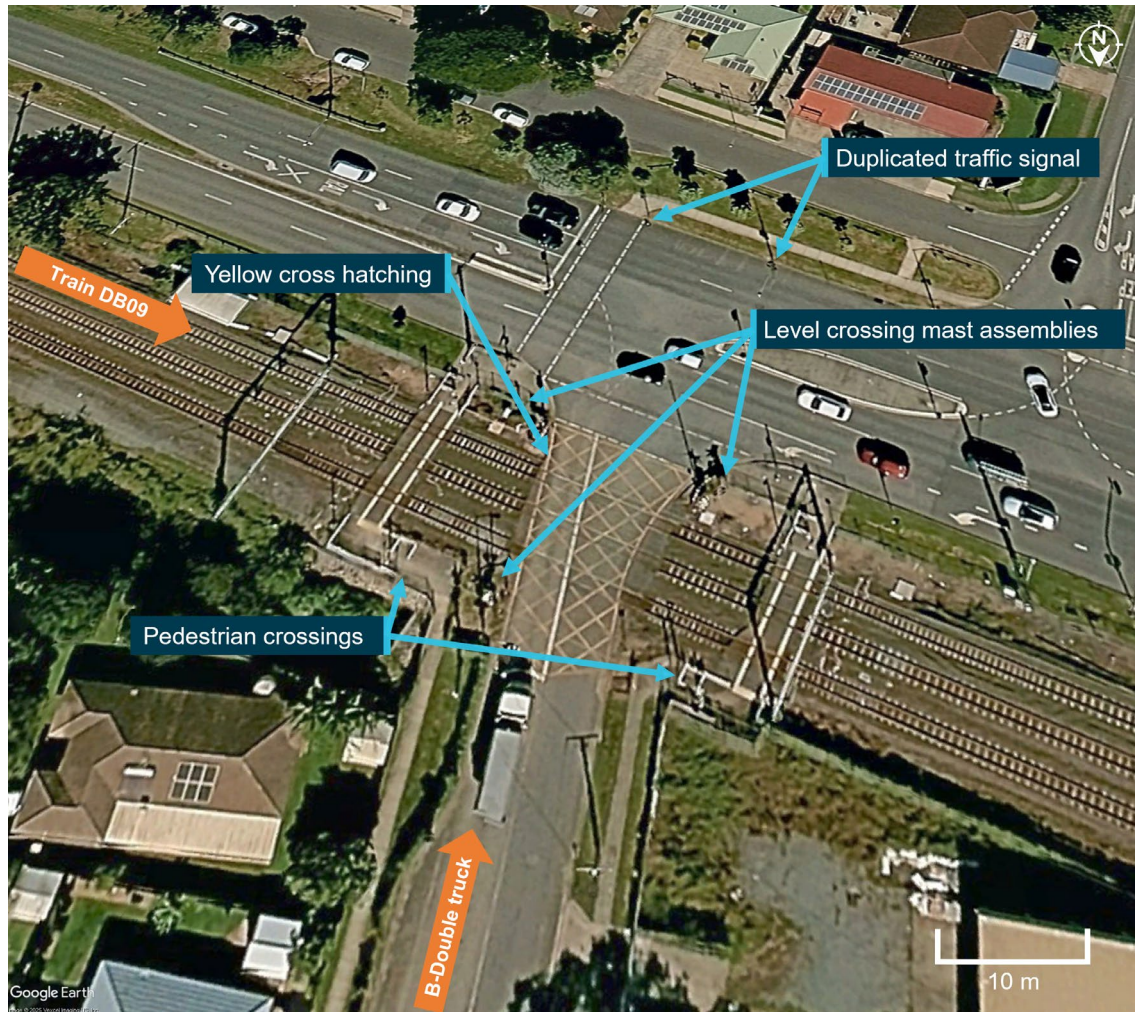
**Figure 5: Bonemill Road level crossing overview and layout**

Road traffic controls at the interface comprised of level crossing mast assemblies, including flashing lights, audible bells and half boom barriers. Keep clear signage and yellow crosshatch pavement markings were also installed to prevent queuing across the level crossing. Additionally, there were 2 active pedestrian crossings on each side of the road. The level crossing was interfaced with the 3-aspect traffic signals that controlled single lane traffic turning onto, and from, Beenleigh Road (Figure 5).
