# Collision between a road vehicle and train 6PM9

Reddies Road level crossing, Cressy, Victoria, on 20 January 2026

## ATSB Transport Safety Report

RO-2026-001

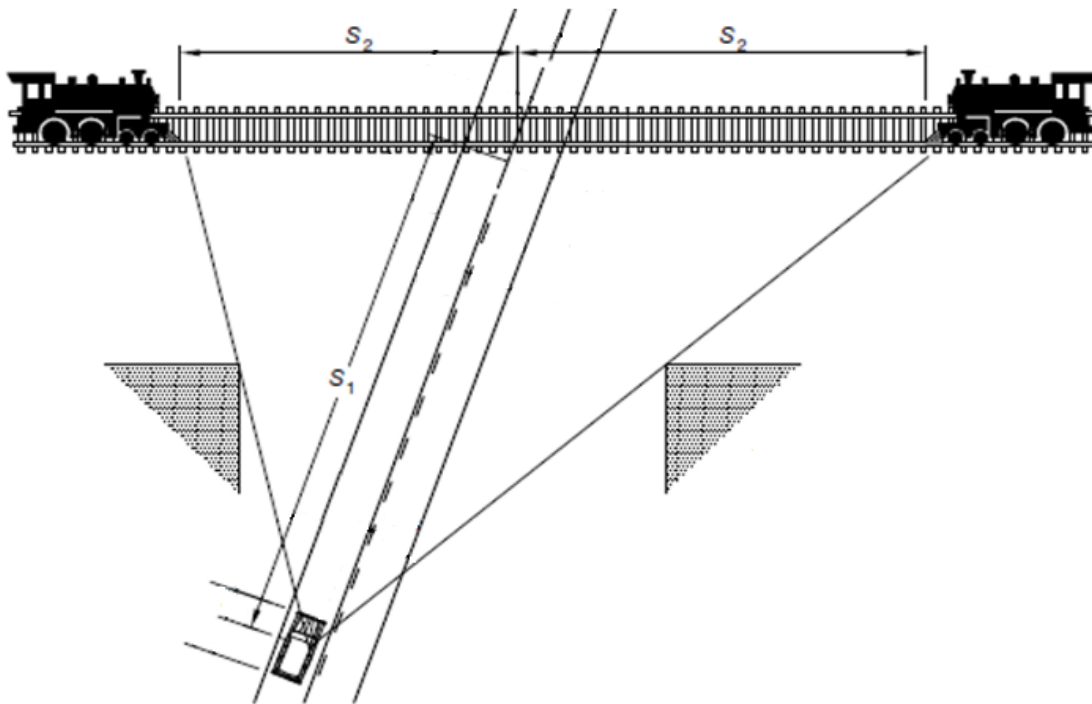
**Figure 7: Approach sighting at give way passive control level crossing**

An assessment against the sighting requirements of AS 1742<sup>7</sup> for a vehicle approaching a give way sign at Reddies Road level crossing was carried out by the OCI.

Observations were made from the  $S_1$ <sup>8</sup> positions for vehicles travelling at 40, 60 and 80 km/h and at 2 eye levels, 1.05 m and 2.40 m<sup>9</sup> and the corresponding  $S_2$ <sup>10</sup> positions were determined (Figure 7).

This compromised easterly view for vehicles approaching the crossing along Reddies Road from the north, meant the use of give way signage at the level crossing was inconsistent with signage recommended in the AS 1742 standard.
