# Steering failure involving *Matthew Flinders III*

8 km north of Waterhouse Island, Bass Strait, Tasmania, on 23 July 2025

## ATSB Transport Safety Report

MO-2025-009

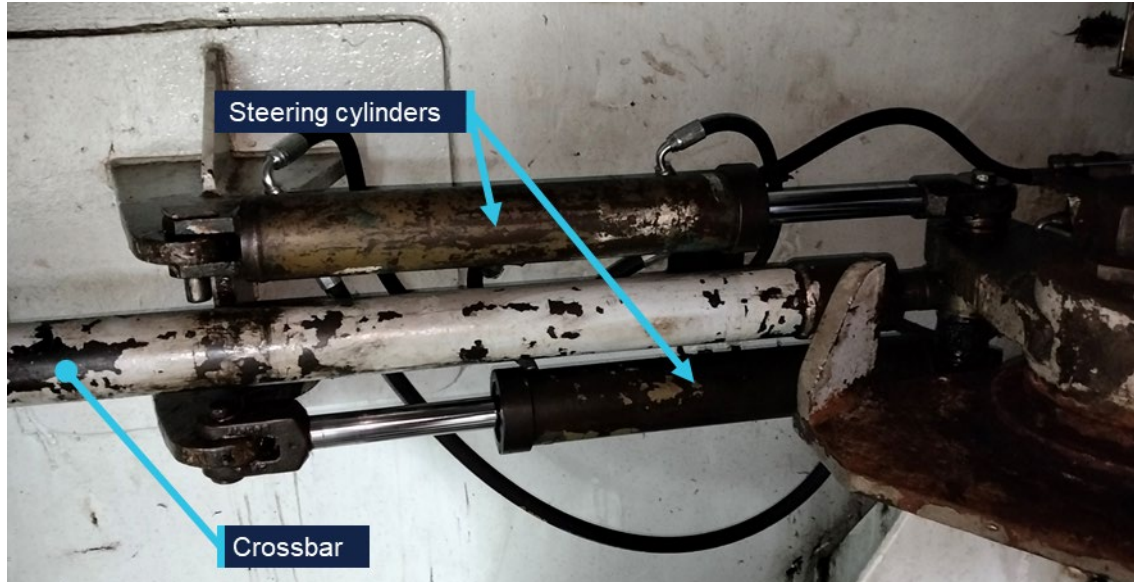
**Figure 2: Steering cylinders**

The ship's twin rudders were interconnected with a crossbar and actuated by 2 double-acting hydraulic steering cylinders, fitted in the port engine room (Figure 2).

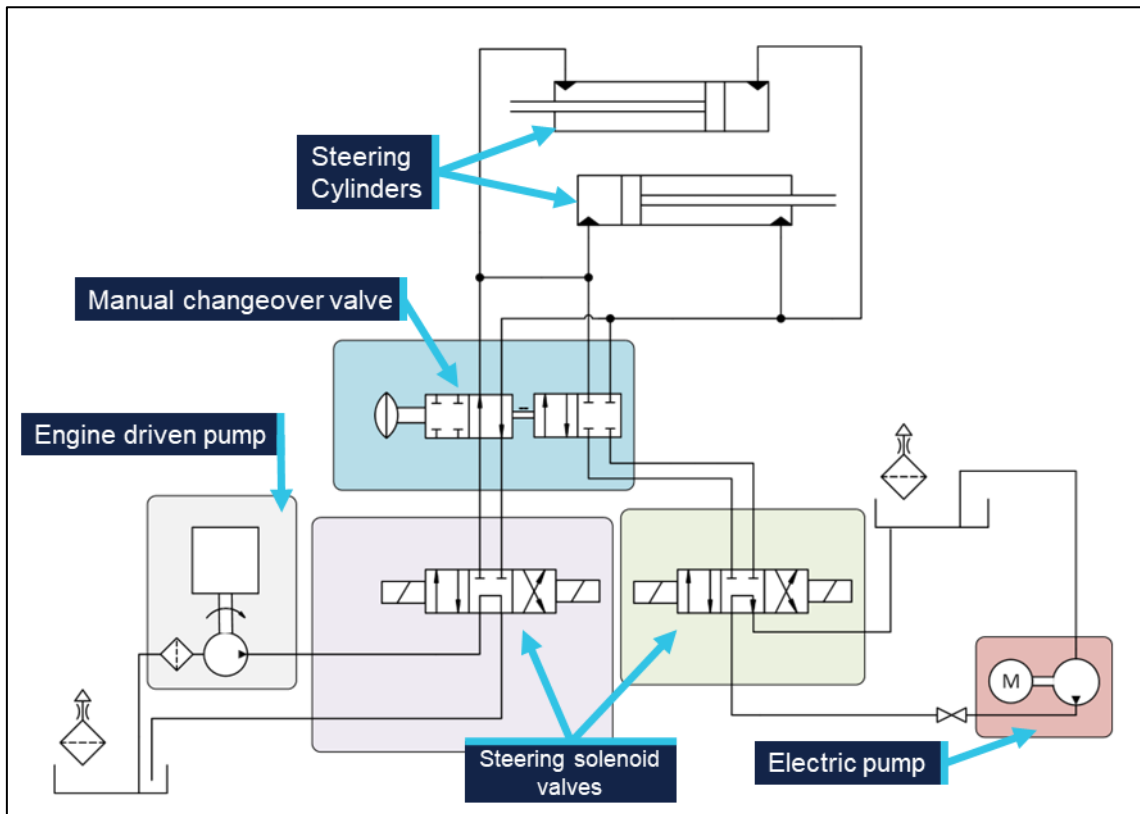
**Figure 3: Hydraulic system**

An electrically-driven emergency pump was fitted in case the mechanically driven pump failed. Although this system used the same hydraulic steering cylinders, it incorporated an independent hydraulic reservoir and a separate steering solenoid (Figure 3).

Activation of the emergency hydraulic system did not impact the steering control systems. That is, the ship could be steered using the autopilot/follow-up system or the non-follow-up system while using hydraulic power from either pump.

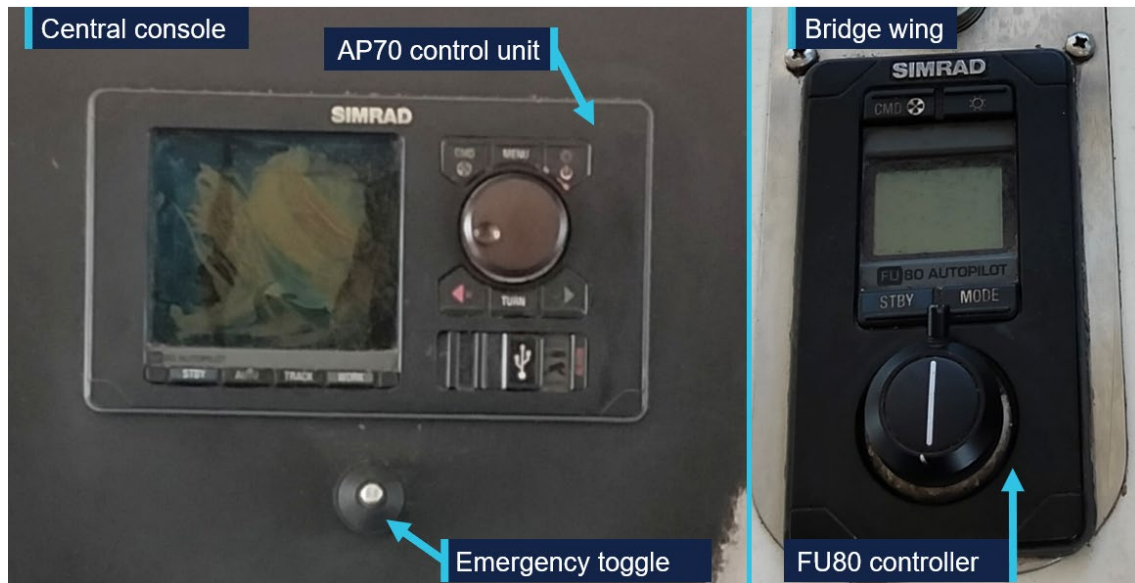
**Figure 4: Autopilot control units and central console emergency toggle**

The AP70 control unit, mounted on the central control panel, controlled the ship's heading while in autopilot mode. The FU80 controllers were mounted on each bridge wing and used for manual steering.
