# Collision with terrain, Garlick Helicopters UH-1H, VH-HUE

24 km south-east of Talbingo, New South Wales, on 17 April 2018

## **ATSB Transport Safety Report**

AO-2018-031

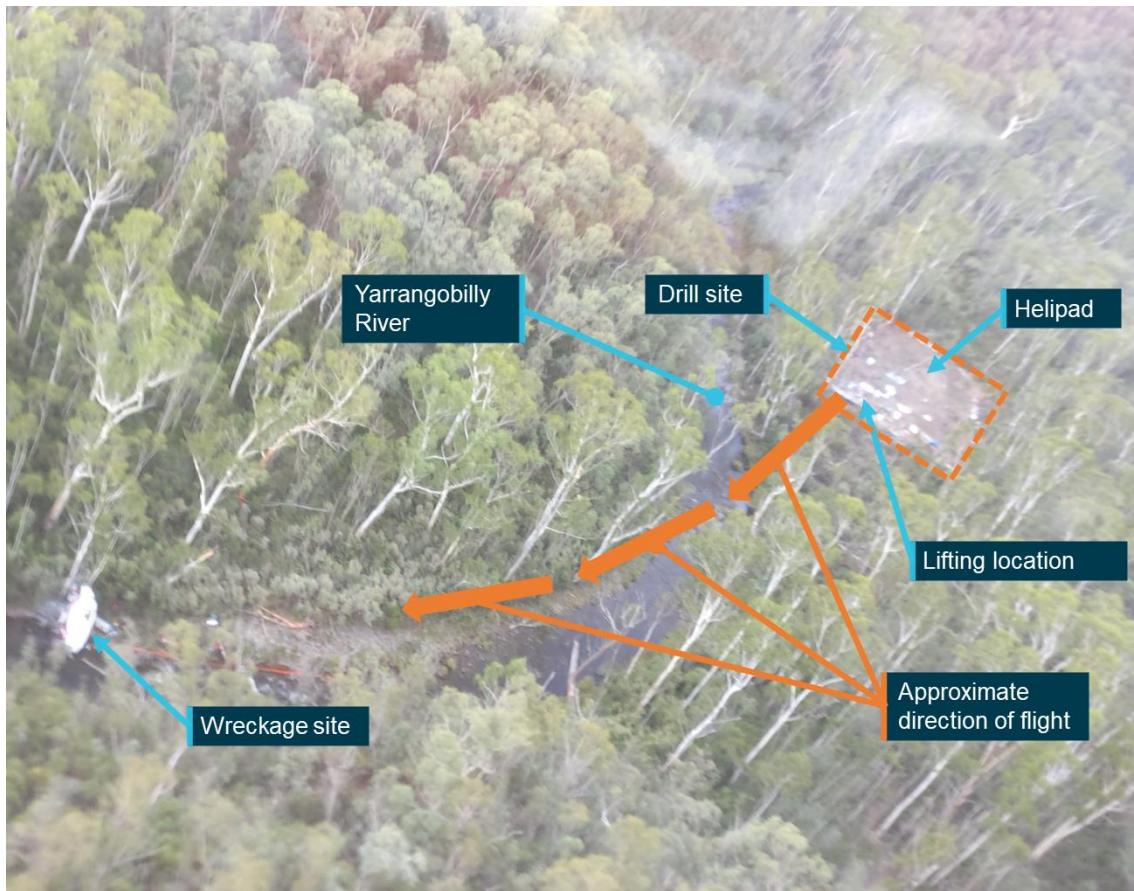
**Figure 4: Forced landing flightpath showing drill site and helicopter wreckage**

The pilot broadcast a ‘Mayday’<sup>3</sup> call and attempted to conduct the forced landing (autorotation) into the Yarrangobilly riverbed, south-west of the lifting area and the ground personnel. The workers observed the helicopter being turned to the south-west, away from the drill site.<sup>4</sup> They described the helicopter as appearing to ‘float’ over the trees, before descending quickly. Around this time, the pilot commanded jettison of the long-line and lifting strops. At interview, the pilot advised that the helicopter was flared prior to the impact with the second tree, but could not recall the remainder of the impact sequence until exiting the helicopter. The helicopter subsequently collided with trees and the riverbed (Figures 4 and 5). Ground personnel from the drill site immediately responded to the accident with fire extinguishers. They extinguished a small fire in the engine bay, removed the pilot from the wreckage, and performed first aid until emergency services arrived at 1520. The pilot sustained serious injuries and the helicopter was destroyed.

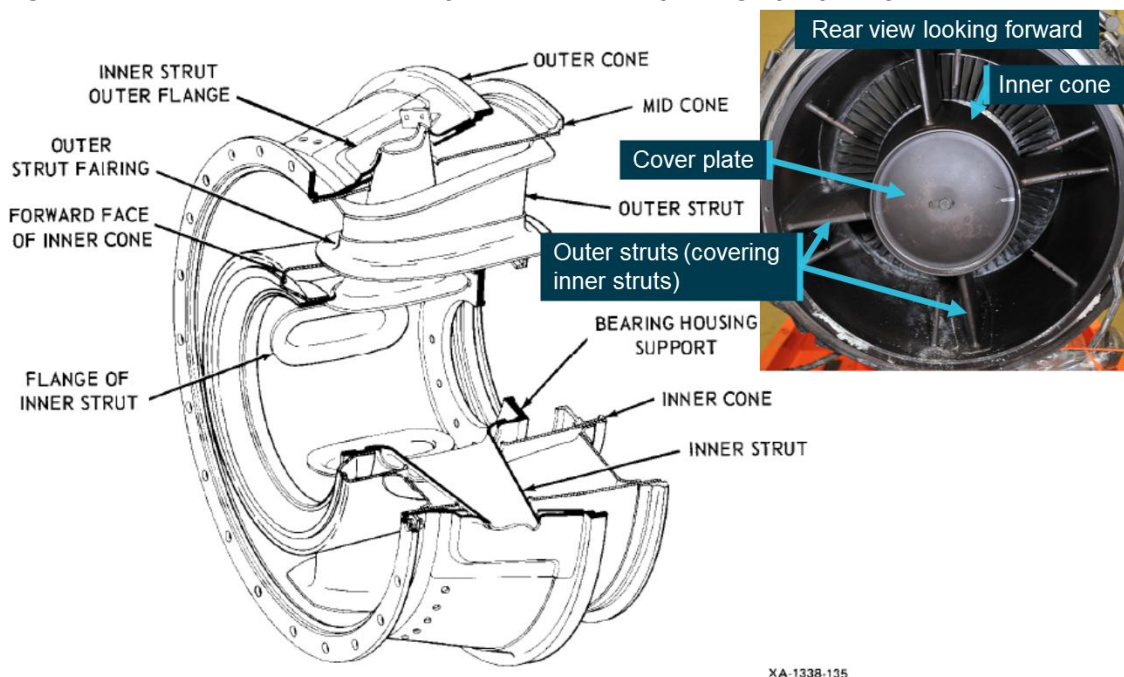
**Figure 9: Exhaust diffuser assembly schematic and photograph (inset)**

The engine was shipped to Honeywell's facilities in Phoenix, Arizona, in the US and underwent a teardown examination under the supervision of a representative from the US National Transportation Safety Board. The purpose of the examination was to identify the technical failure mechanism, or mechanisms of the engine failure. This included a detailed examination of the exhaust diffuser assembly illustrated in Figure 9.

The Honeywell engine teardown identified extensive fatigue cracking in the exhaust diffuser inner struts (Figure 10 inset). The inner struts were a critical engine component that supported the rear of the power turbine assembly through the number 3 and number 4 bearings (Figure 10). Note for reference that Figure 10 (inset) shows missing material in the exhaust diffuser inner cone also shown in Figure 8. Honeywell identified the location of the cracking for each of the four inner struts:

The analysis by Honeywell determined that the cracking in the inner struts resulted in the complete loss of structural integrity of the four struts. This led to the power turbine assembly moving rearward, indicated by the arrow labelled 'direction of PT movement' in Figure 10. The rearward movement was sufficient for the rear tapered section of the power turbine drive shaft (labelled 'PT drive shaft rear taper') to contact the adjacent rear shaft of the compressor assembly, highlighted in blue. Due to the compressor and turbine assemblies rotating in opposite directions, the contact resulted in considerable friction, and deformation of the rear compressor shaft. This led to the compressor assembly contacting the walls of the engine case.

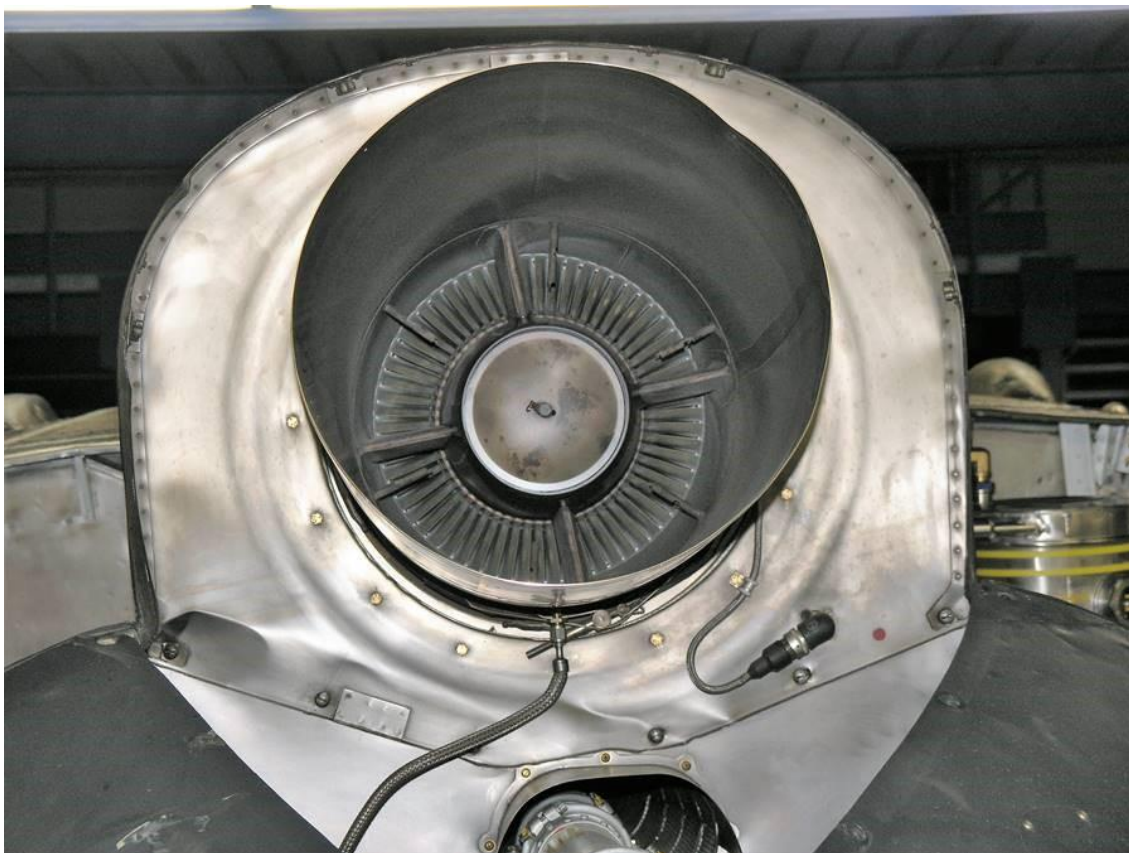
**Figure 11: Typical exhaust, showing accessibility for inspection**

The tailpipe and exhaust diffuser could be readily accessed via a ladder (Figure 11). Inspection of this area was typically carried out with the aid of a bright torch and mirror. A borescope could also be utilised if closer inspection was warranted.

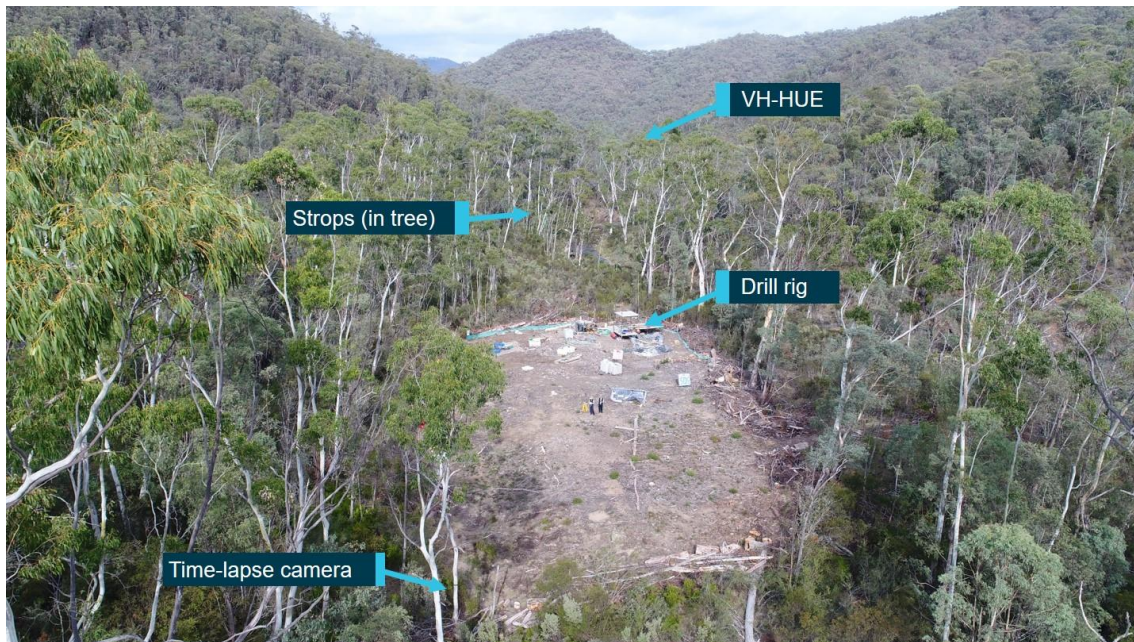
**Figure 12: Drill site looking in direction of flight**

The pilot reported that there were personnel working in and around the drill site when the helicopter was on approach to hook-up the load (the drill site also included a helipad). This was supported by time-lapse images from the drill site, which confirmed ground personnel moving in and around the drill site, including this approach. Consequently, when the engine failed, the pilot attempted to autorotate<sup>11</sup> the helicopter clear of the drill site and towards the river to keep clear of ground personnel. When asked where the pilot would have conducted the forced landing if the drill site was assured to be clear of personnel, the pilot reported that the drill site (Figure 12) would have been used. Figure 12 also shows the high trees and generally inhospitable terrain surrounding the drill site.

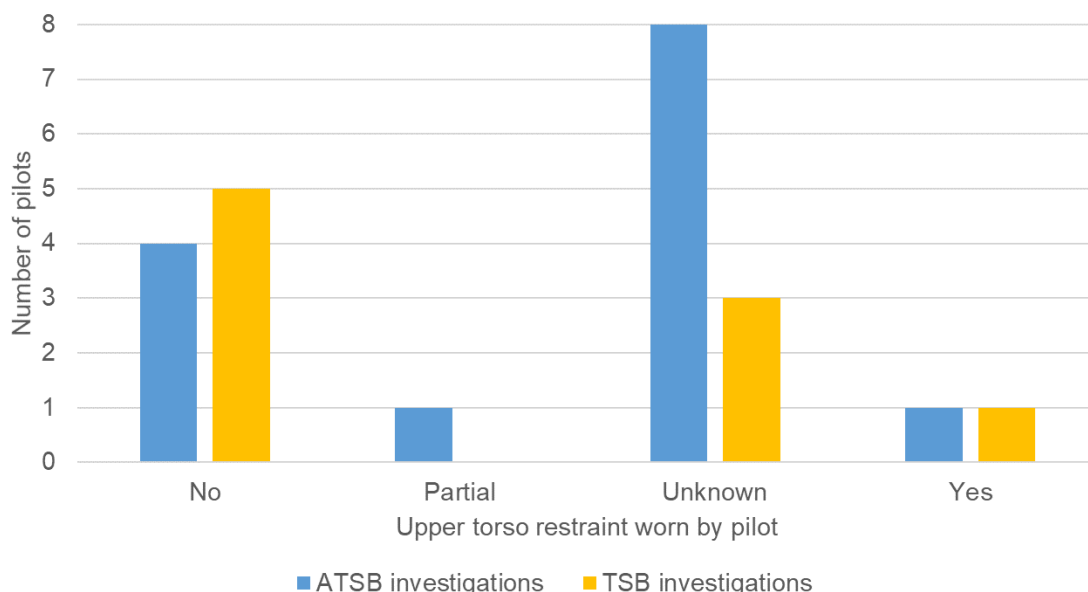
**Figure 18: Number of pilots in ATSB and TSB investigations involving vertical reference flying by upper torso restraint use, January 2000 to June 2020**

At least<sup>15</sup> 14 Australian and 9 Canadian investigations involved the conduct of vertical reference flying operations between January 2000 and June 2020 (Figure 18). From the 14 Australian investigations it was found that 4 pilots confirmed they did not wear their UTR (recorded as 'No' in Figure 18), 1 partially wore it (recorded as 'Partial'), 1 did wear it, and 8 were unknown. For the partially worn case, it was found that the UTR provided no benefit due to it being incorrectly worn. Therefore, where the use of UTR was determined,<sup>16</sup> it was found that 67 per cent (4/6) of pilots were not wearing their UTR, and 83 per cent (5/6) when considering cases where the UTR was not effectively worn. This result was consistent with known cases in Canadian investigations. When considering all investigated occurrences (including unknown cases), at least one-third of pilots conducting vertical reference flying were not correctly wearing a UTR.

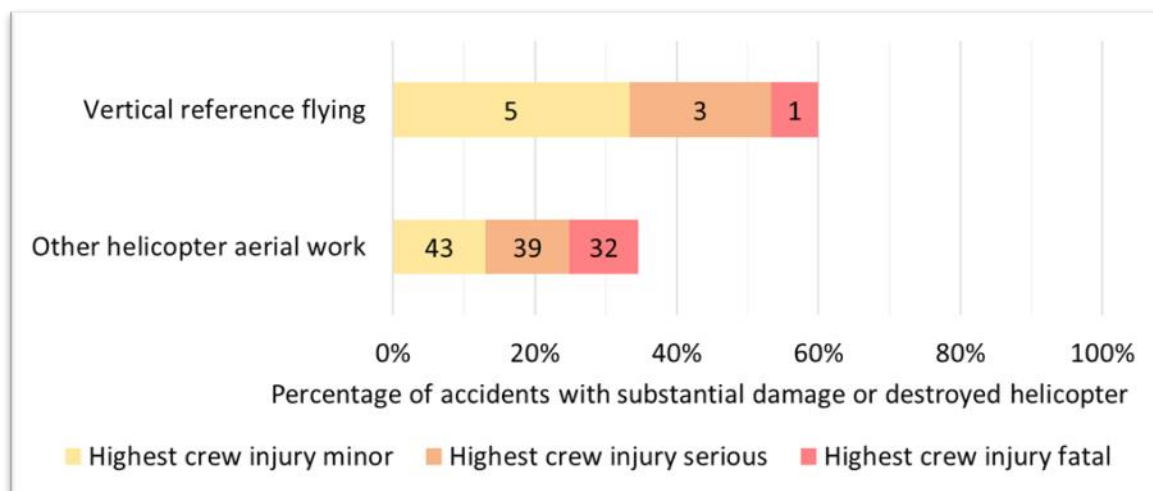
**Figure A1: Percentage of accidents with substantial damage or helicopter destruction by highest crew injury for vertical reference flying and other helicopter aerial work, 2000 to 2019**

One fatal, three serious and five minor highest injury accidents with substantial damage or airframe destruction occurred for vertical reference flying, equating to 60 per cent (9/15) for this operation. In contrast, about 35 per cent (114/329) of all other helicopter aerial work accidents with the same damage categories resulted in injuries. The mean for all other helicopter aerial work produced a significantly lower percentage of accidents with injuries in comparison to vertical reference flying.<sup>19</sup> Considering only serious and minor injury accidents as an indication of known survivable impacts, the difference was also significant between vertical reference operations and all other helicopter aerial work.<sup>20</sup> This indicated that it was very likely that the chances of an injury were higher during vertical reference flying, than the mean of all other aerial work, in survivable impacts.
