# Foreign object debris involving Airbus A380, VH-OQK

Sydney Airport, New South Wales, on 9 January 2026

## **ATSB Transport Safety Report**

AO-2026-004

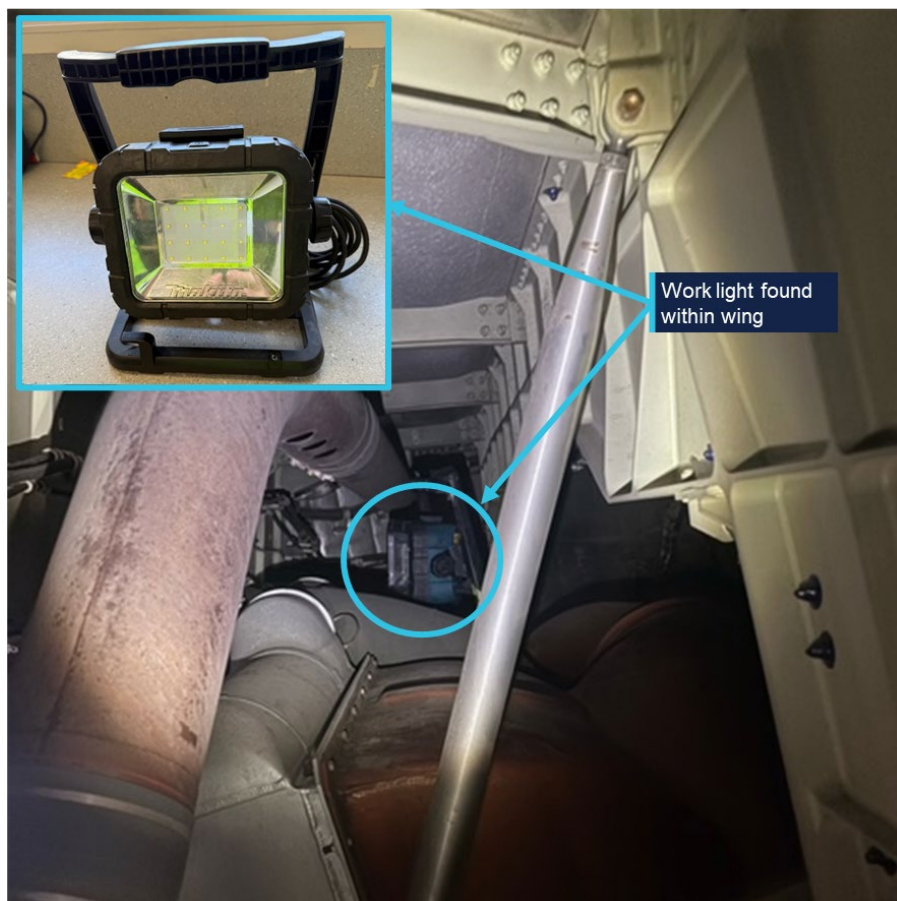
**Cover photo:** Aircraft operator, annotated by the ATSB

A lost tool search was initiated, and the missing work light was subsequently located inside the wing of the aircraft (Figure 2). No adverse consequences, structural damage, or system disruptions resulted from the work light remaining in the wing.

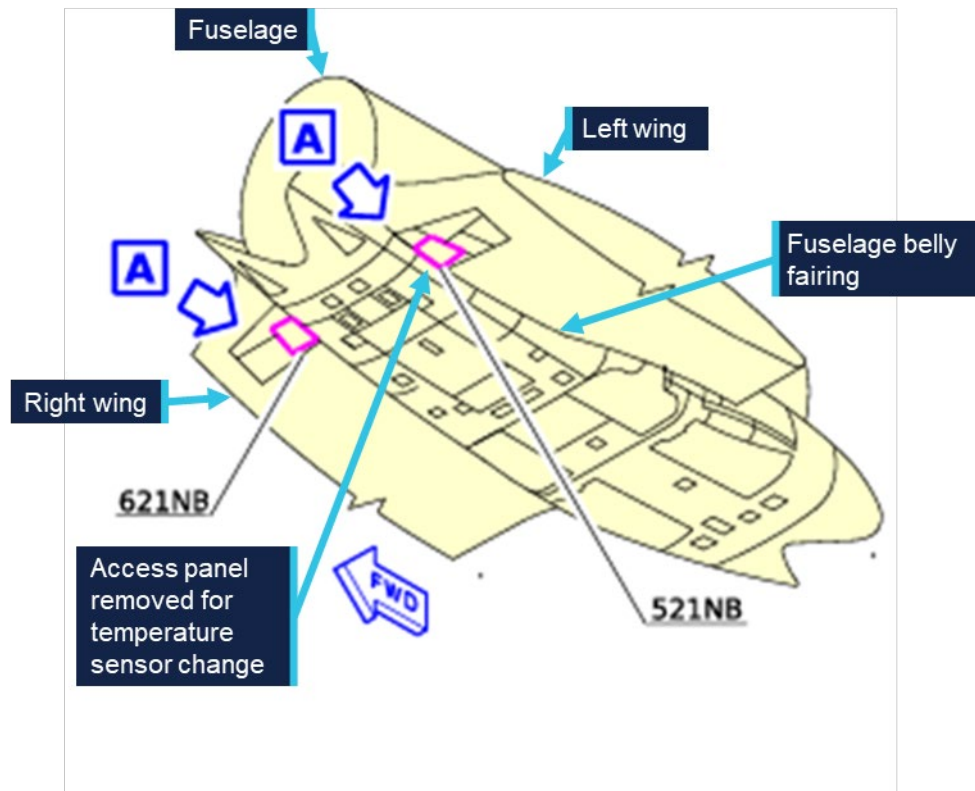
Figure 4: Aircraft access panel location

The maintenance task required a change of the outlet temperature sensor on the secondary heat exchanger of the left AGU. The removal of an underwing inboard leading edge access panel (Figure 4) is required to gain access into the wing where the AGU is positioned. A work platform is required to access and remove the panel due to the height of the aircraft's underside and wing.
