# Engine failure involving a Eurocopter AS350-BA, VH-SFX

Whyanbeel Valley, Queensland, 2 November 2015

**ATSB Transport Safety Report**  
Aviation Occurrence Investigation  
AO-2015-124  
Final – 17 October 2017

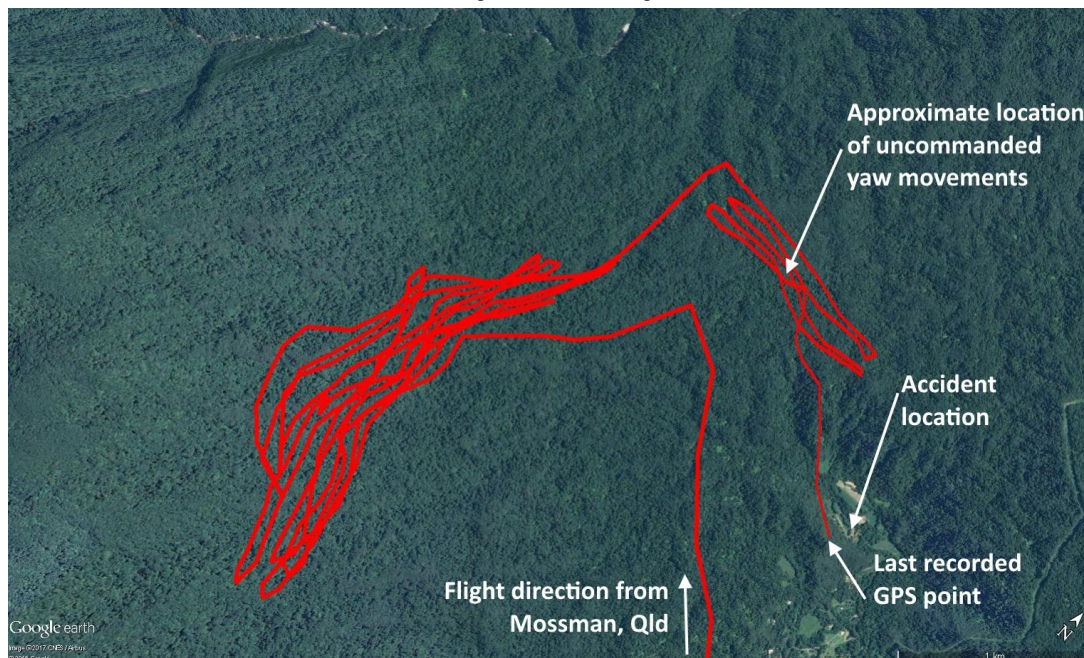
**Figure 1: The helicopter's GPS track, arriving in the area of operations, its flight path around the forested terrain in the Whynabeel valley, and the accident site.**

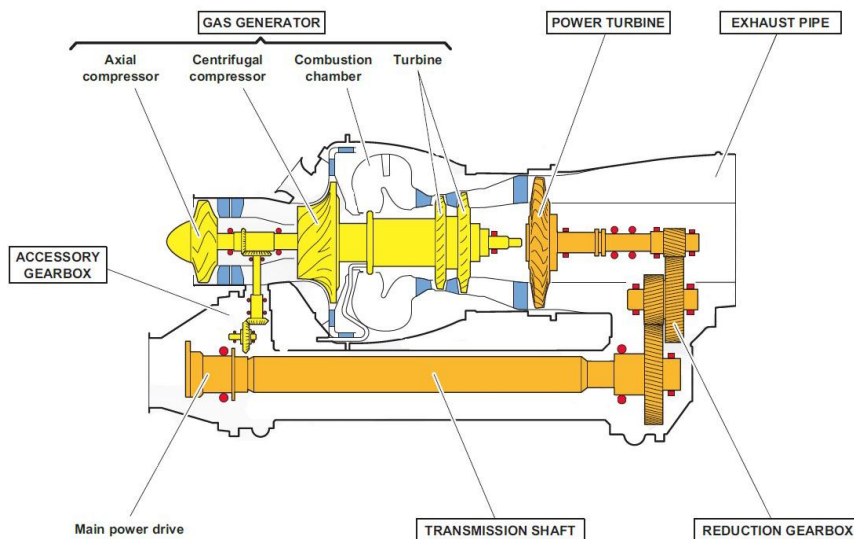
The helicopter was powered by a Turbomeca<sup>3</sup> Arriel (model 1B) engine, located above and to the rear of the passenger compartment. The Arriel 1B engines feature a modular design with the major modules consisting of an axial and centrifugal compressor, an annular combustion chamber, a two-stage axial turbine, a single-stage axial power turbine and a reduction gearbox (Figure 4). This occurrence related to a failure within the power turbine.

**Figure 4: General arrangement of a Turbomeca Arriel 1B turboshaft engine showing the locations of the major sub-components**

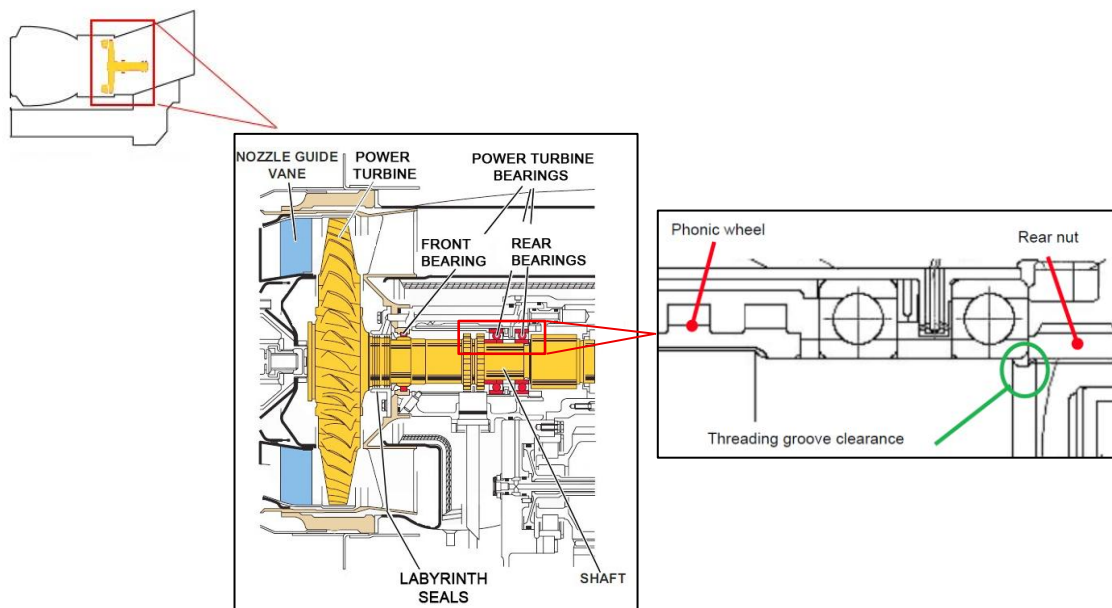
Gases from the two-stage axial turbine are directed downstream to the power turbine. The power turbine disc and shaft is a cantilevered design supported by front and rear bearings (Figure 5). Surrounding the power turbine is a containment shield to prevent high-energy engine debris from exiting the engine in the event of a blade fracture or disc separation from the shaft. The fractured turbines blades did not penetrate the containment shield in this occurrence.

**Figure 5: General arrangement of the power turbine showing the relative location of the major parts including; the guide vanes, labyrinth seal, power turbine shaft, rear nut, and the front and rear bearings.**
