# Loss of separation involving Boeing 737 aircraft, VH-YFN and VH-VZV and Robinson R44, VH-WYR

near Essendon Airport, Victoria, on 26 January 2016

**ATSB Transport Safety Report**  
Aviation Occurrence Investigation  
AO-2016-005  
Final – 9 March 2017

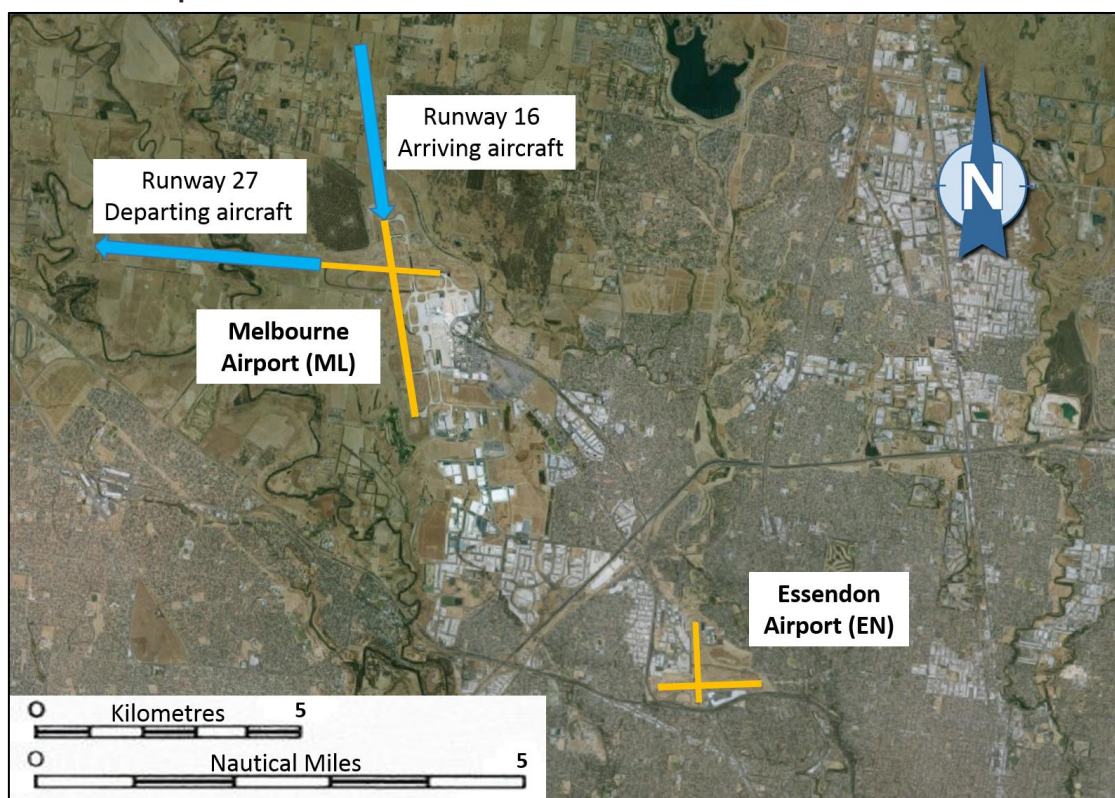
Early on the morning of 26 January 2016, the active runways at Melbourne Airport, Victoria were runway 16<sup>1</sup> for arrivals and runway 27 for departures (Figure 1). The Melbourne Tower Coordinator (coordinator)<sup>2</sup> reviewed the forecast weather and noted that a runway change to runway 16 for arrivals and departures would be required due to increasing downwind on runway 27. At the time, there was broken cloud<sup>3</sup> at 1,400 ft above ground level at Melbourne Airport.

**Figure 1: The runway configuration in use at Melbourne Airport prior to the runway change, showing runway 16 for arrivals and 27 for departures, and the location of Essendon Airport**

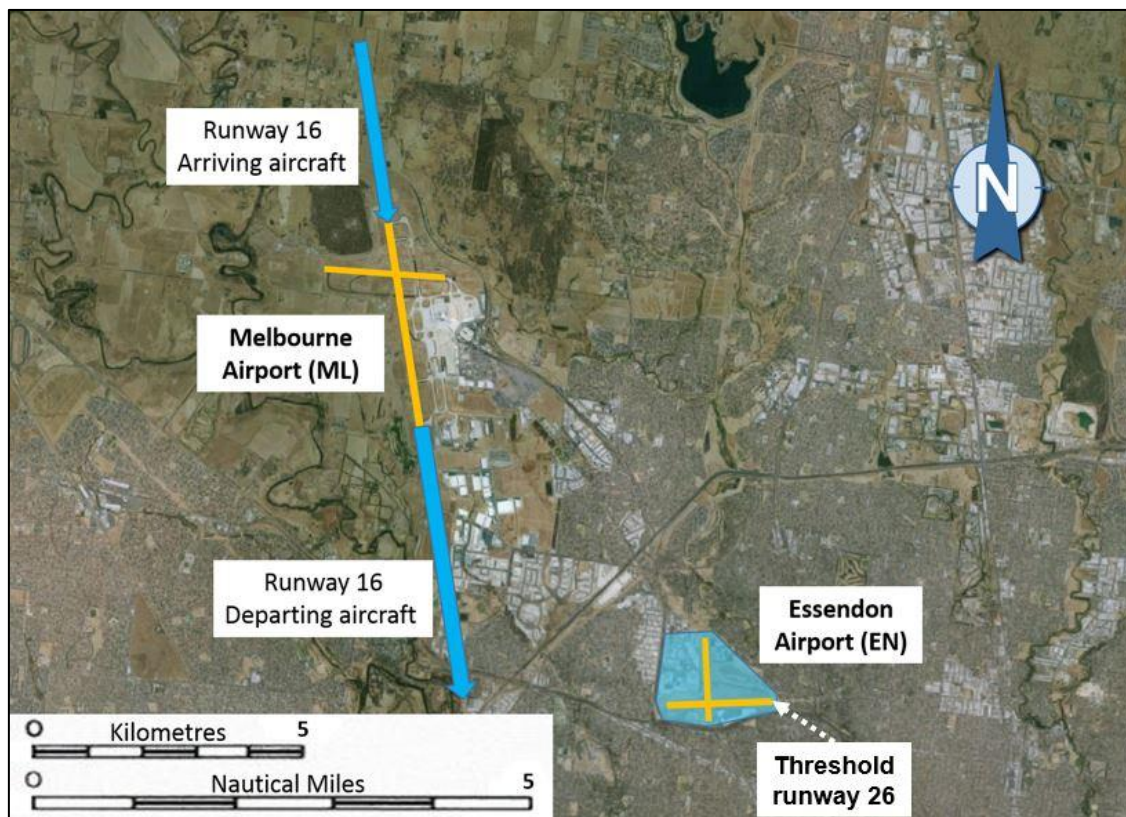
At Essendon Airport, at 0656, the pilot of a Robinson R44 helicopter, registered VH-WYR (WYR), requested taxi and airways clearance for operations at Essendon Airport. The Essendon tower controller<sup>9</sup> cleared the pilot to operate overhead the airport (Figure 2), not above 1,500 ft above mean sea level (about 1,200 ft above ground level). The pilot had elected to operate overhead the airport due to the overcast cloud<sup>10</sup> at 1,300 ft above ground level. In addition, the Essendon tower controller stated that, believing that runway 16 was only in use for arrivals at Melbourne Airport, they arranged with the pilot of WYR to land on the threshold of Essendon runway 26 (Figure 2). This arrangement was in order to ensure separation if there was a missed approach from Melbourne runway 16.

**Figure 2: Indicative flight paths for runway 16 operations at Melbourne Airport and the area overhead Essendon airport and the threshold of runway 26, where WYR was operating**
