# Breakaway of *Spirit of Tasmania II*

Station Pier, Port Melbourne, Victoria 13 January 2016

**ATSB Transport Safety Report**

324-MO-2016-001

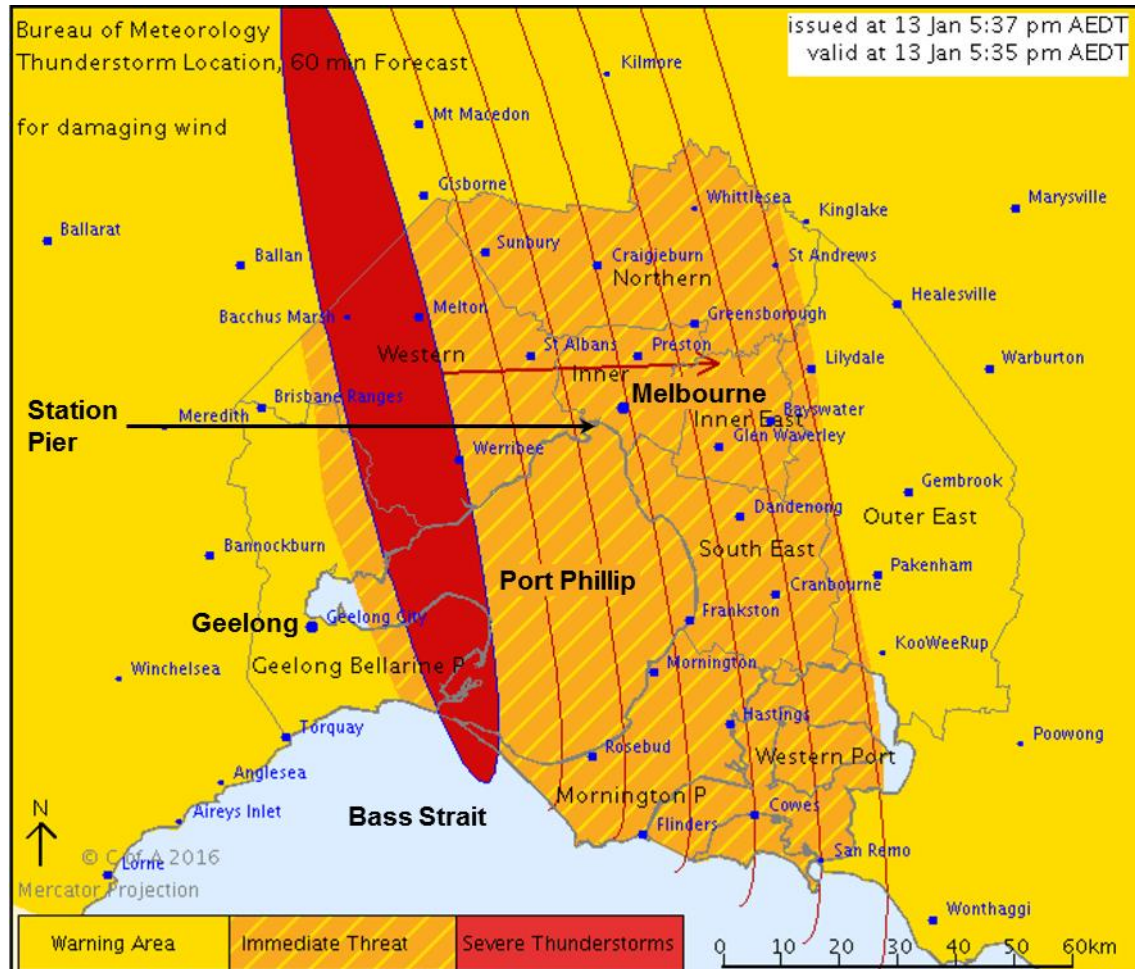
**Figure 2: Map issued with the severe thunderstorm warning at 1737 on 13 January**

It was not until shortly after 1745 that the master returned to his cabin and again checked the BoM website (no internet access was available on the bridge). He saw that a 'severe thunderstorm warning'<sup>4</sup> had been issued at 1737. The website indicated a series of thunderstorms approaching Station Pier from about 13 miles<sup>5</sup> to the west (Figure 2).

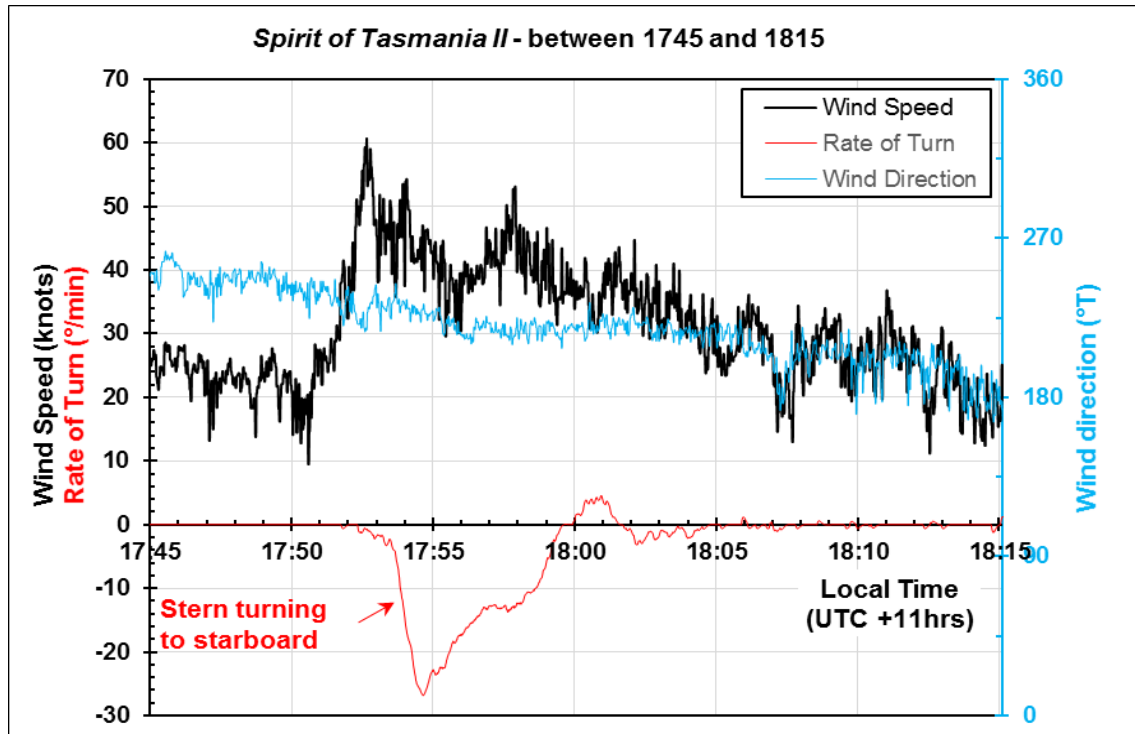
Figure 3: Wind speed and direction, and the ship's rate of turn

Shortly after, as the master left his cabin to go to the bridge, he saw the wind speed indicator outside his cabin indicated gusts of up to 59 knots. He hurried to the bridge. At 1753, the wind peaked at 60.5 knots (112 km/h) from the southwest (Figure 3). By then, about 120 passengers had boarded and the ship's stern had started to move off the wharf.

By 1755, the ship was at an angle of approximately 45 degrees to the wharf and turning away from it (negative rate of turn in Figure 3) at 27°/min.

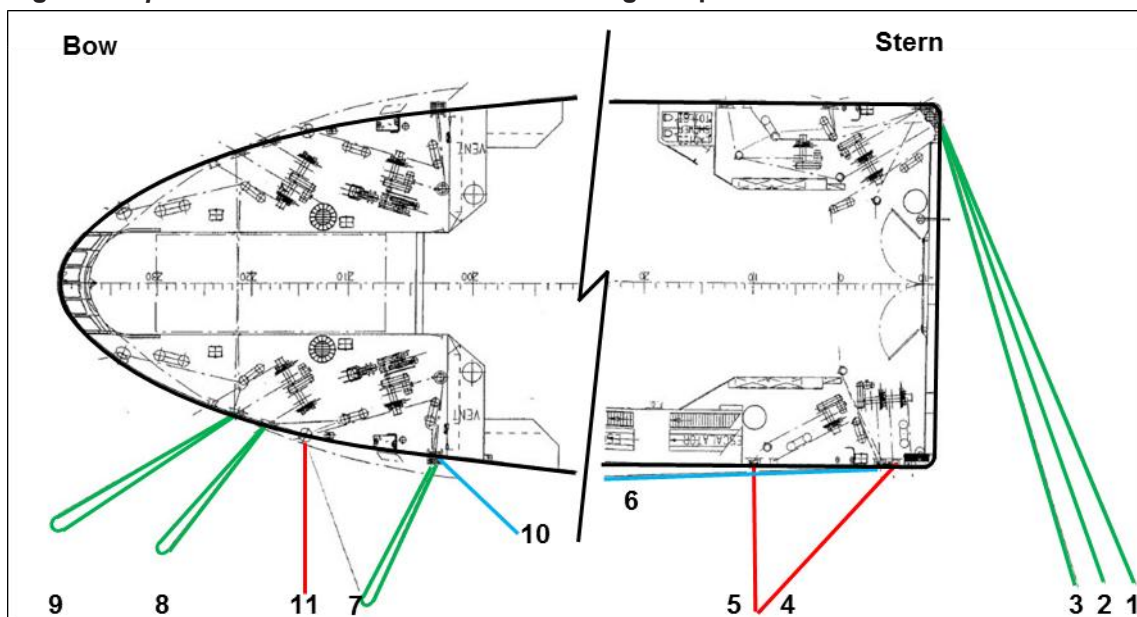
**Figure 6: *Spirit of Tasmania II*'s standard mooring line pattern for Station Pier**

*Spirit of Tasmania II*'s standard mooring line pattern<sup>7</sup> had been developed for the Station Pier berth (Figure 6). This consisted of three head lines on bights<sup>8</sup> (numbered 7, 8 and 9 in Figure 6), a spring line (10) and a breast line (11) forward, and three stern lines (1, 2 and 3), two breast lines (4 and 5) and a spring (6) line aft. All mooring lines were 64 mm diameter, mixed synthetic fibre rope,<sup>9</sup> each with a breaking load of 82 t.

Between 1751 and 1753 on 13 January 2016, the south-westerly wind at Station Pier, Melbourne, increased from about 25 knots to 60 knots. As the wind speed was peaking, *Spirit of Tasmania II*'s aft mooring lines parted in quick succession and its stern broke away from the Station Pier wharf. As the stern swung away from the wharf, the originally slack forward breast line (11) came under tension and, along with one head line on the bight (9), did not part (Figure 6).

*Spirit of Tasmania II's* mooring line pattern on 13 January was effectively the same as the standard pattern for that berth (Figure 6). The only difference was that a forward headspring<sup>22</sup> had not been run that day, and the forward breast line was slack at the time of the breakaway. Therefore, the ship was effectively being held alongside by three mooring lines on the bight forward and six lines aft (Figure 10).

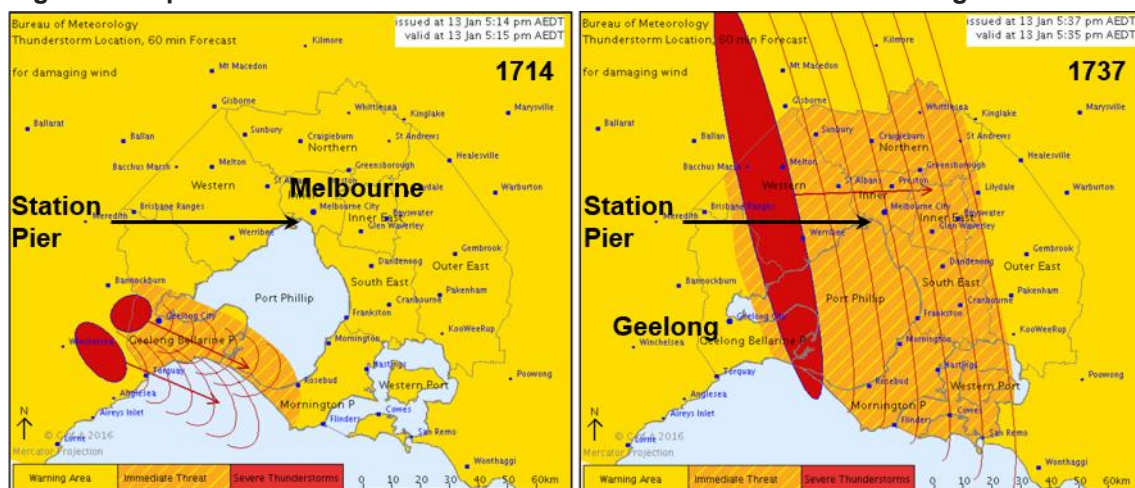
**Figure 9: Maps issued with the 1714 and 1737 severe thunderstorm warnings**

The local waters forecast at 1640 retained information about the cold front and squalls associated with thunderstorms. At 1714, a severe thunderstorm warning was issued for the Melbourne area, which indicated that two thunderstorm cells with damaging winds located southwest of Melbourne were moving southeast (Figure 9). The next warning was due to be issued an hour later, at 1815.

However, at 1737, a further severe thunderstorm warning was issued after thunderstorms were detected west of Melbourne. This band of thunderstorms with winds up to 54 knots (100 km/h) was moving east toward Melbourne and forecast to affect the city by 1805. The thunderstorm passed across Station Pier at 1753, bringing with it a sudden increase in wind speed. By 1830, the storm had passed and, a couple of hours later, the thunderstorm warnings were cancelled.
