# **Derailment of freight train 6DA2**

Near Marla, South Australia, 31 October 2015

**ATSB Transport Safety Report**

RO-2015-020

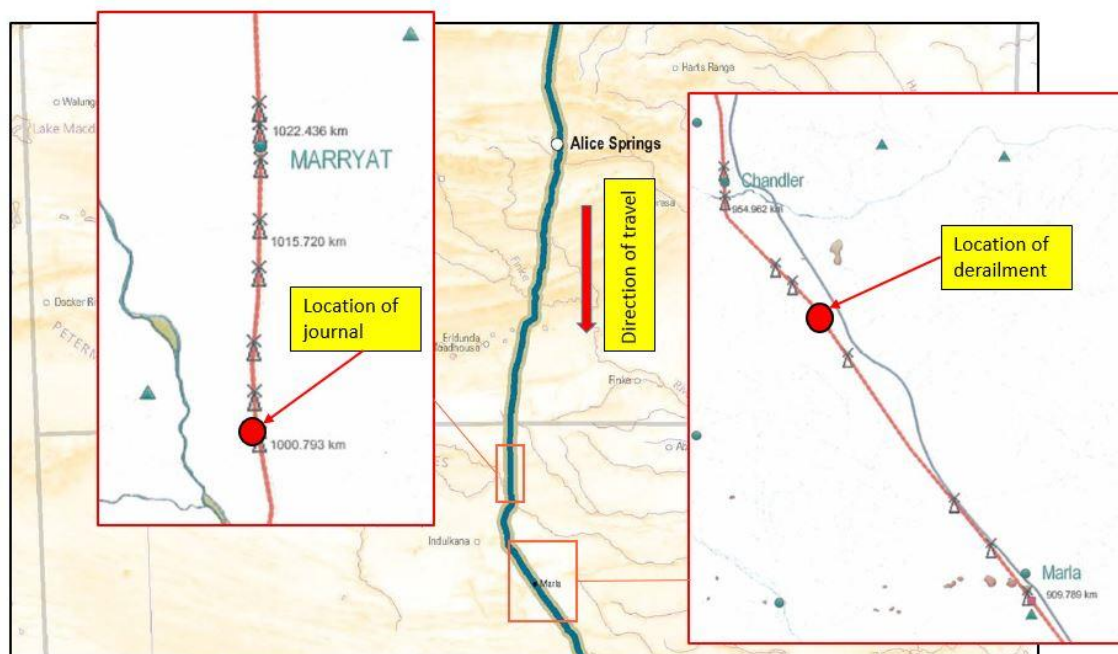
**Figure 1: Map of locality of the occurrence, the journal, and the derailment site**

Figure 1 illustrates the locality of the derailment in relation to Alice Springs. The callout box on the left illustrates where the journal was located. The callout box on the right illustrates where the train derailed. Source: Natmap annotated by the ATSB

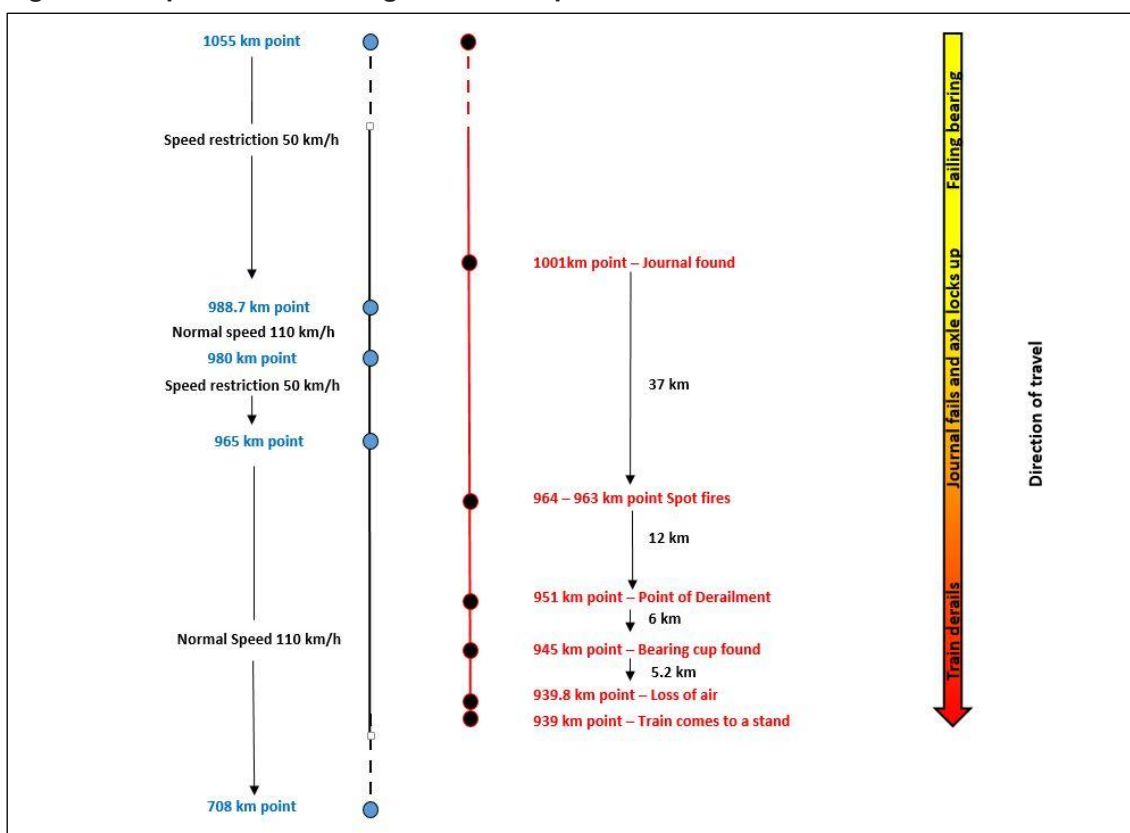
**Figure 2: Sequence of event against track speed**

Figure 2 illustrates the position of key events leading up the derailment against the permitted track speeds (speed restrictions). The illustration is not scale. Source: ASTB
