# **Derailment of freight train 9T92**

Near Julia Creek, Queensland, 27 December 2015

**ATSB Transport Safety Report**

RO-2015-028

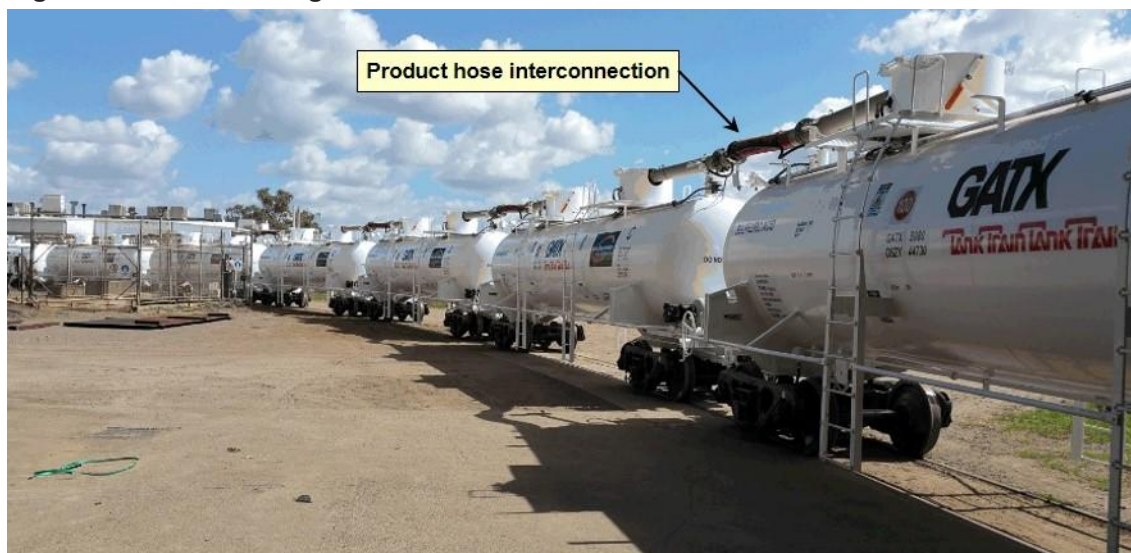
**Figure 5: GATX tank wagons**

Image of a GATX tanker wagons coupled in a string and the product hoses interconnecting each vessel. Source: Incitec Pivot

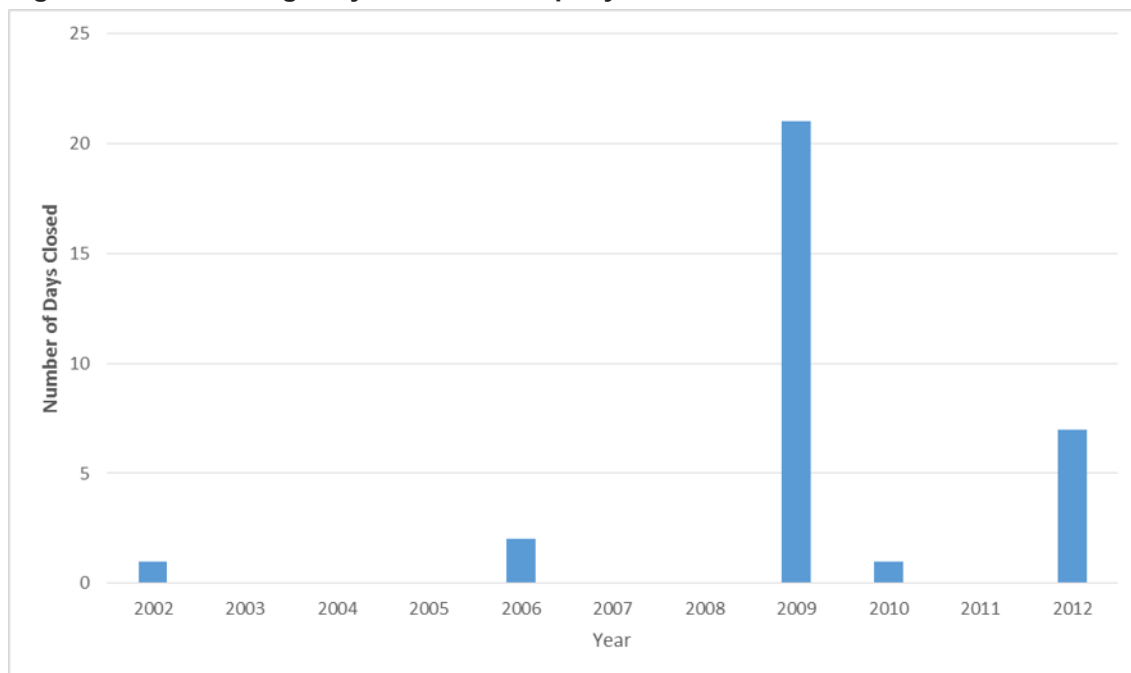
**Figure 10: Flinders Highway road closures per year between Richmond and Julia Creek**

Illustration of the number of days each year that rainfall runoff inundated the Flinders Highway at locations between Richmond and Julia Creek, resulting the closure of the highway to road traffic. The 2009 year shows a significantly larger number of days closed, which aligns with severe flood events in the region (due to active monsoon trout that developed into tropical cyclones Charlotte and Ellie). Source: Queensland Department of Transport and Main Roads data, plotted by ATSB

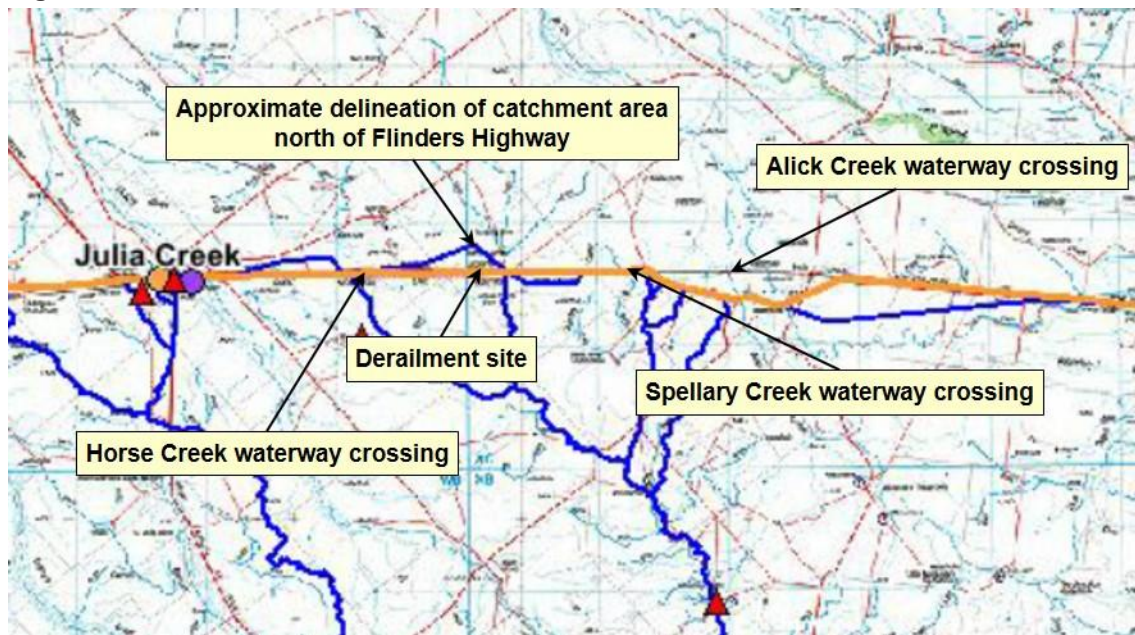
**Figure 11: Catchment Delineation Julia Creek area**

Extract from Flinders Highway Flood Study Catchment Delineation – Richmond to Cloncurry. Image illustrates catchment area to the north and south of the Flinders Highway at the derailment site. Source: Queensland Department of Transport and Main Roads

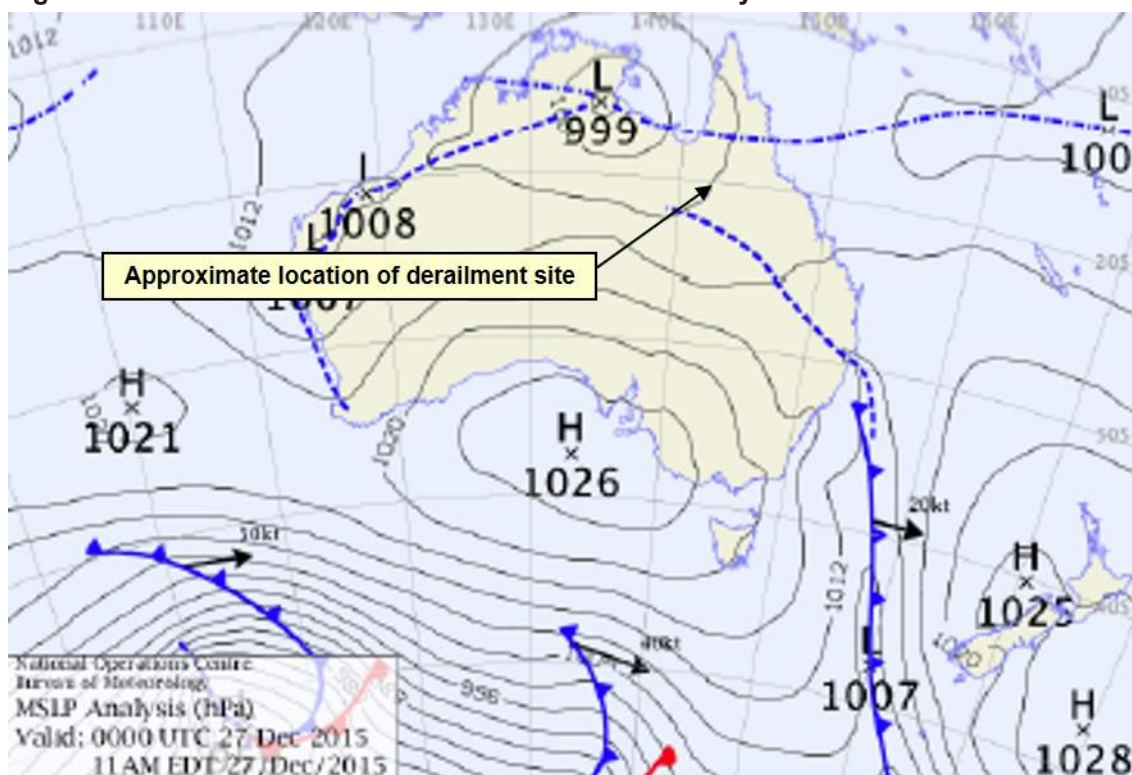
**Figure 14: Mean sea level weather chart at 1100 on Sunday 27 December 2015**

Image shows the approximate location of the derailment site relative to the path of the tropical low-pressure system tacking eastward across the Gulf of Carpentaria and the trough from the cold front extending into inland north-western Queensland. Source: Bureau of Meteorology

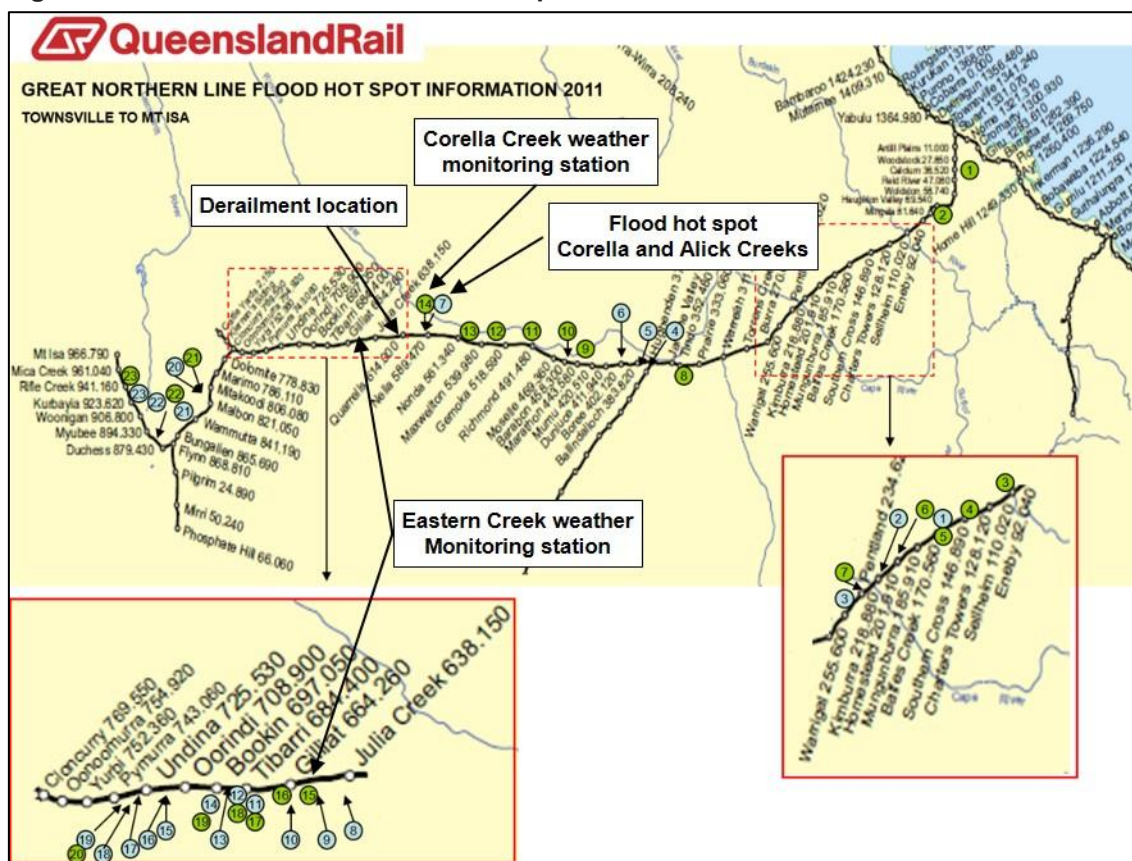
Figure 15: Great Northern Line flood hot spot information

Between Richmond and Julia Creek, the hot spot information identified one flooding hot spot located between the 590 and 601 km points that encompassed the Corella and Alick Creeks. There was no record of a flooding event at the derailment site since the early 1980s, after which QR installed the three additional 600 mm drains. QR did not consider this location to be a flooding hot spot.

Map showing locations of weather monitoring stations and identified flood hotspot areas. Weather stations indicated by green markers. Areas identified as prone to flooding identified by blue markers. Source: Queensland Rail

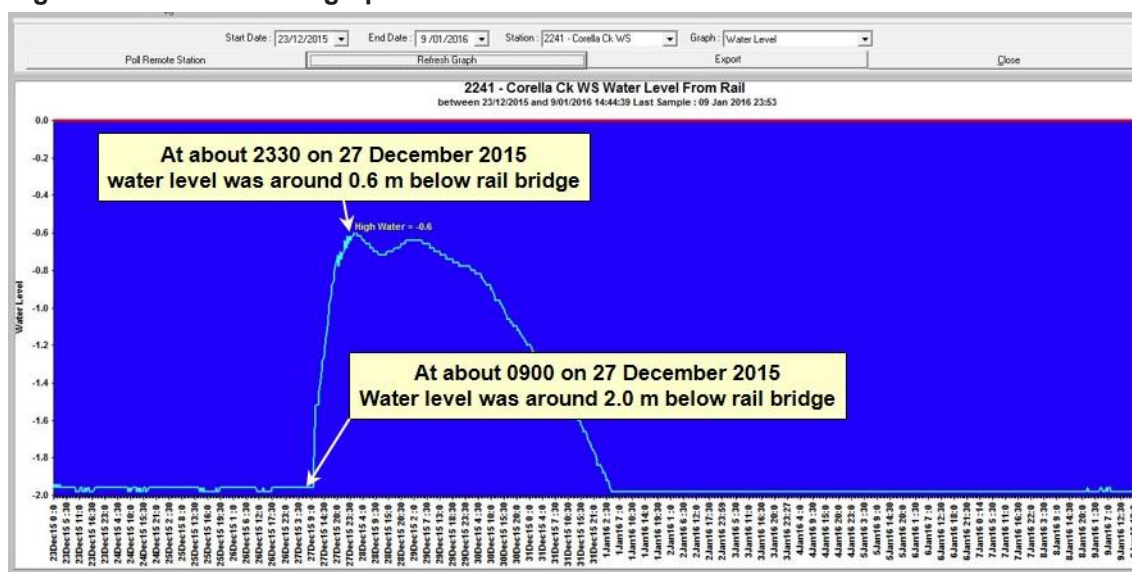
**Figure 16: Corella Creek graph of measured water level under rail**

Graph of data from the Corella Creek weather station illustrating of rise in water level under the rail bridge at that location. After the passage to train 9T92, the water level rose about 1.4 metres over the next 14 hours to a level around 0.6 m below the rail level. Source: Queensland Rail

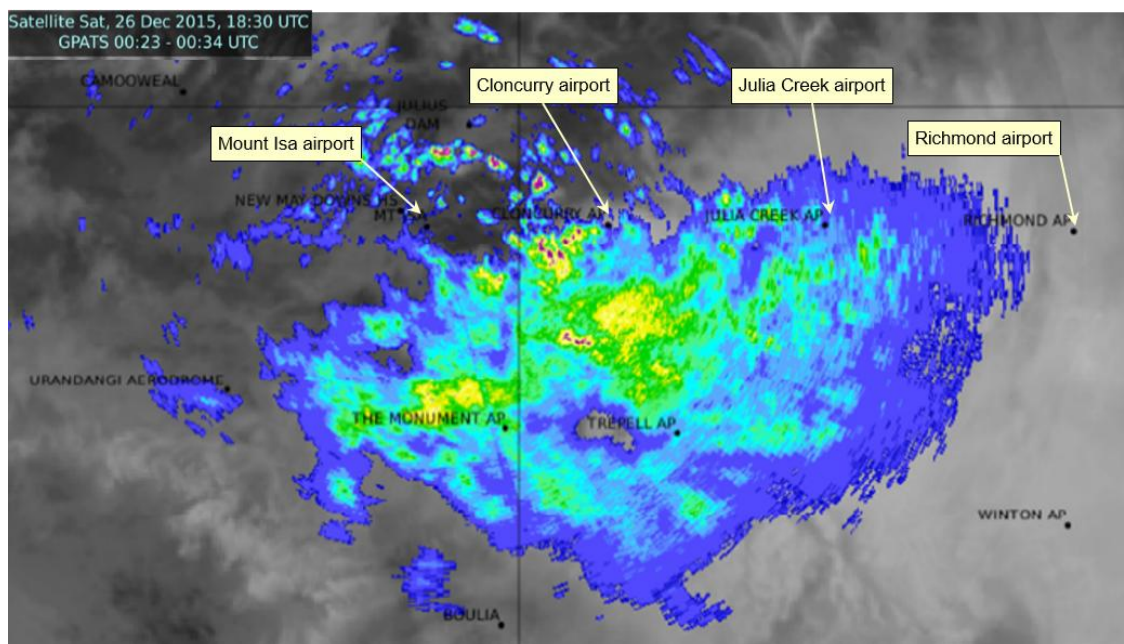
**Figure 18: Combined satellite and radar reflectivity imagery over north-western Queensland at 0430**

The information indicated a considerable amount of moisture and instability in the tropical atmosphere and the presence of heavy cloud cover and an intense cluster of thunderstorms in a rough line south of Cloncurry in the west to south of Julia Creek in the east (Figure 18). For several hours from about 0130 on Sunday 27 December thunderstorms and rainfall in the general area of the derailment appeared to be at a peak

Image depicts cloud cover at 1830UTC Saturday 26 December 2015. This equates to 0430 AEST on Sunday 27 December 2015, about 5 hours before the derailment of 9T92. Colour on image blue through green/yellow to red indicate increasing rain rate from light toward Heavy. Source: Australian Bureau of Meteorology

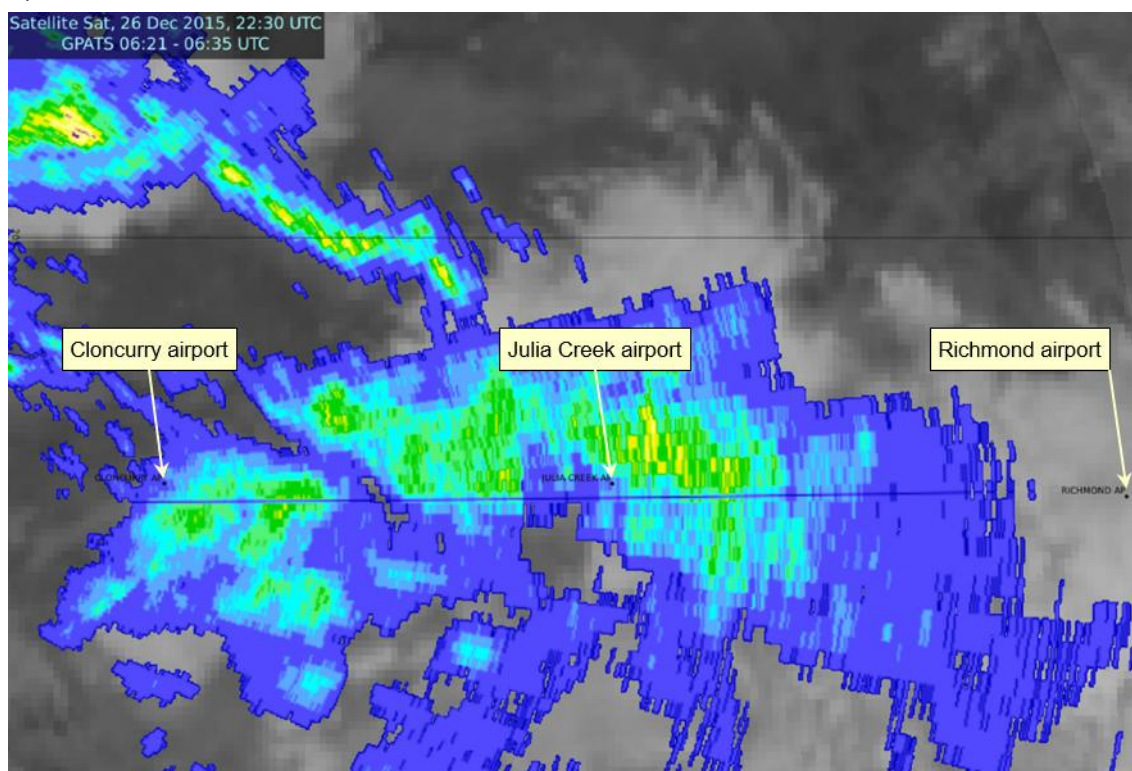
**Figure 19: Combined satellite and radar reflectivity imagery over north-western Queensland at 0830**

By about 0730 on Sunday morning, the intense storms appeared to have weakened considerably, though areas of rain and showers persisted about the Julia Creek area for the remainder of the morning – most notably to the east of Julia Creek between 0800 and 0930 prior to the passage of 9T92 through Quarrels (Figure 19).

Image depicts cloud cover at 2230UTC Saturday 26 December 2015. This equates to 0830 AEST on Sunday 27 December 2015, about one hour before the derailment of 9T92. Colour on image blue through green to yellow indicate increasing rain rate from light toward moderate. Source: Australian Bureau of Meteorology

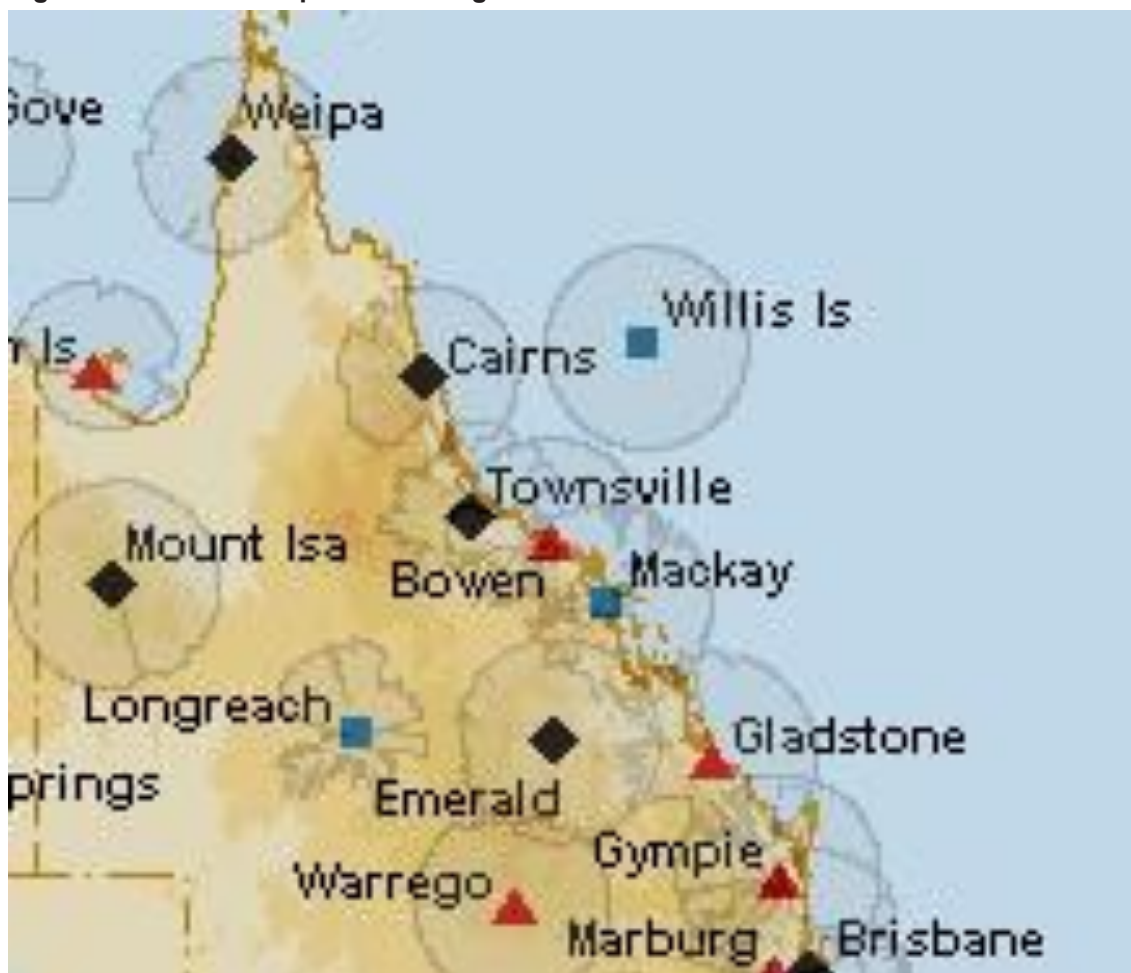
**Figure 20: BoM radar optimal coverage areas - Queensland**

An over reliance on the individual interpretation of radar images to obtain predictive information could result in the underestimation/inconsistency in assessment of likely hazard posed by weather present along the railway.

Image shows the optimal coverage areas surrounding BoM weather radar installations in Queensland. Queensland Rail references images from the Mount Isa and Bowen weather radars to identify weather conditions that may affect the Mount Isa railway. Source: Bureau of Meteorology

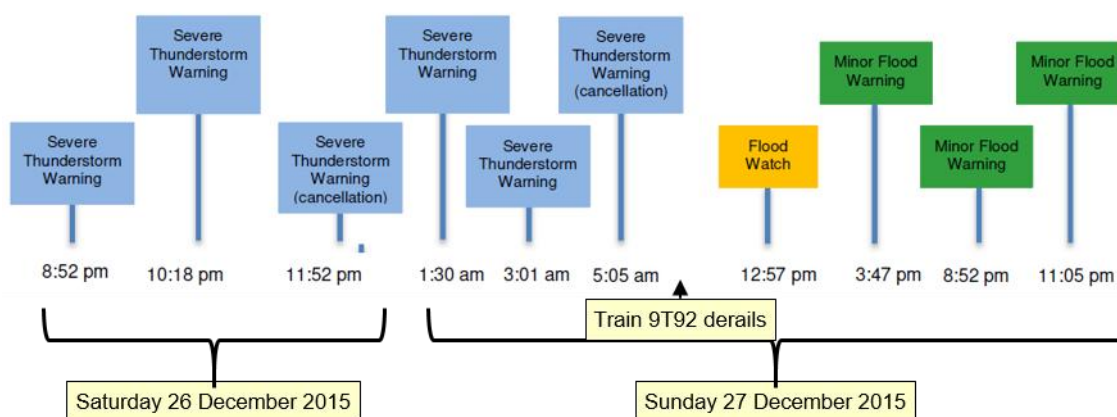
**Figure 21: Timeline of weather warnings issued on 26 and 27 December 2015 for the Julia Creek area.**

Image depicts the time line for the issuance and cancellation of severe thunderstorm warning, which included the warning of potential flash flooding. An advice for the cancellation of severe weather warnings occurred about 4 hours before train 9T92 encountered the washout and derailed. Source: Bureau of Meteorology, annotations by ATSB

Around the time of the cancellation of the Severe Thunderstorm Warnings (0505) train 9T92 was approaching the passing loop at Marathon, about 170 km from the derailment site. There was no Severe Weather Alert, Severe Thunderstorm or Flood Warning current for the Julia Creek area at the time 9T92 derailed.

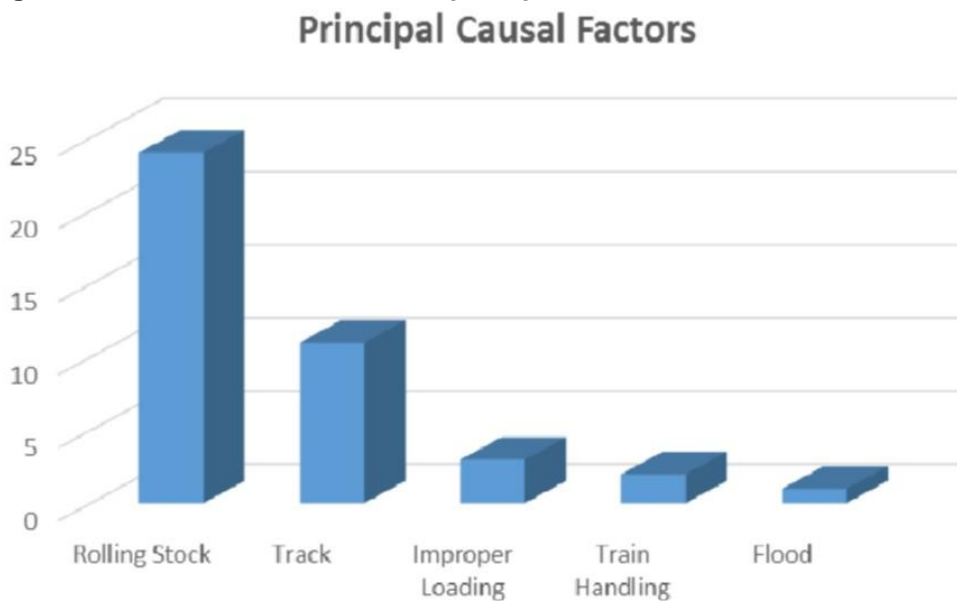
**Figure 22: Mount Isa line derailment principal causal factors**

The rail regulation unit assessed each derailment to identify the principal causal factor identifying rolling stock and track related defects as the majority contributors (Figure 22). Flooding was the causal factor identified against one main line derailment.

Graph illustrating relative incidence for each identified causal factor to a main line derailment. Source: The State of Queensland (Department of Transport and Main Roads)

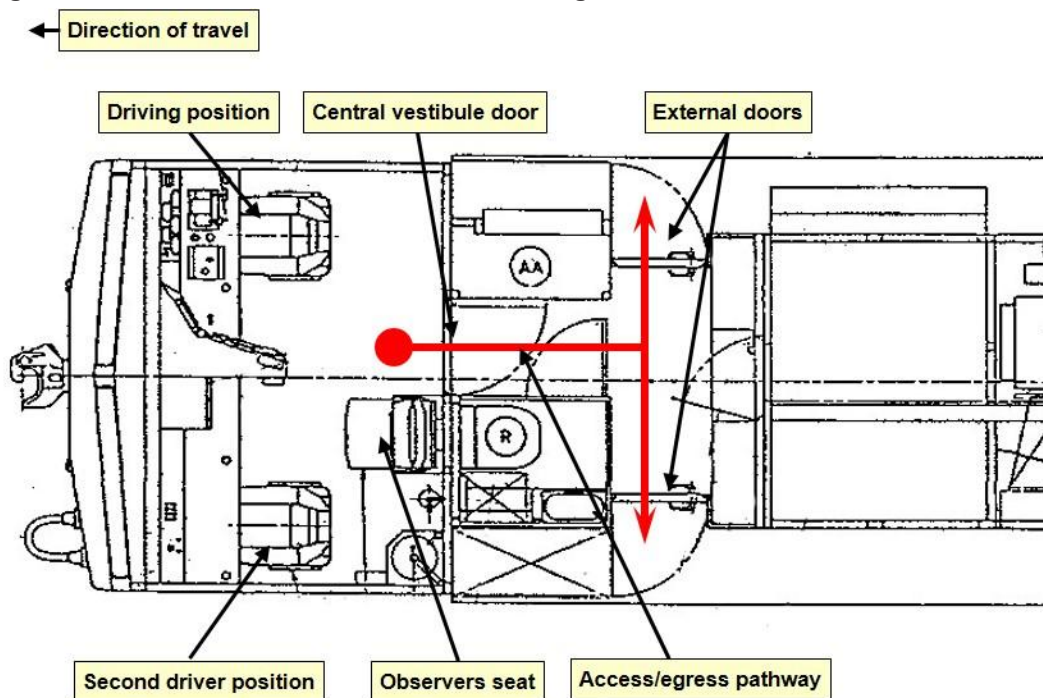
**Figure 25: 2800 class locomotive cab access/egress schematic**

The locomotive was a 2800 class locomotive, which had an enclosed cab. Access and egress to the cab was via two external doors into a central vestibule, then a central door into the rear of the cab (Figure 25). This access was also the primary emergency escape path. The supplemental escape path through side windows was available after sliding open the window, or using an emergency smash glass hammer to break out the side window.

Diagram of 2800 class locomotive emergency egress path (in red) through centre vestibule and rear side doors. Source: Queensland Rail Annotated by ATSB.
