# Derailment of freight train 9305

Katunga, Victoria 30 May 2016

**ATSB Transport Safety Report**

RO-2016-007

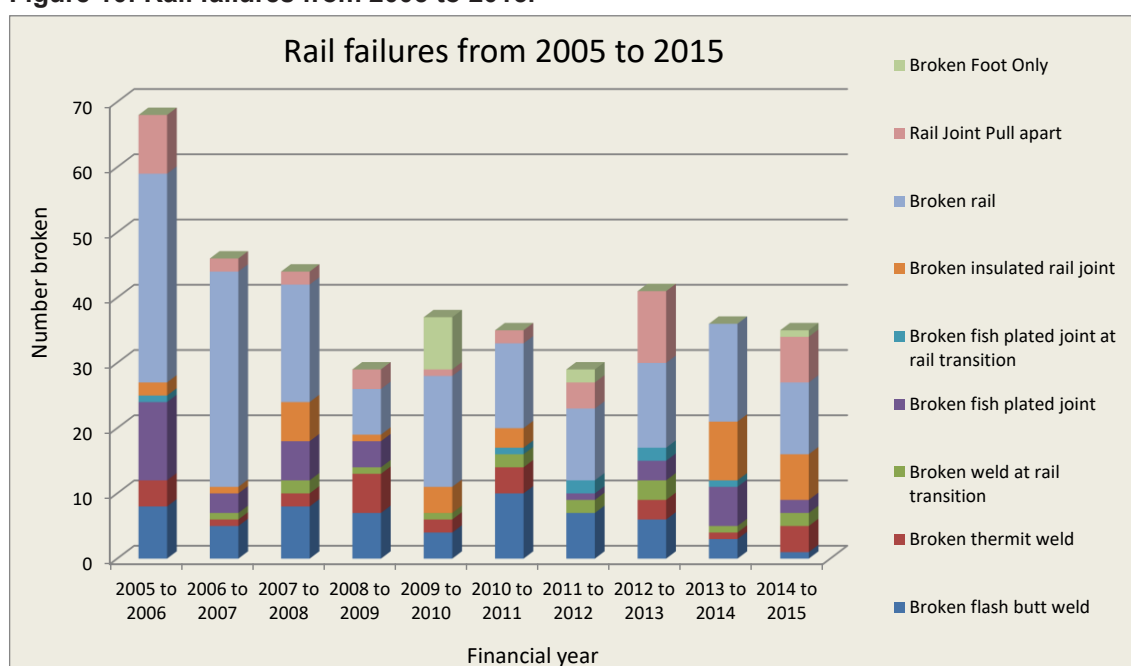
**Figure 10: Rail failures from 2005 to 2015.**

V/Line advised that there were about 330,000 flash butt welds and about 180,000 thermit welds<sup>13</sup> on their operating network. From 2005 to 2015, there were 59 flash butt weld failures, 27 thermit weld failures and a range of other fractures (Figure 10). The flash butt failures represented 15 per cent of the total annual rail failures and the failure rate is similar to other welded connections on the network.
