# TAWS alert involving ATR-GIE Avions de Transport Regional ATR72-212A, VH-FVR

Moranbah Airport, Queensland | 15 May 2013

**ATSB Transport Safety Report**  
Aviation Occurrence Investigation  
AO-2013-085  
Final – 12 March 2015

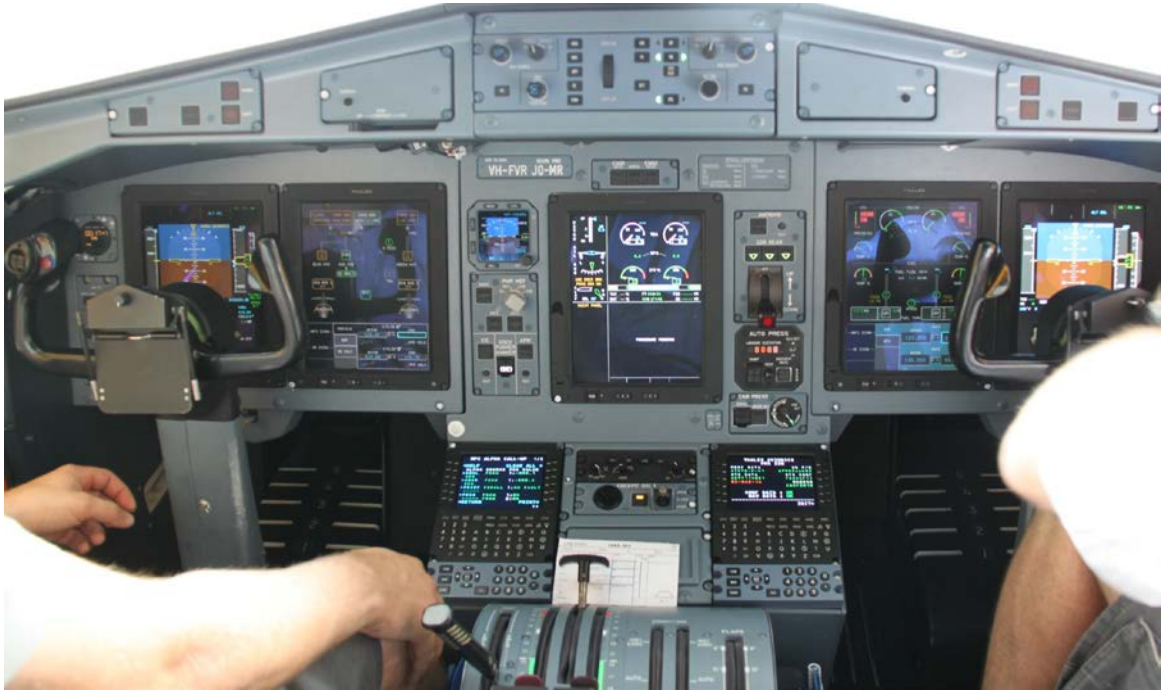
**Figure 3: VH-FVR flight information displays**

A number of cues were available to the crew to assist with monitoring the aircraft’s performance and flight profile (Figure 3). The FO reported that during flight, attention was normally given to information presented on the primary flight display (Figure 4). This included monitoring the radio altitude when at lower altitudes, the speed indicator (or ‘tape’) to ensure the aircraft did not exceed

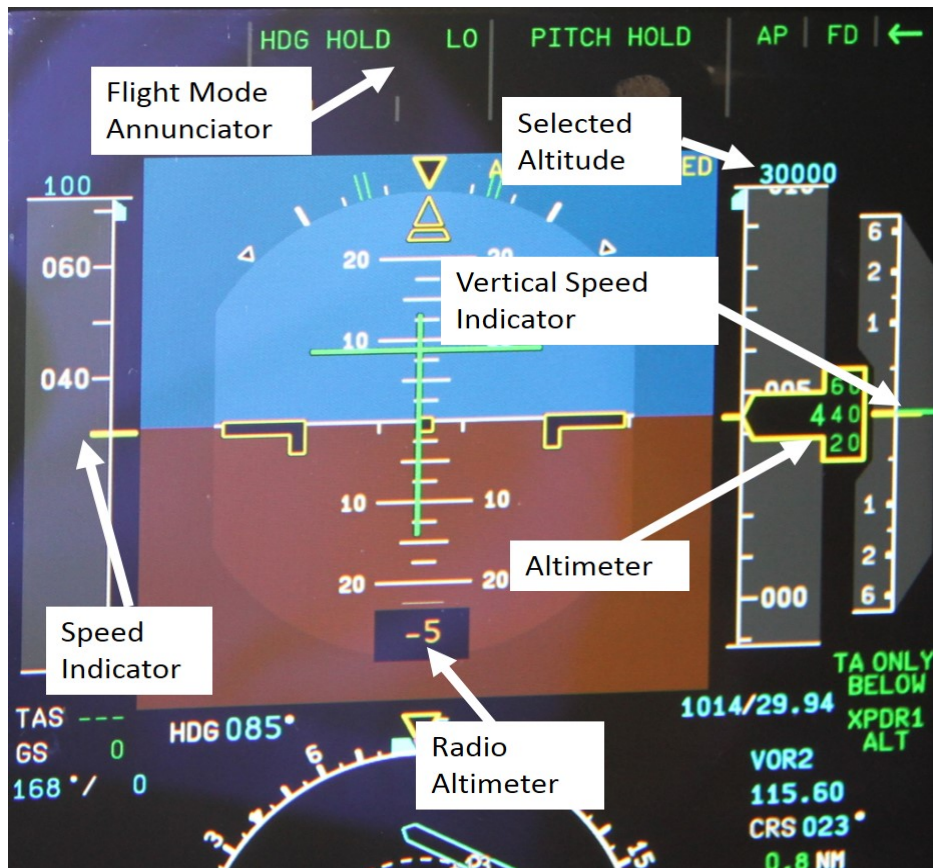
**Figure 4: ATR primary flight display**

any limitations and the vertical speed indicator to ensure the aircraft's vertical speed was appropriate for the phase of flight.

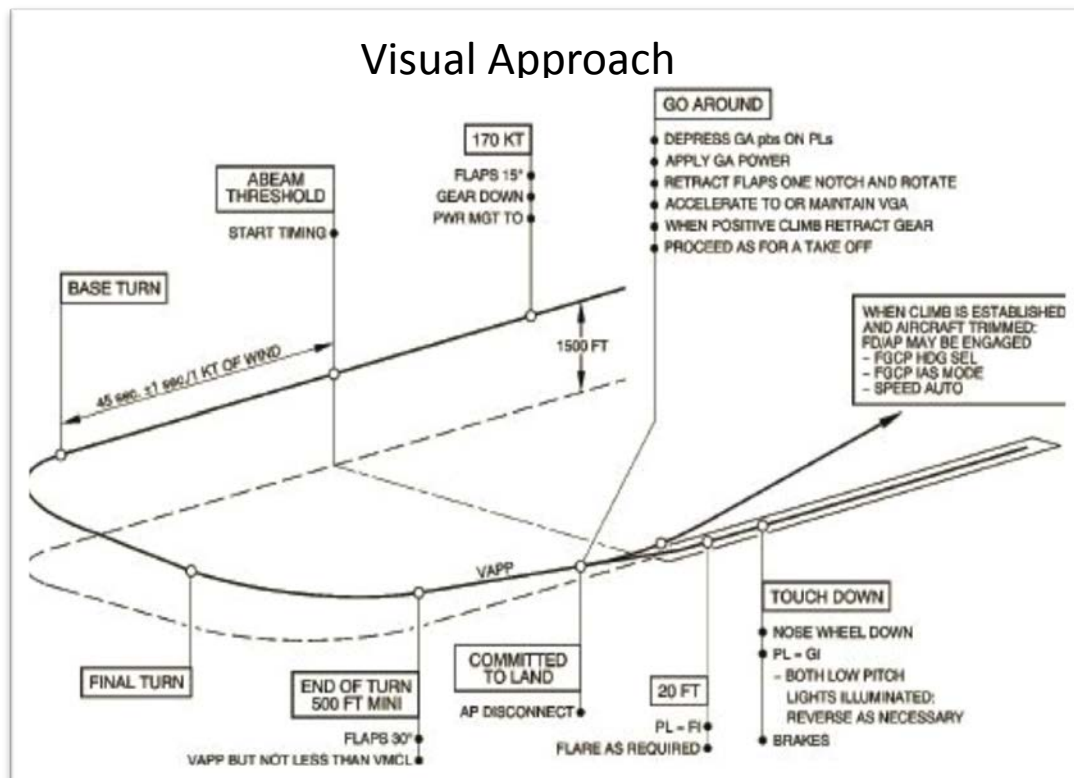
**Figure 5: Visual approach procedure in the ATR72 FCOM**

The FCOM includes the aircraft manufacturer's information and procedures specific to the operation of the ATR72 and the contents are unable to be modified by the operator. A visual approach procedure diagram was included that highlighted the required altitudes, speeds, descent positions, aircraft configuration and crew actions at various points in the approach (Figure 5).

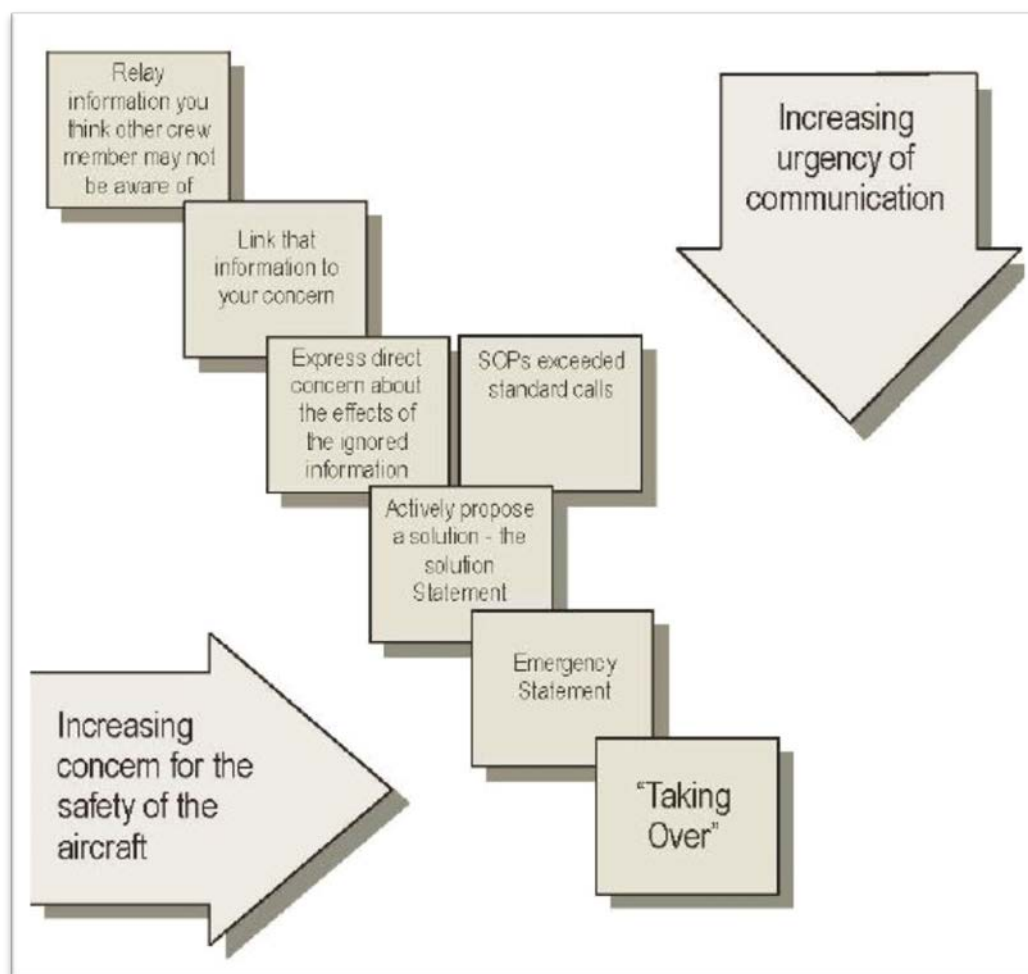
**Figure 6: Support Process – a guide to the relative urgency of communication**

The FOPPM also contained information on the importance of effective Crew Resource Management and of the support crew member proactively responding to any non-standard in-flight deviations that increase the risk to the safety of the flight. The urgency of communicating those concerns or observed deviations and taking appropriate action to ensure they were addressed in a considered way was highlighted (Figure 6). This included the use of standard calls.
