# **Descent below lowest safe altitude and ground proximity alert involving Cirrus SR22T, VH-XXO**

Canberra Airport, Australian Capital Territory, on 2 October 2025

## **ATSB Transport Safety Report**

AO-2025-061

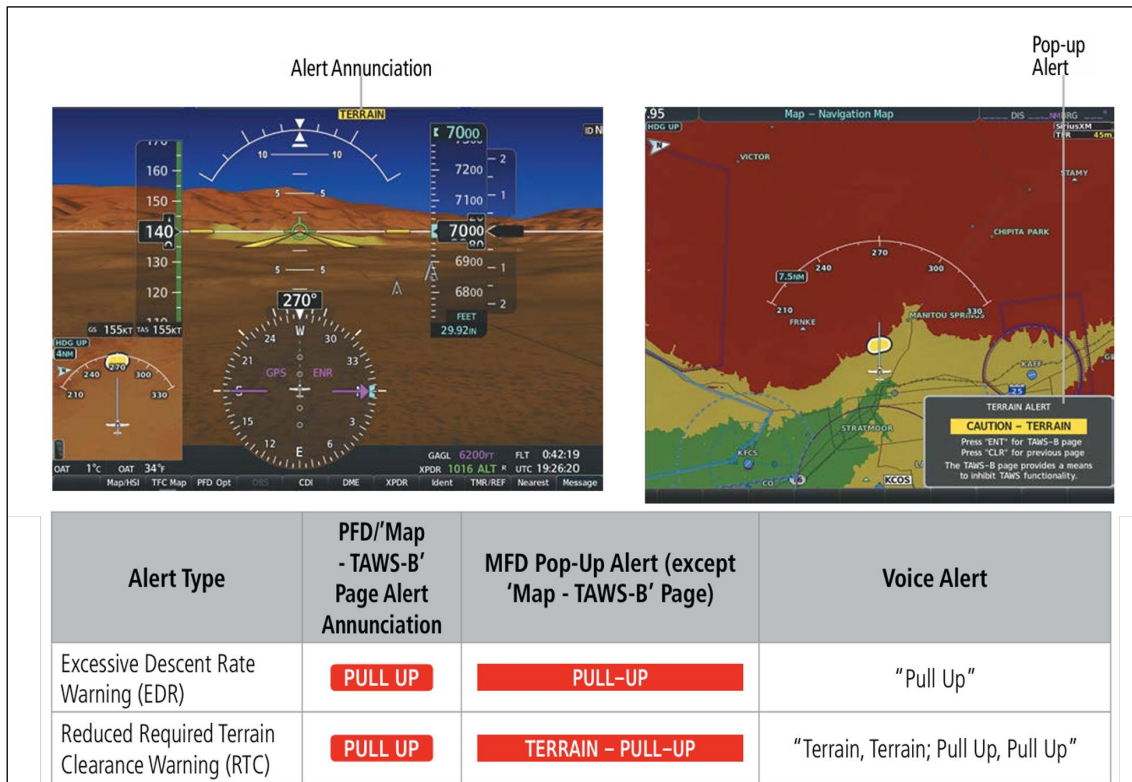
Figure 4: Synthetic vision and terrain awareness warning system alerts

The aircraft's avionics system included a TAWS certified by the United States Federal Aviation Administration (FAA). The TAWS is a system designed to provide visual and auditory advisory alerts to a pilot if their aircraft is in immediate danger of flying into the ground or an obstacle. In VH-XXO, terrain alerts were displayed in red and yellow shading on the primary flight display (PFD) and MFD (Figure 4). The Cirrus pilot operating manual did not provide guidance on the actions to take in response to a TAWS alert.

Garmin synthetic vision technology (SVT) is an optional visual enhancement to the system that was fitted to VH-XXO. SVT depicts a forward-looking display of the topography immediately in front of the aircraft, derived from the system's internal database.

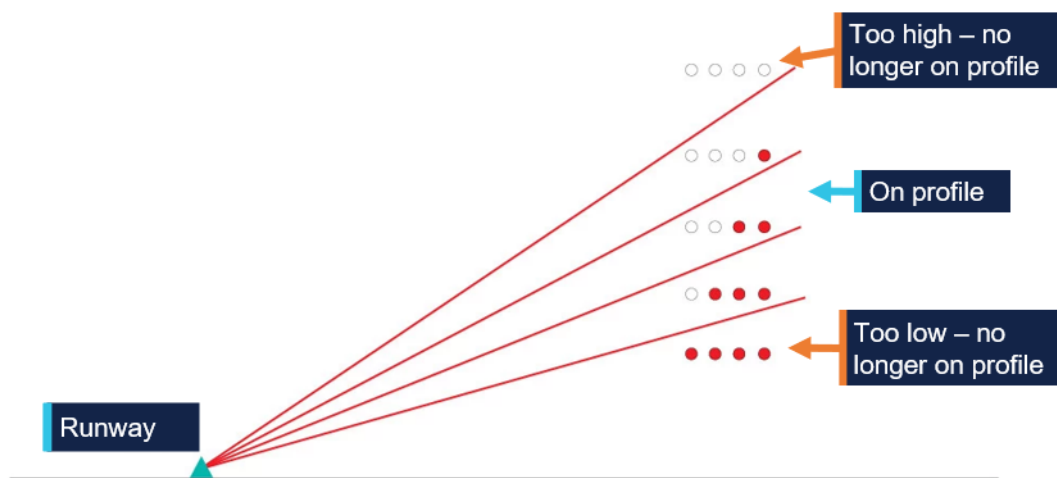
**Figure 5: Generic PAPI light indications (not to scale)**

The elevation of Canberra Airport is 1,886 ft. Runway 30 was equipped with a precision approach path indicator (PAPI). This system used a set of lights that provided visual guidance for the pilots to help establish and maintain the correct approach slope (vertical glide path or angle). When flying a normal approach path, an equal number of red and white lights would be seen by the pilot (Figure 5). If an aircraft is below the nominal approach slope, there would be more red lights than white, and above the slope, more white lights than red would be visible.

The approach slope for runway 30 was 3.9° and the PAPI lights changed indication with approach slope. When close to the nominal slope, 2 red and 2 white lights would be visible (this is called 'on profile' or 'on slope'). It is generally acceptable to allow 3 red or 3 white lights to be visible. For runway 30 at Canberra, 3 red lights would be visible on an approach of less than about 3.65°, and 4 red lights would be visible on an approach of less than about 3.32°. The standard, and most common, slope for runways without high terrain on approach is 3.0°.

The ATSB found that there was a misinterpretation of the available visual cues for maintaining glidepath, which probably affected the pilot's ability to assess and correct the aircraft's low final approach altitude. This resulted in the pilot continuing the approach despite being below the normal approach profile.

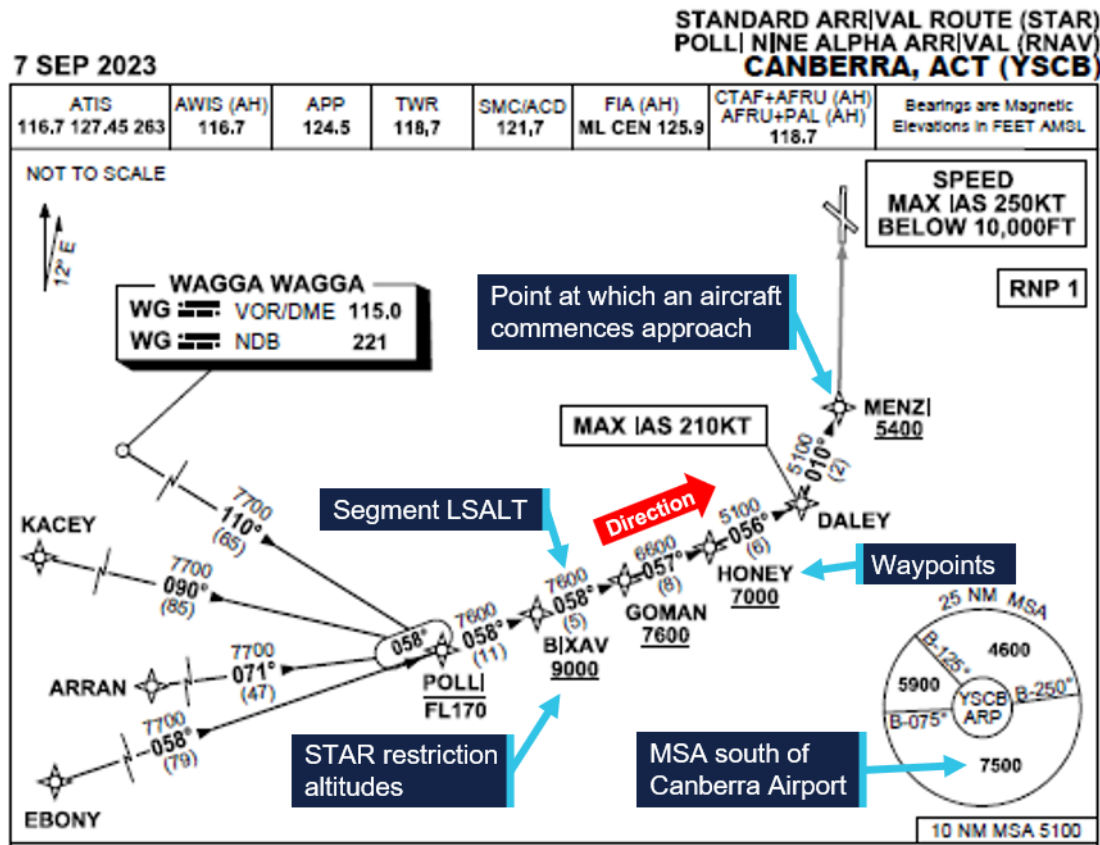
Figure 6: POLLI 9 ALPHA standard arrival route

The STAR had a requirement to not descend below 9,000 ft<sup>1</sup> until after the waypoint BIXAV. As the aircraft approached waypoint BIXAV, the approach controller, based in Melbourne, provided the following clearance: 'when ready descend via the STAR to 7,000 [ft]'. The pilot asked the controller to repeat the clearance, which the controller did. The pilot read back the descent clearance, then read back the 'via STAR' condition in a second transmission. The pilot believed that they were cleared to descend immediately, and at 1829:29, the pilot commenced a descent from the cruising altitude of 9,000 ft (point ① on the diagrams).

A standard arrival route (STAR) is a series of waypoints with speed and/or altitude restrictions to guide aircraft towards a runway for an approach to landing. The Canberra POLLI 9 ALPHA STAR is shown in Figure 6. Lowest safe altitudes (LSALT) are shown above each segment, and the altitude restrictions are shown below each waypoint name. A line beneath the number means that the aircraft must remain at or above the given altitude.
