**BUREAU OF AIR SAFETY INVESTIGATION  
REPORT**

**BASI Report  
B/925/3042**

**British Aerospace BAe 146-200A  
Near Meekatharra, Western Australia  
22 March 1992**

**British Aerospace BAe 146-200A VH-JJP**  
**Near Meekatharra, Western Australia**  
**22 March 1992**

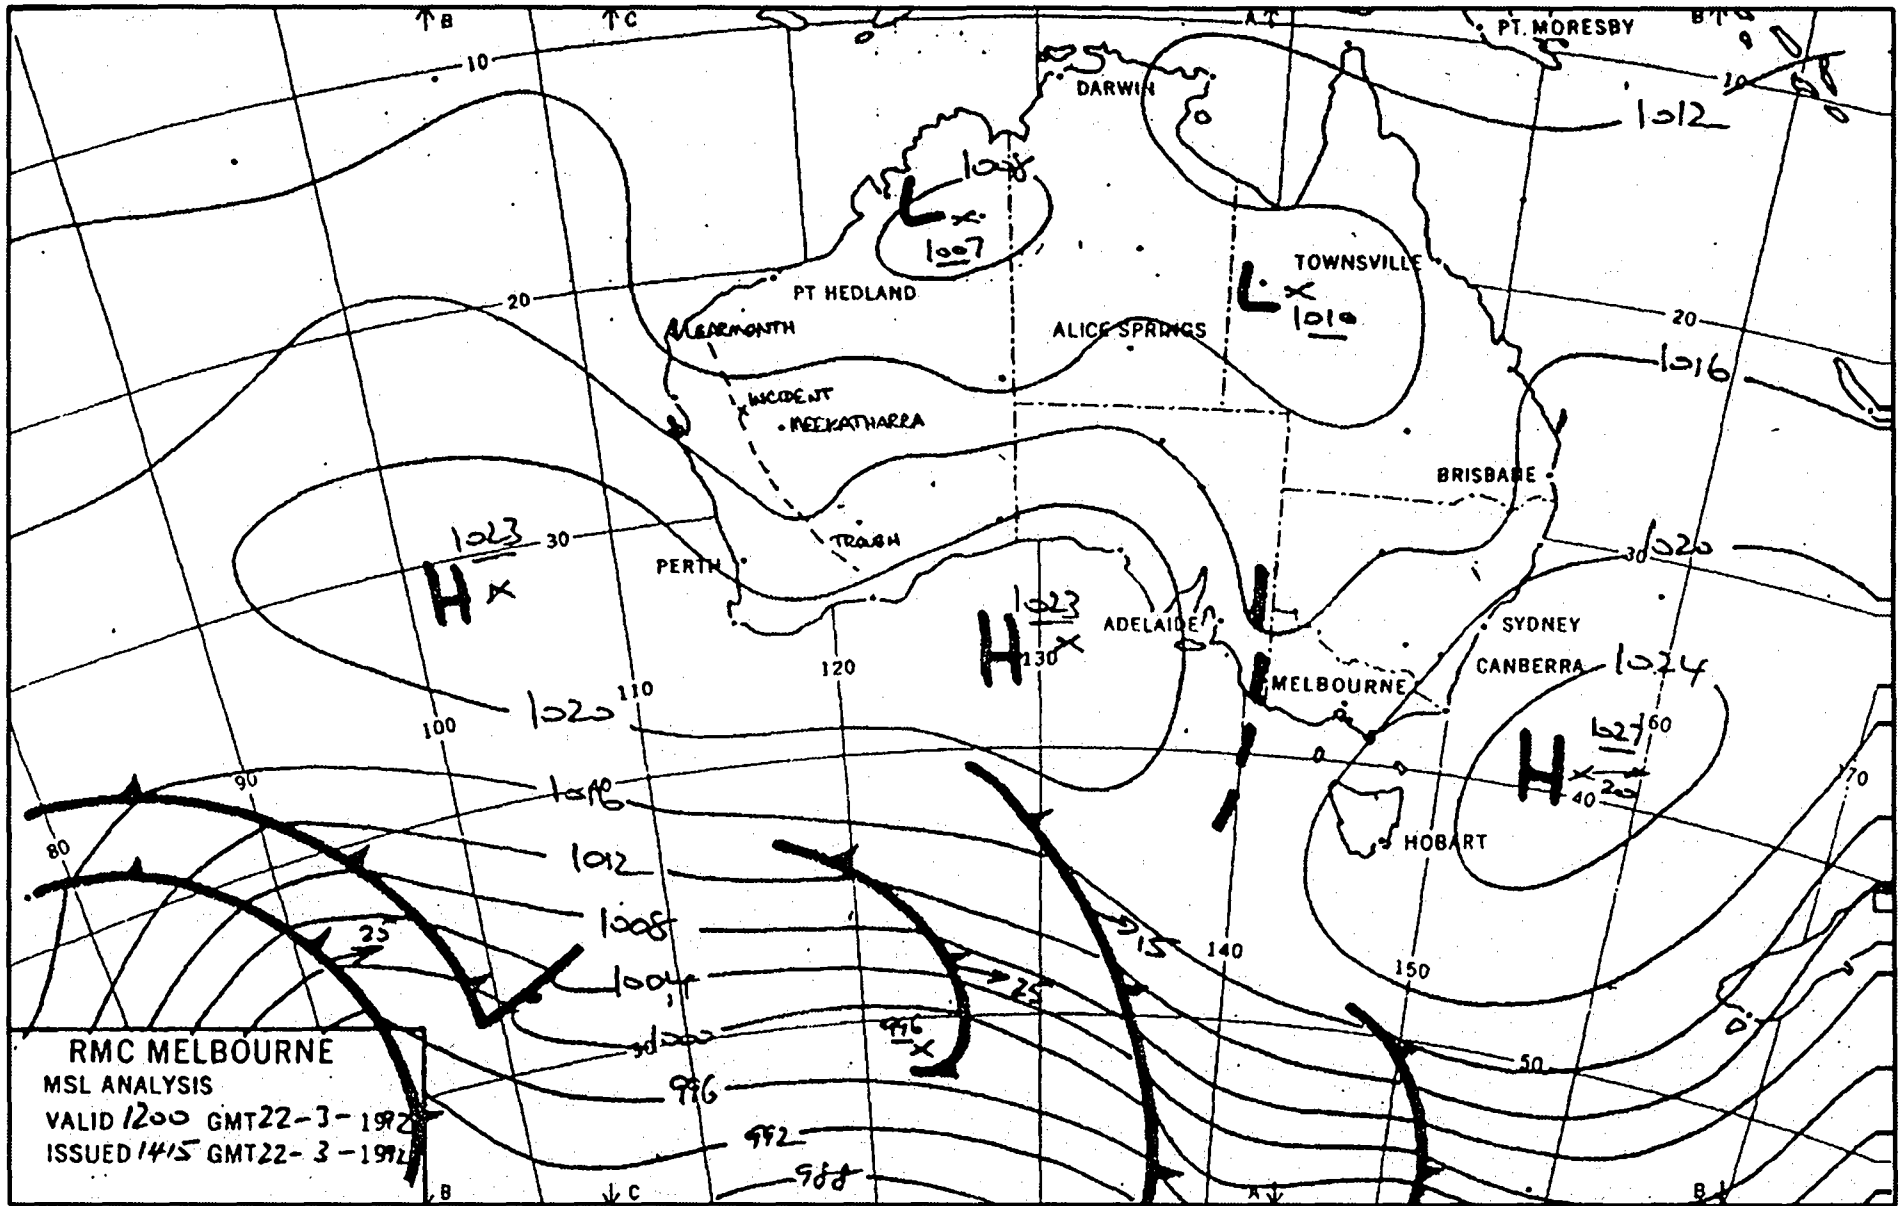
Figure 1: MSLP Analysis for 1200Z 22 March 1992

At 1200Z 22 March 1992, a high pressure ridge lay with its axis to the south of the state. High centres of approximately 1023 hectopascals (hPa) were identified near 31°S 105°E and 36°S 131°E (Figure 1). A low of 1007 hPa was located over the central Kimberley area.

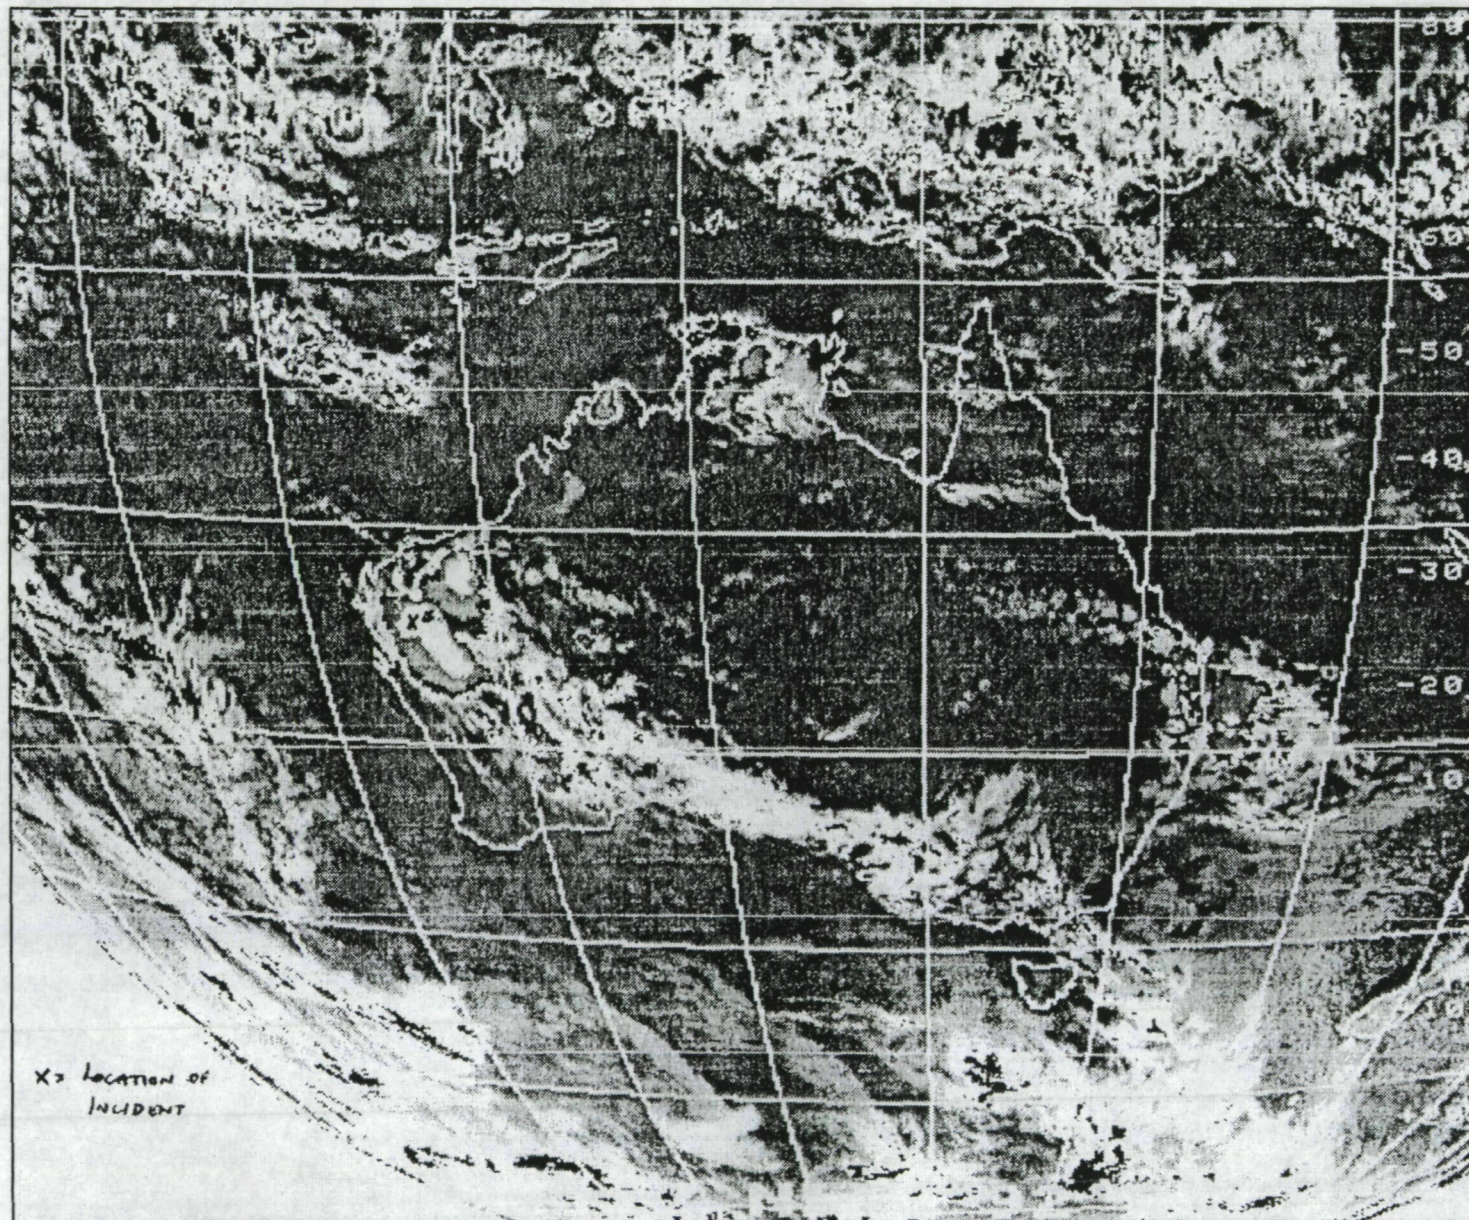
Figure 2: Enhanced Infrared Imagery (GMS4) for 1200Z 22March 1992

From the infrared satellite image (GMS4) taken at 1130Z on 22 March (Figure 2), it can be seen that the most active weather area Australia-wide was located in the general vicinity of the incident.
