Aircraft proximity event between two Piper PA-28 aircraft, VH-LXH and VH-TAU

Moorabbin Airport, Victoria, 26 November 2012

ATSB Transport Safety Report
Aviation Occurrence Investigation
AO-2012-159
Final – 21 March 2013

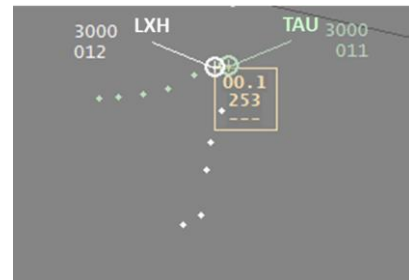
Figure 1: Aircraft position at 1528

At 1528, TAU was observed commencing the turn onto crosswind, at 700 feet above mean sea level (AMSL)². At that time, LXH was on mid-crosswind, maintaining 1,100 feet (Figure 1). The instructor of TAU noted that the turn was commenced at an earlier than normal position and advised the student to conduct the turn later on the next circuit. At that time, the instructor of LXH also observed TAU turn onto crosswind early and continued to monitor the aircraft. A review of the radar data indicated that the turn occurred earlier than other aircraft in the circuit.
