Aviation Occurrence Investigation AO-2007-060

Collision with terrain

Uaroo Station, Pilbara, WA

Cessna Aircraft Company 172M

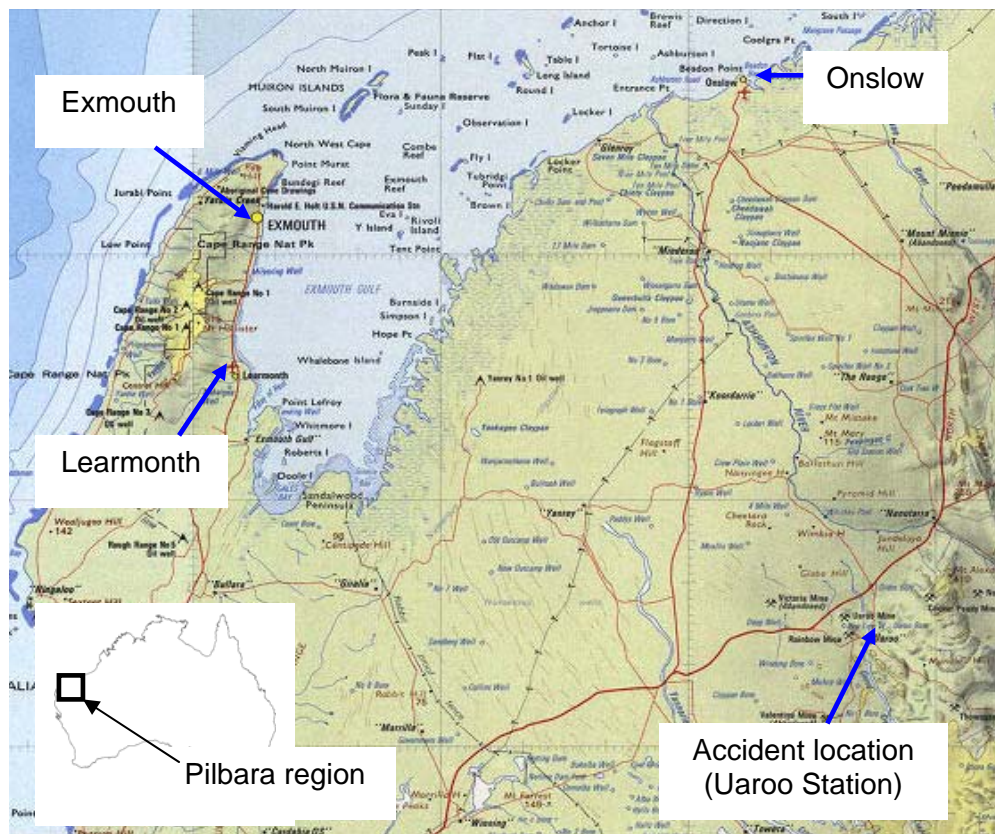
Figure 1: Accident location

At about 0730 Western Daylight-saving Time¹, on 17 November 2007, the wreckage of a Cessna Aircraft Company C172M aircraft, registered VH-TCS, was discovered on the side of a hill at Uaroo Station, in the Pilbara region of WA (Figure 1). The wreckage was located about 500 m from the property airstrip (Figure 2). The aircraft had been destroyed by impact forces and a post-impact fire. The pilot, who was the sole occupant, had been fatally injured.

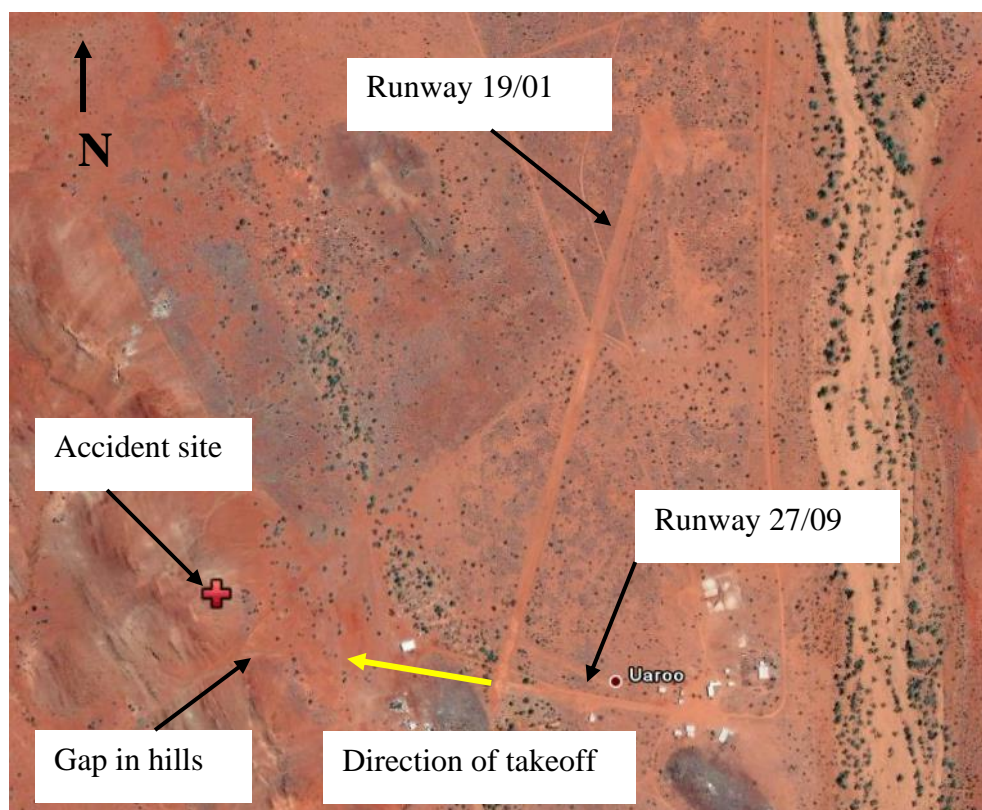
Figure 3: Accident location

The airstrip at the property included two gravel runways aligned 195/015 degrees and 1,100 m (3,600 ft) long, and 270/090 degrees and 400 m (1,300 ft) long (Figure 3). A line of hills, which ran in a north-south direction, was located to the west of the airstrip. The tops of those hills were about 46 m (150 ft) above the level of the

airstrip. A gap in the line of hills was located about 50 m to the south of the accident site.
