Aviation Occurrence Investigation – AO-2007-060

Preliminary

**Collision with terrain  
Uaroo Station, Pilbara, WA  
15 November 2007  
Cessna Aircraft Company 172M, VH-TCS**

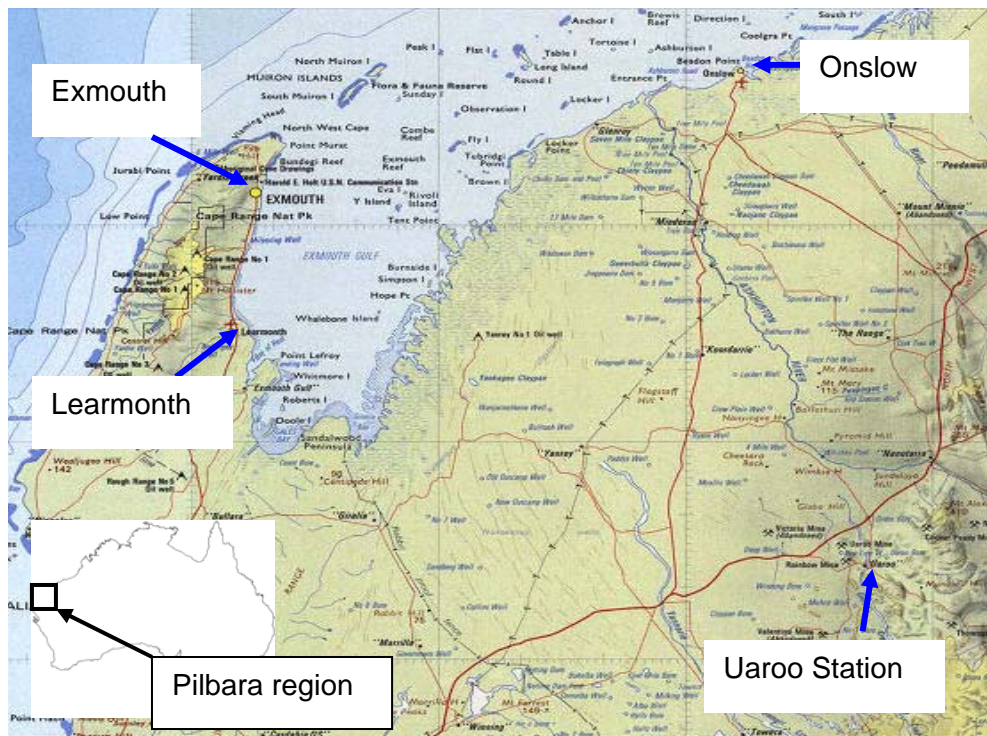
**Figure 1: Accident location**

Late in the afternoon on 15 November 2007, a Cessna Aircraft Company 172M aircraft, registered VH-TCS, took off from Uaroo Station, in the Pilbara region of WA (Figure 1), for a local flight under the visual flight rules. A witness driving in a northerly direction along the North West Coastal Highway subsequently reported seeing a column of ‘dark smoke’ in the direction of the property between about 1700 and 1730 Western Daylight-saving Time<sup>1</sup>.
