ATSB TRANSPORT SAFETY REPORT

Aviation Occurrence Investigation – AO-2008-010

Interim Factual

Mid-air collision

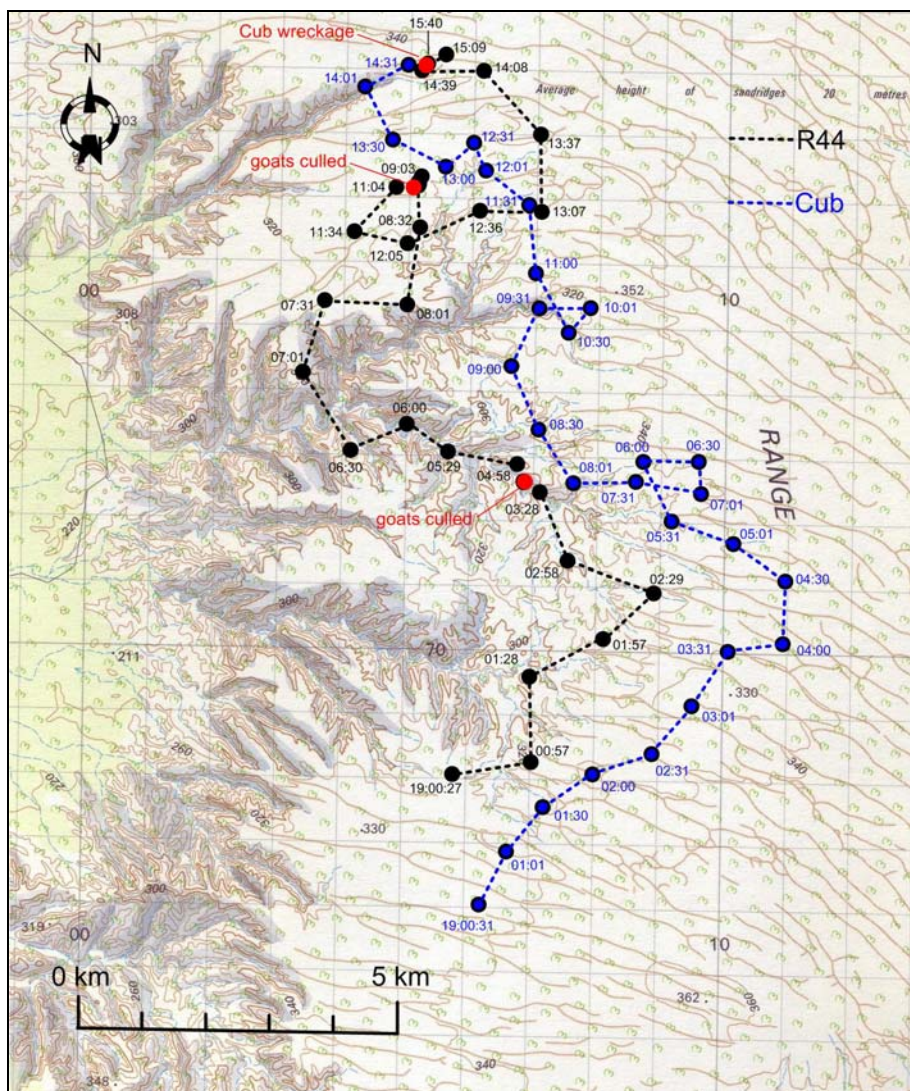
Figure 2: GPS track data for both aircraft²

The operation proceeded without incident until about 1914, when the R44 pilot and shooter observed the Cub flying towards them at the same height, estimated to be about 300 ft above ground level (AGL) (Figure 2). The pilot of the R44 reported that the Cub diverged slightly right, putting it on the left side of the R44. At about the time the aircraft passed each other, the R44 pilot entered a climbing left turn, intending to take up a reciprocal heading to continue the search for goats, while

² Both aircraft's onboard GPS units recorded their respective aircraft's position at 30 second intervals. The lines between those recorded points approximate the aircrafts' movement and do not accurately reflect any turns by the aircraft – for example, the turn described by the R44 pilot prior to the collision.
