Aviation Occurrence Investigation – AO-2008-014

Preliminary

Mid-air collision – 10 km NE of Wee Waa, NSW

26 February 2008

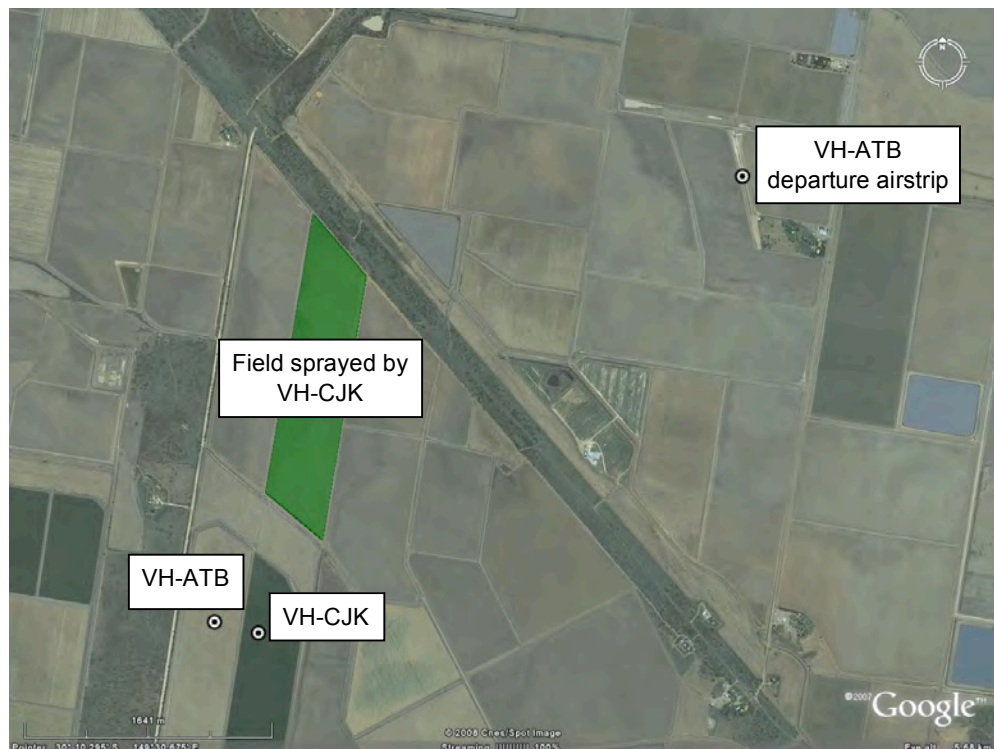
Figure 1: Satellite image of accident site

KIAS² to his usual transit height of between 500 ft and 600 ft above ground level (AGL) when the two aircraft collided. Both aircraft crashed into fields just to the south of the field being sprayed by CJK (Figure 1).
