Bureau of Air Safety Investigation

**MU-2 ACCIDENT INVESTIGATION**  
and  
**RESEARCH REPORT**

**VH-BBA near Leonora WA, 16 December 1988**  
**VH-MUA at Meekatharra WA, 26 January 1990**

January 1992

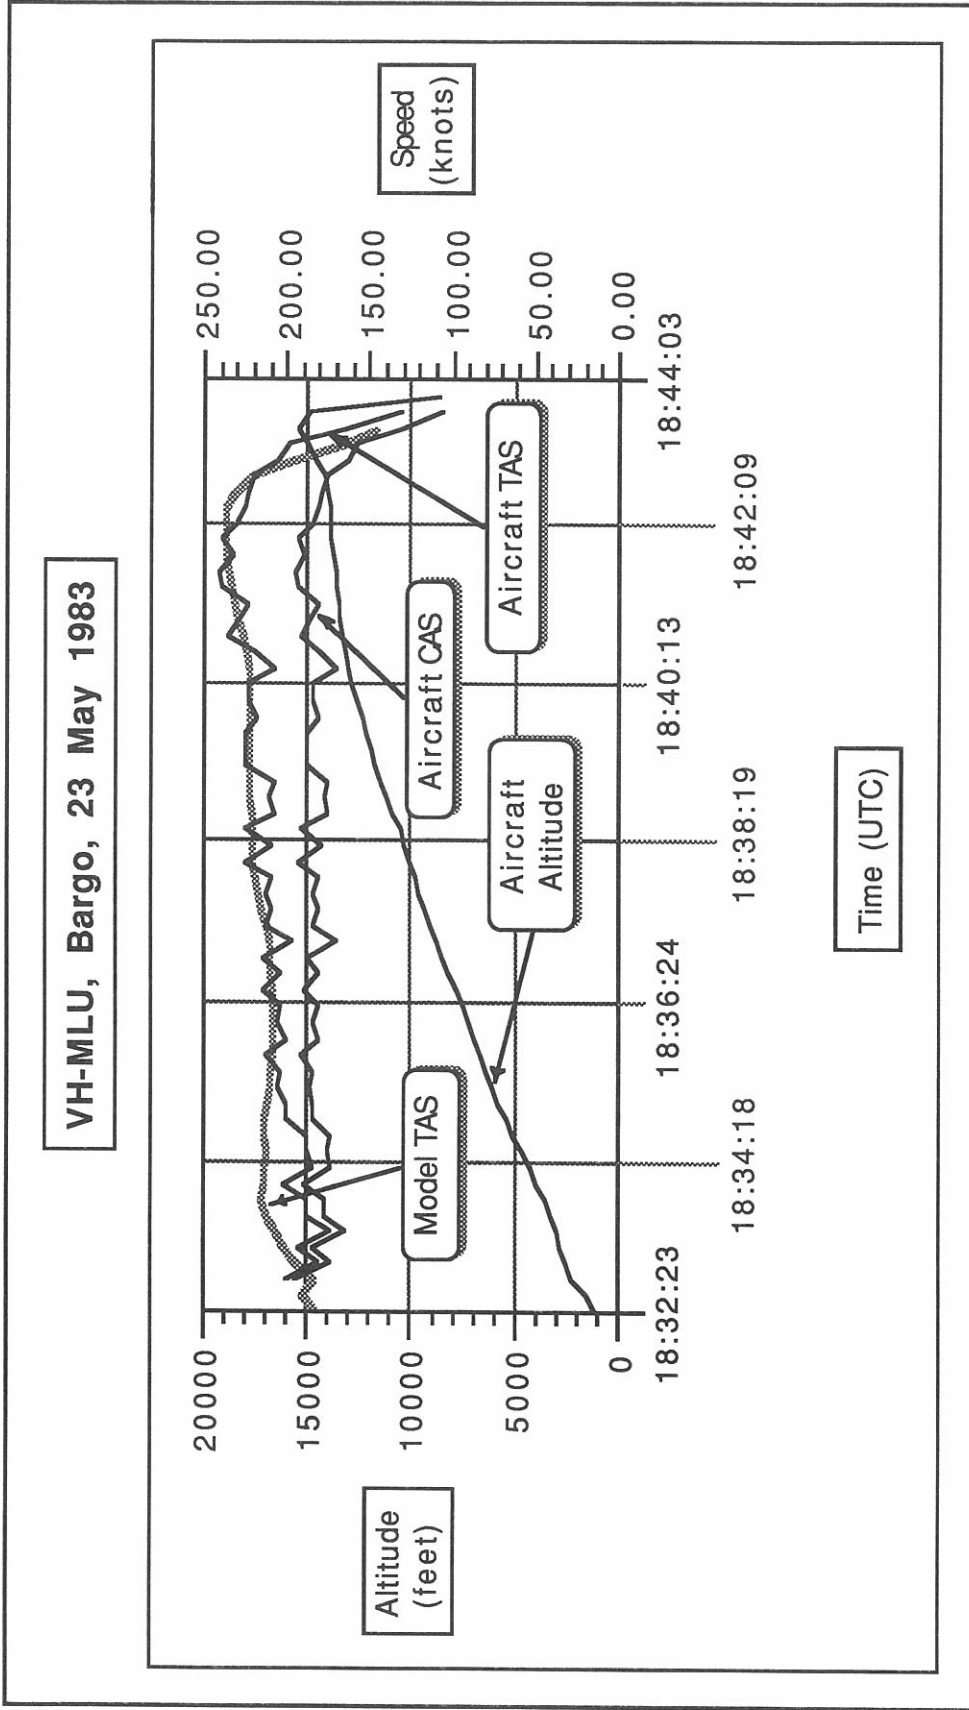
VH-MLU: The model was able to approximate the climb profile to 12 900 ft using MCP and small changes in attitude only. The resultant TAS profile appeared to be a smoothed version of the averaged radar data. An average icing factor of 40% was required to be applied to the model to simulate the reduced rate of climb between 12 900 ft and 14 250 ft. The final deceleration of the aircraft to the loss of control speed was simulated by a combination of a further increase in icing to 85%, and a large increase in attitude to produce a similar TAS and altitude profile to that of the aircraft. At the loss of control altitude of 15 500 ft, the averaged aircraft TAS was 164 kts (131 kts CAS) compared with the model 158 kts TAS.

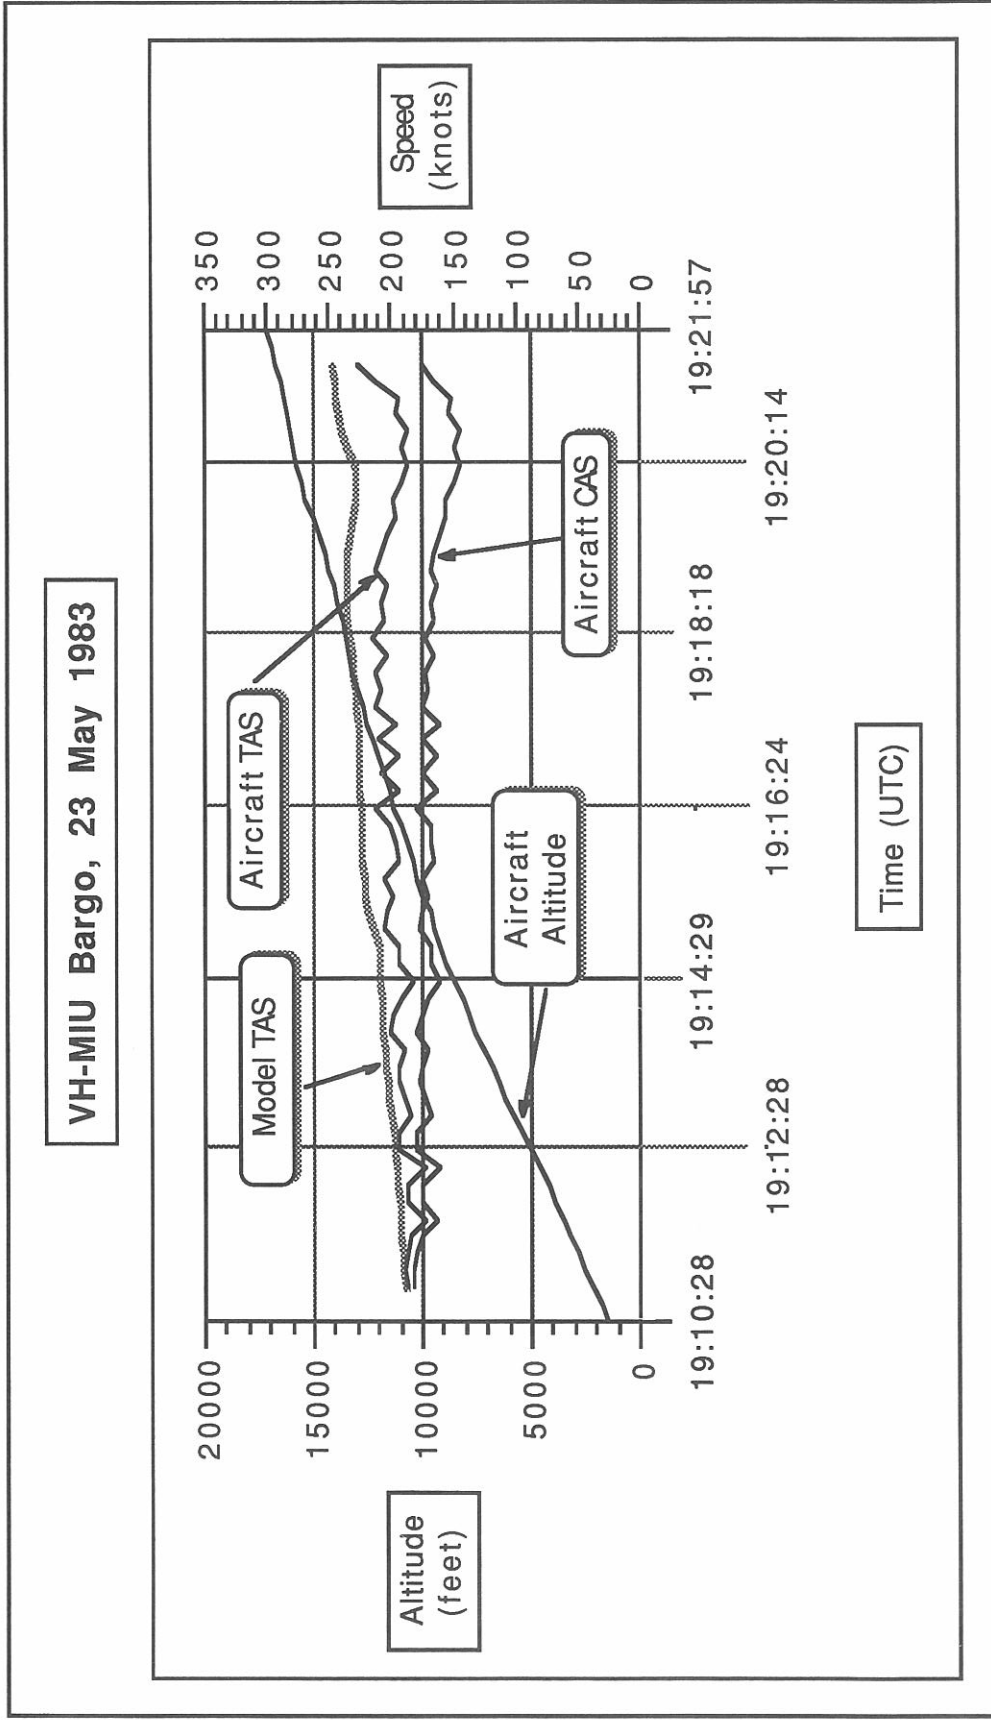
CASE 2

VH-MIU: The climb for this aircraft was modelled by using MCP and changes in aircraft attitudes but without the addition of any icing factors. The model produced good agreement with the recorded data to 9 400 ft, and then diverged from the recorded data and climbed faster than the aircraft to the top of climb. No explanation was determined for this observation.

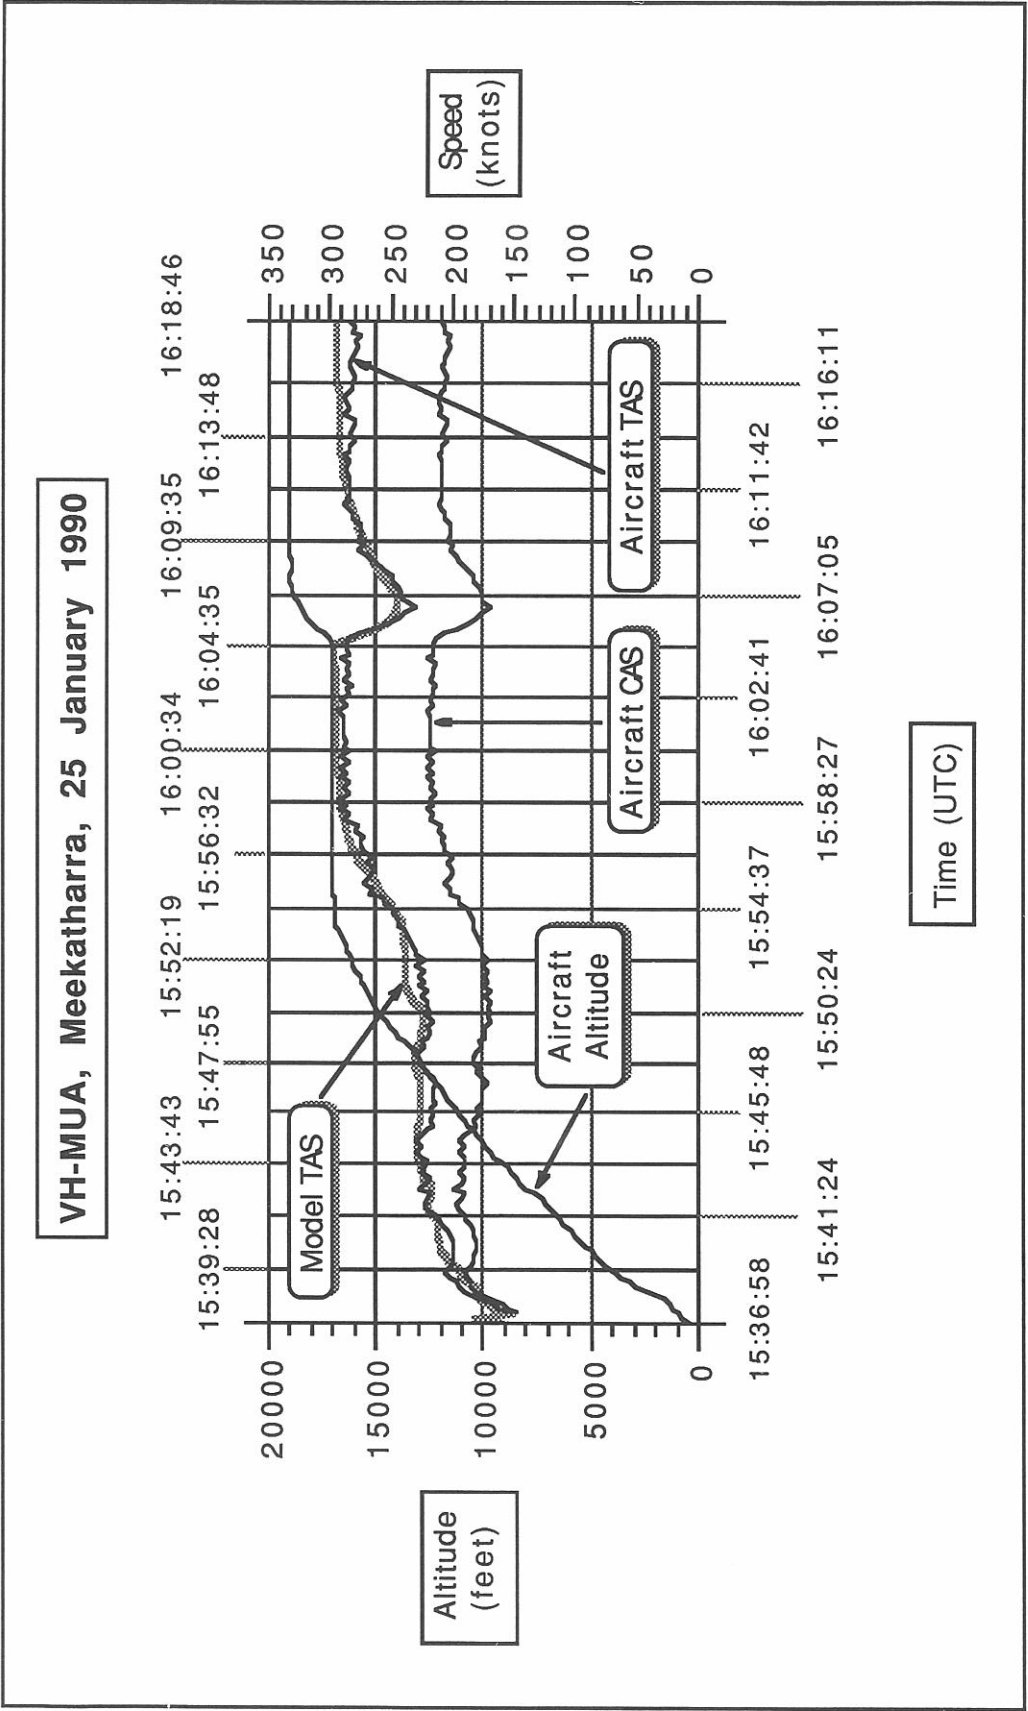
VH-MUA: The model was used to reproduce the radar flight profile for this aircraft from shortly after take-off until the end of the recorded radar data at 160 nm from Perth. Using MCP, the model produced a good likeness to the recorded data, except for the latter stages of the initial climb, where the model outclimbed the aircraft. By reducing the power at the top of both the initial and en route climbs, the model was able to reproduce the step in airspeed seen in the recorded data at the commencement of both cruise segments. No IFs were introduced during the flight comparisons and the simulations indicated that MCP was most probably used during the recorded cruise segments. No attempt was made to reproduce the speed variations seen towards the end of the recorded data due to the unknown nature of the variations and their frequency.

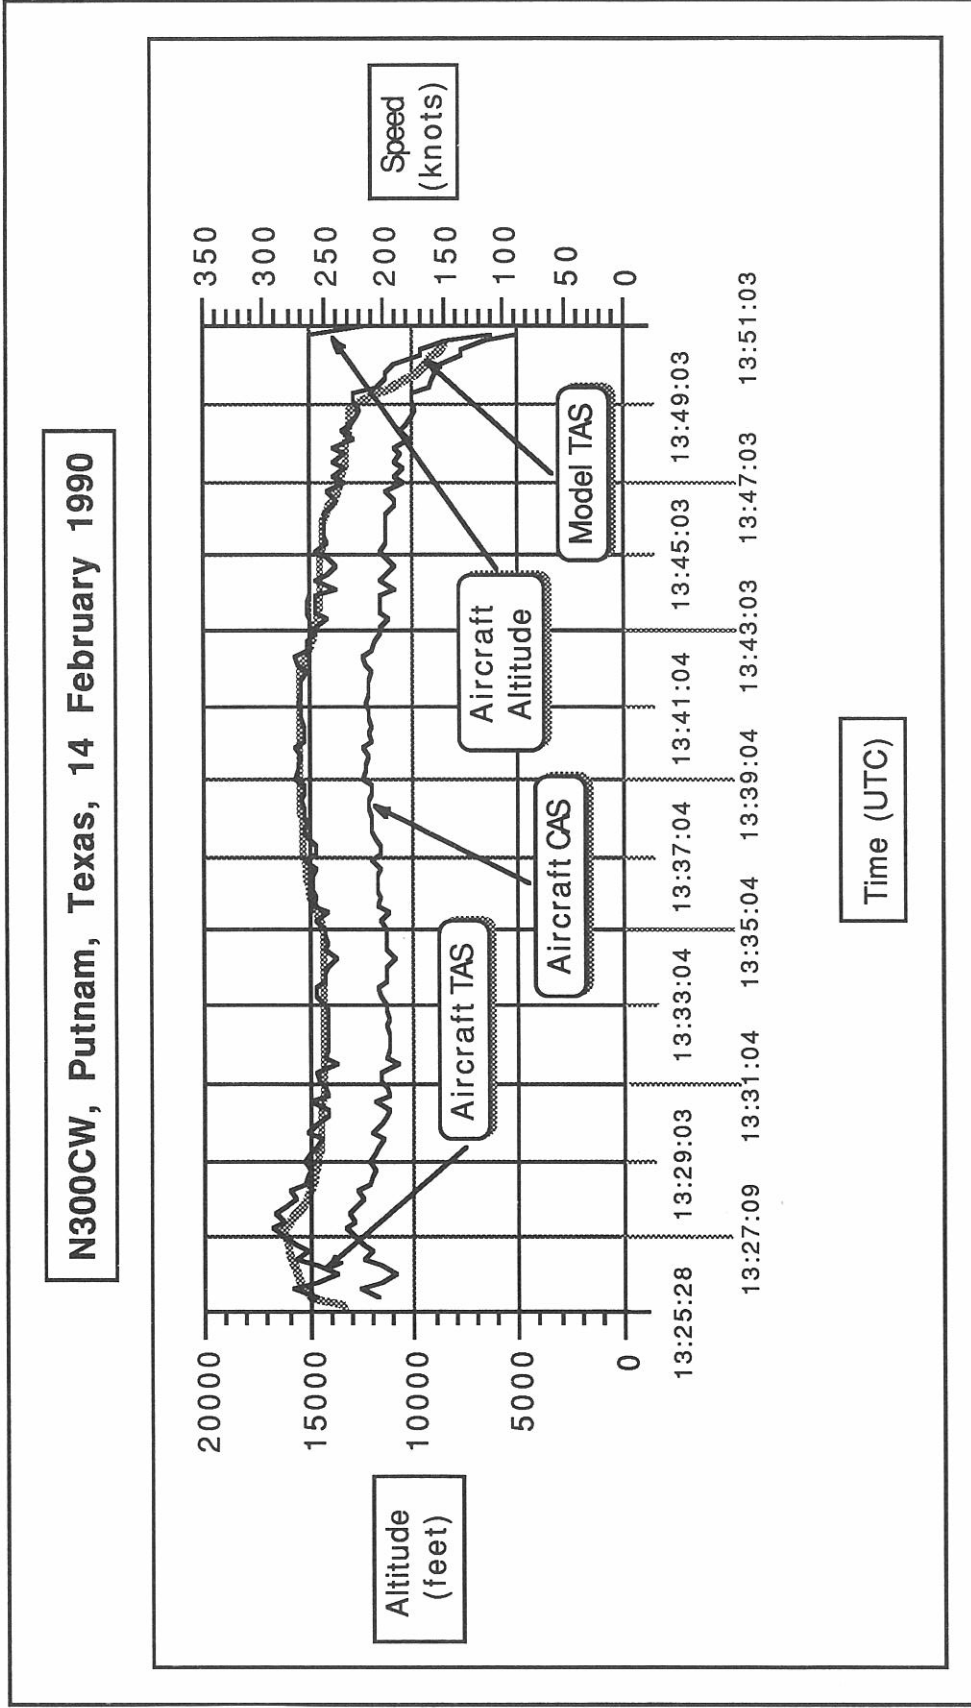
CASE 4

N300CW: The model produced an excellent likeness to the recorded data provided by the NTSB investigation team. The accelerations and decelerations seen in the data were simulated assuming an accumulation and shedding of ice. Throughout the simulations, 100% power was used and IFs were progressively added to reproduce the actual flight. The recorded data showed that control was apparently lost at a TAS of 146 kts (116 kts CAS), and the model simulated the final deceleration to a TAS of 155 kts with an approximate icing factor of 1.85 (185%).

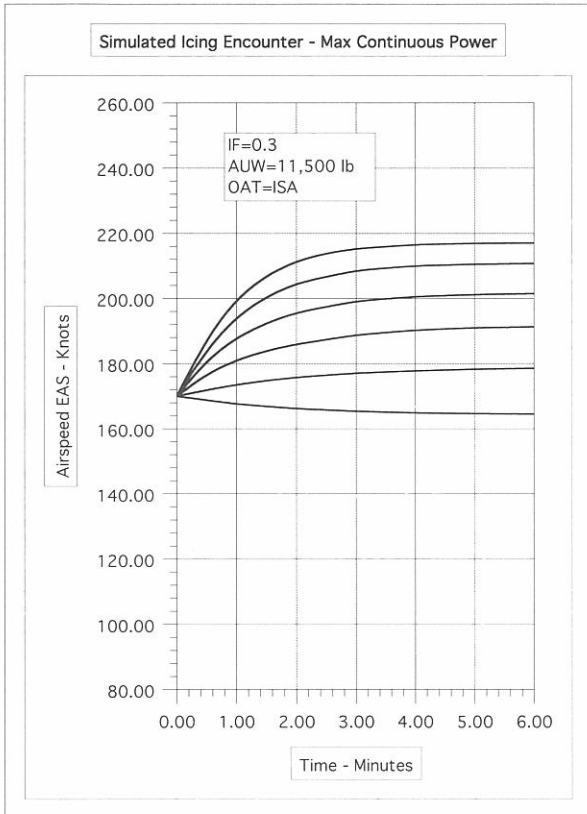
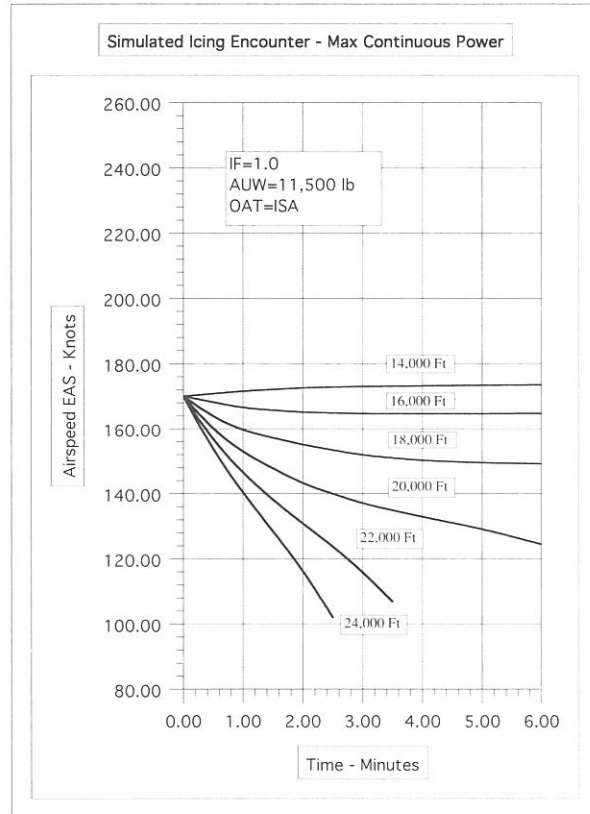
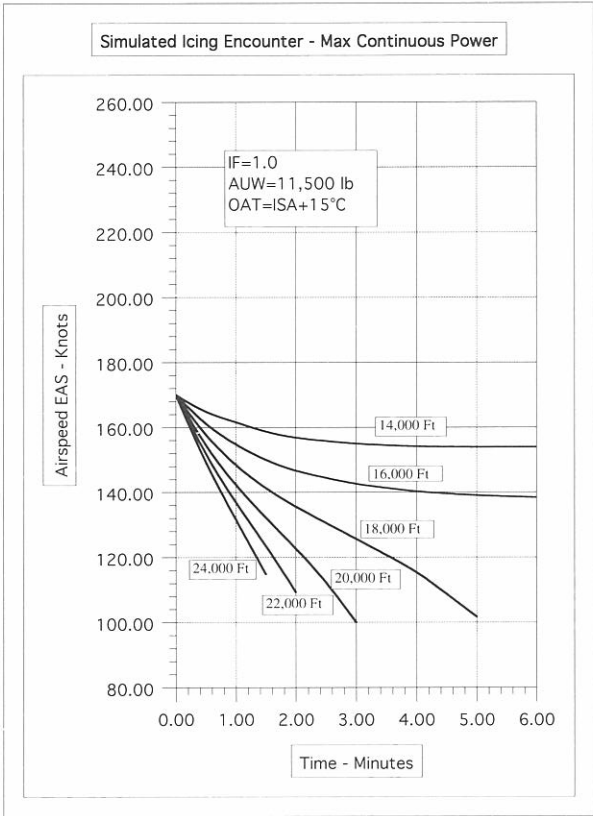
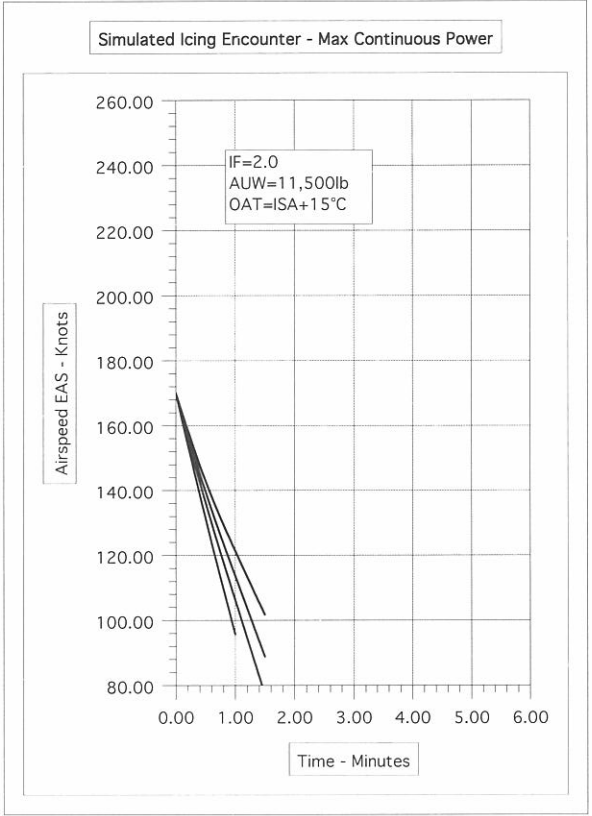
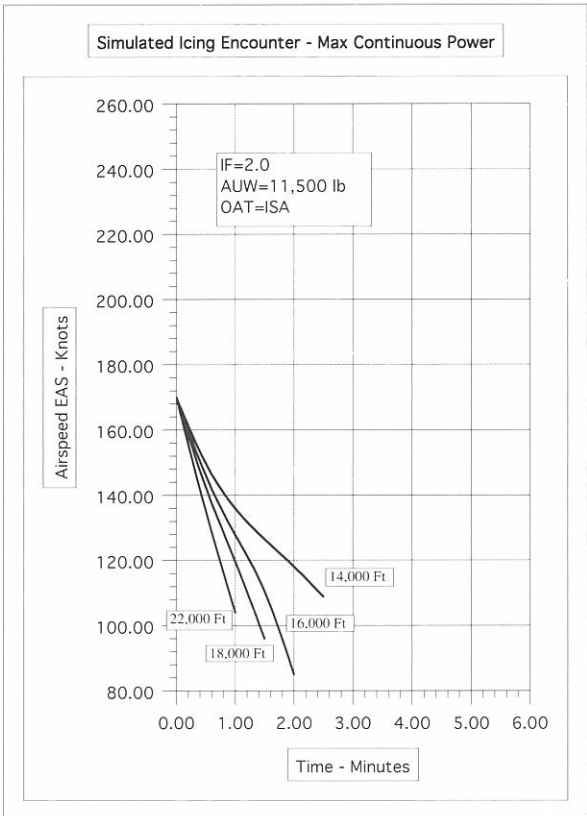
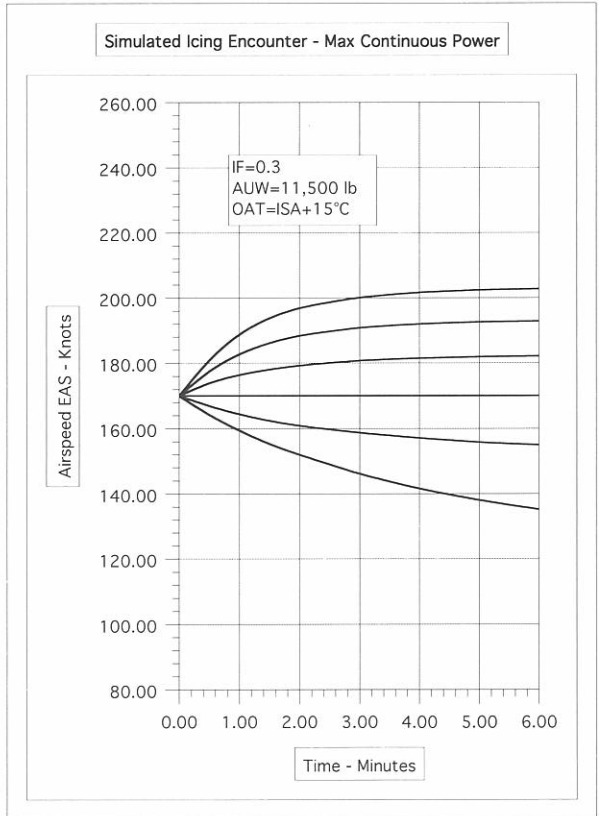
Simulation of the performance of the MU-2 in ice at high altitudes, particularly when the encounter is with moderate or severe ice, indicates a very high rate of speed loss. For example, at the altitude (21 000 ft) and temperature (ISA+12°C) at which VH-MUA was operating, the results indicate that decelerations of about 40 kts/min for moderate icing (IF=1.0), and about 90–100 kts/min in severe icing (IF=2.0), could be experienced. Such decelerations would require a very rapid response from the pilot if a stall was to be avoided, particularly if the autopilot was engaged in the altitude-hold mode. The graphs below show the results of the simulations.

Figures 1a to 1f show the aircraft accelerating (or decelerating) from 170 kts at MCP. The results indicate that the aircraft can only maintain altitude and a reasonable flying speed at very light icing conditions below about 18 000 ft. Under moderate (IF=1.0) or severe icing (IF=2.0) the speed decays, sometimes at alarmingly high rates. For example, a severe encounter (IF=2.0) could cause the speed to decay to the stall speed in about 1 min or less for all altitudes above 14 000 ft.

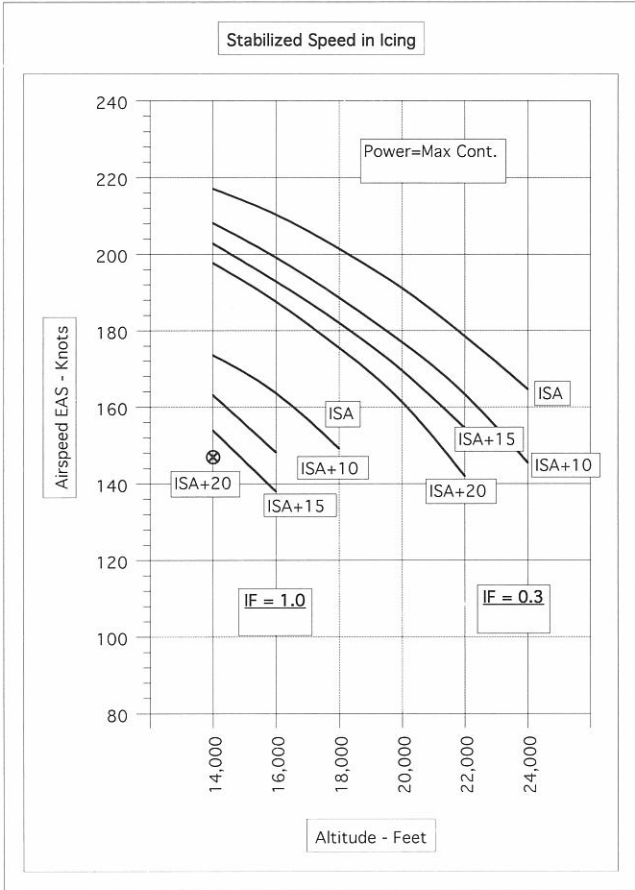
Figure 2

The speed at which the aircraft will stabilise in level flight and MCP is shown in figure 2. Note that no data is shown for IF=2.0. This is because the aircraft speed would not stabilise under any of the combinations of altitude and outside air temperature (OAT).

Even under moderate icing conditions (IF=1.0), a reasonable flying speed could only be maintained at temperatures close to ISA standard and relatively low altitudes of approximately 14 000 ft.

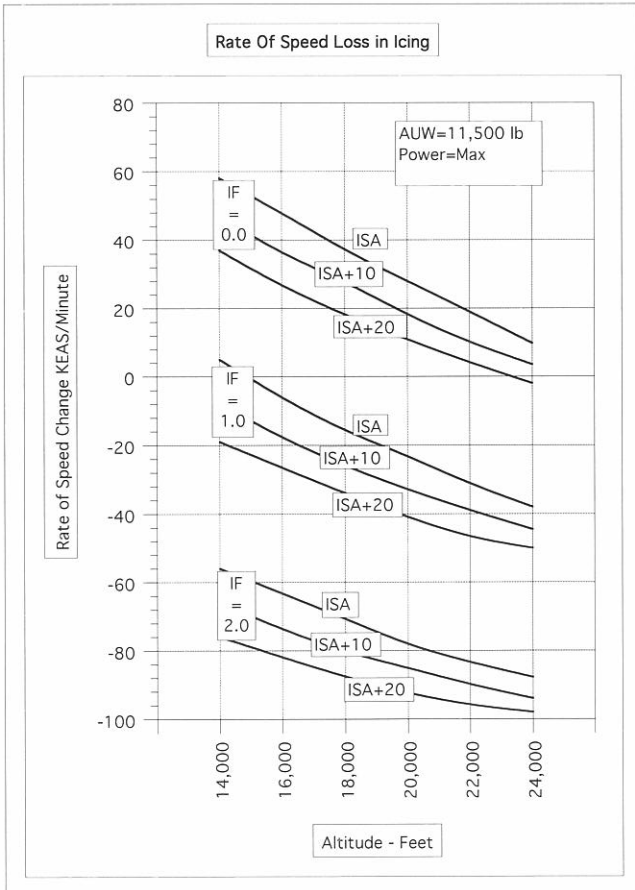
Figure 3

Finally, figure 3 shows the rate of speed loss as the aircraft accelerates or decelerates through 170 kts EAS. The aircraft weight is 5216 kg and MCP is selected. Temperatures range from ISA to ISA+20°C and icing factors of 0.0, 1.0 and 2.0 are used. The data indicates that the clean aircraft performs quite well at all conditions except high altitudes and high temperatures. However, when icing (either moderate or severe) occurred, the rate of speed loss was very high. For example, at the altitude and temperature VH-MUA was operating (21 000 ft and ISA+12.5°C), decelerations are of the order of 40 kts/min for moderate icing (IF=1.0) and about 90–100 kts/min for severe icing (IF=2.0).
