**Boeing 747-438, VH-OJU
Sydney Aerodrome, NSW
2 July 2003**

**INVESTIGATION REPORT
BO/200302980**

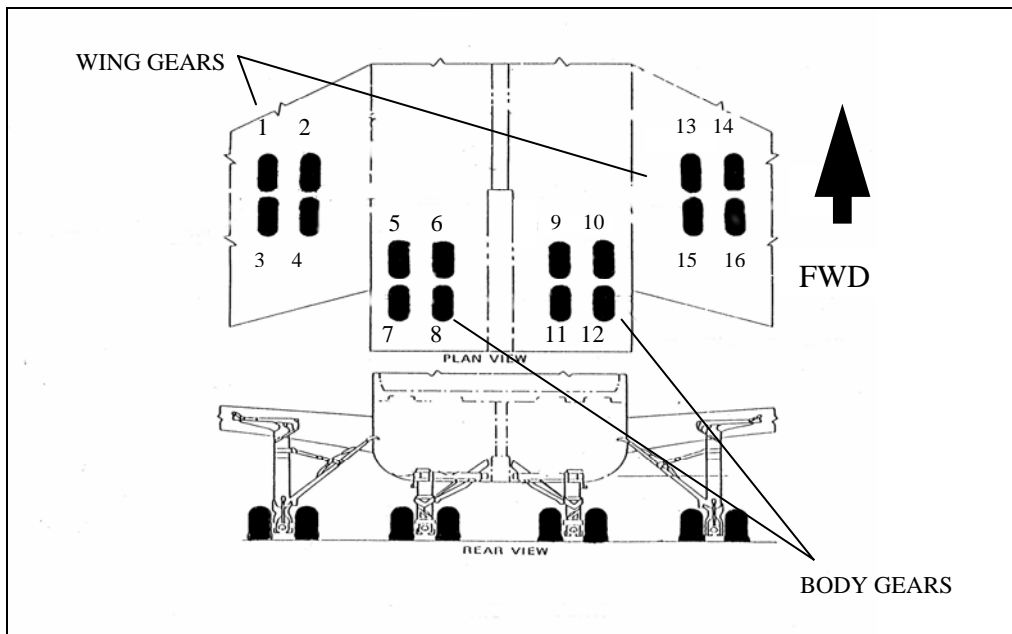
Figure 1: Main landing gear, wheel and brake configuration

When the aircraft was aligned with the designated parking bay, the flight crew instructed the cabin crew, via the passenger address system (PA), to disarm³ the cabin doors. The flight crew then observed a 'BRAKE TEMP' message on the primary Engine Indicating and Crew Alert System (EICAS) display screen on the flight deck instrument panel. The PIC checked the landing gear display page on the secondary EICAS screen and observed that the wheel brake temperature on wheel number-12 the rear right wheel on the right body landing gear (see Figure 1) was showing an amber five⁴ indication.

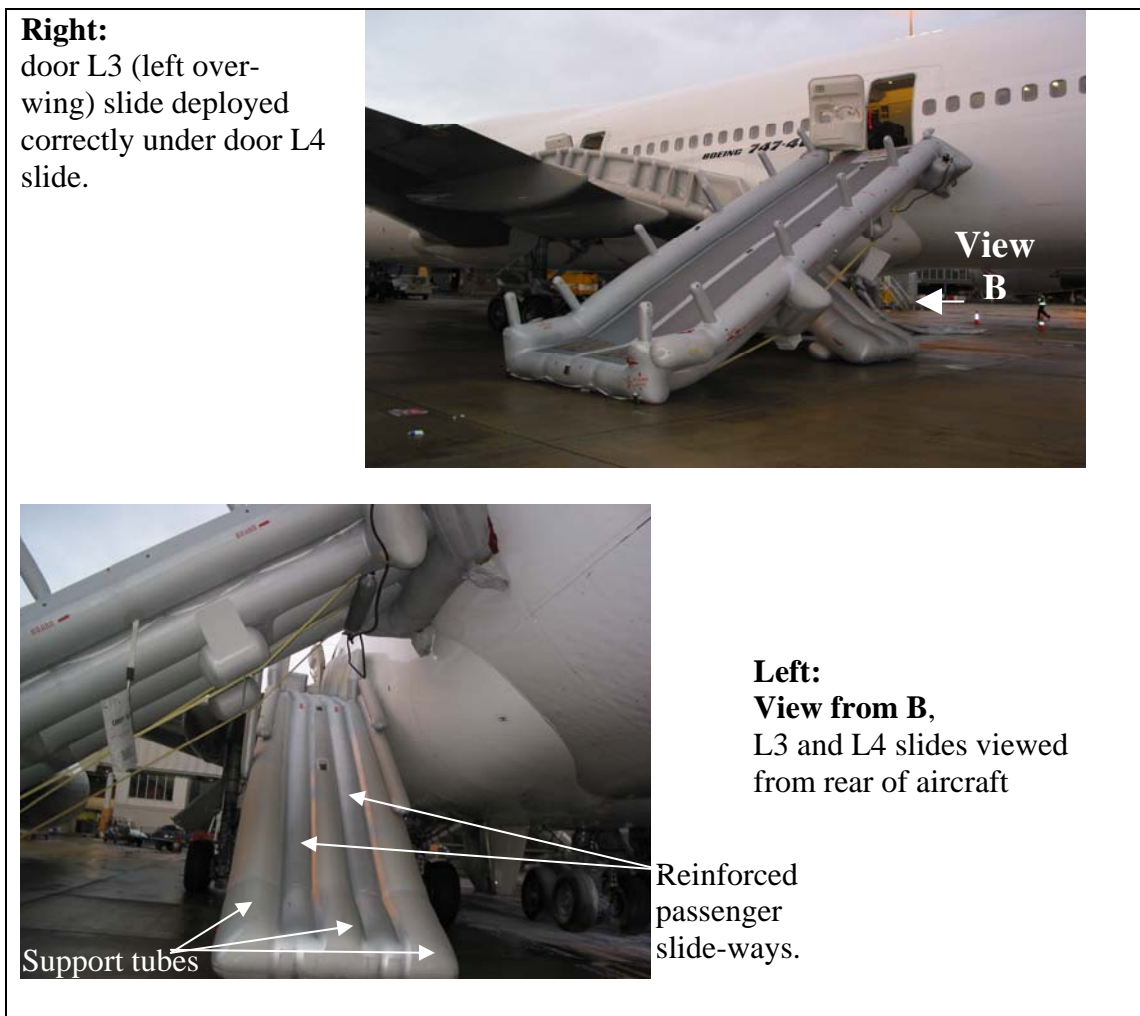
Figure 4: Left over wing slide deployment

Doors L3 and R3 were over-wing doors, their evacuation slides inflated to form a corridor directing passengers rearward over the wing to its trailing edge, then continuing as a slide to the ground. The slides were air inflated, self-supporting structures, which comprised two inflated reinforced slide-ways separated by an inflated central tube and bounded by outer inflated support tubes (see Figure. 4).

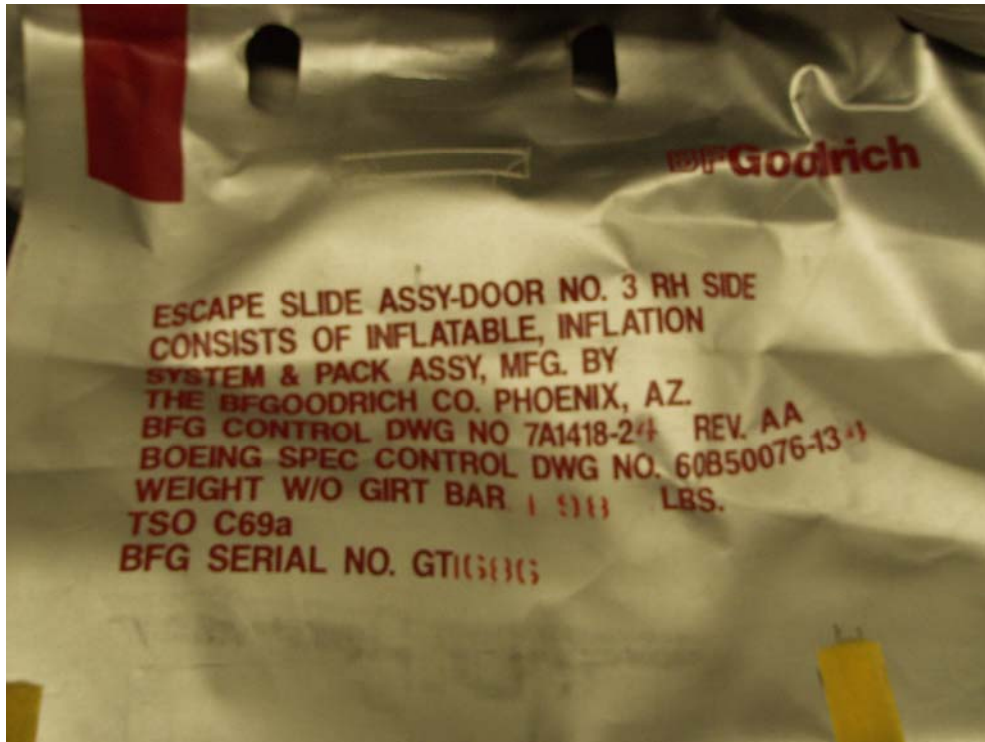
Figure 2: Escape slide serial number and construction details

Escape slides on Boeing 747 aircraft are constructed from a polyurethane coated polymeric fabric. The slides are self-supporting structures, with support being provided by gas-inflated integral tubes. The over-wing slide comprises two slideways separated by an inflated central tube and bounded by outer inflated tubes. A heavy fabric is used to reinforce the slideway. This reinforcing does not extend over the central or outer tubes.

Visual examination of the escape slide material did not reveal any indication of fabric proofing deterioration or fabric fibre deterioration.
