Australian Transport Safety Bureau

AVIATION SAFETY INVESTIGATION
200303579

Cessna 404, VH-ANV
Jandakot Airport, WA
11 August 2003

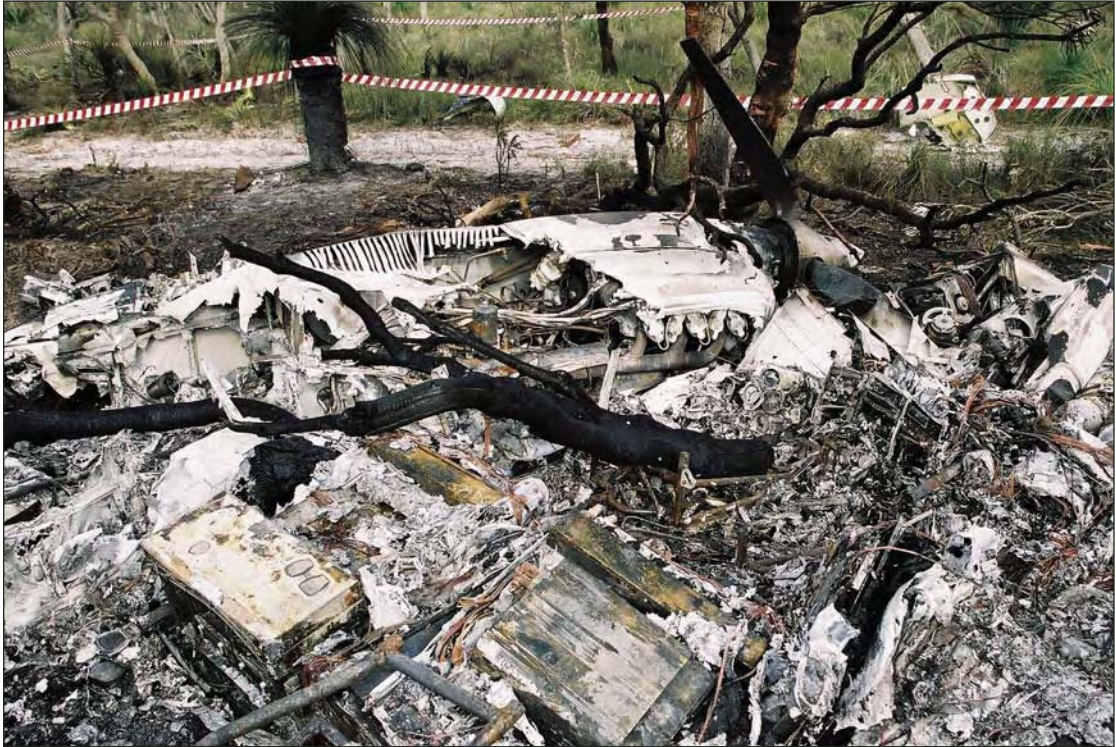
FIGURE 3: Forward aircraft cabin

The aircraft collided with several other trees during the impact sequence and there was evidence of significant damage to the leading edge of the wings and horizontal stabilisers. The fuselage came to rest with the cabin area intact, on a heading of approximately 290 degrees magnetic and about 20 m from where the fuselage initially impacted the ground. The wing flaps and landing gear were retracted (up) at the time of impact. The aircraft was consumed by the post-impact fire (see Figures 3 and 4).

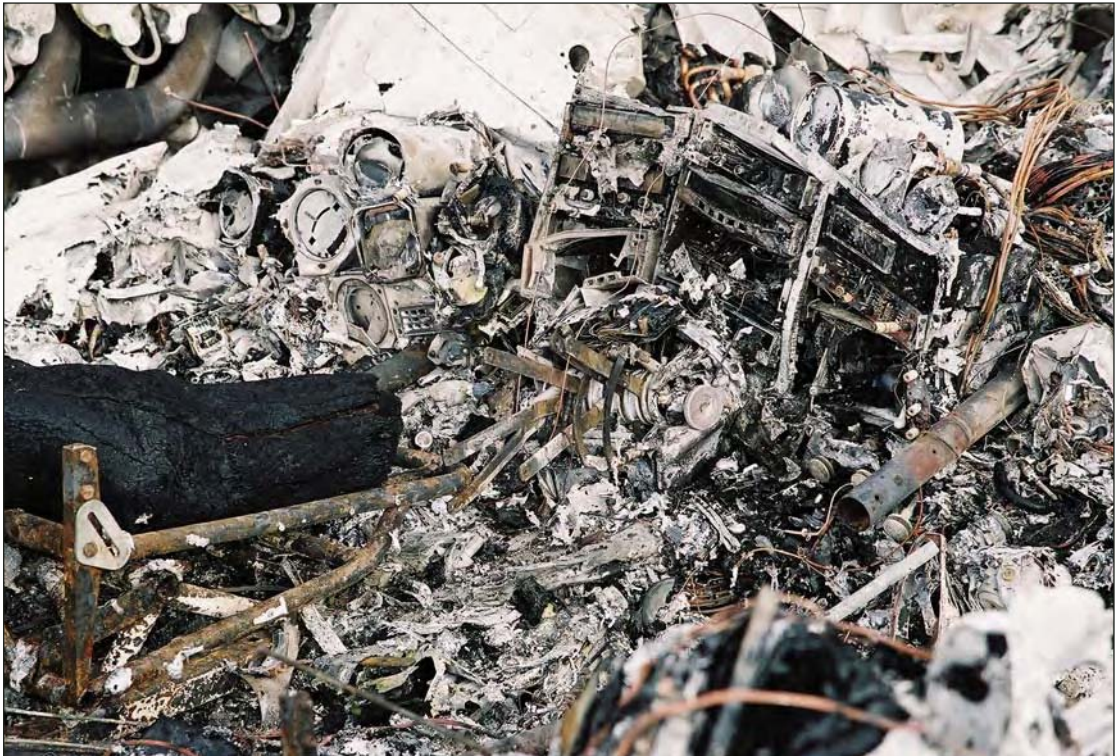
FIGURE 4: Cockpit area

The cockpit fuel selector for the left engine was found in the 'LEFT MAIN' position. The cockpit fuel selector for the right engine was found rotated clockwise from the 'RIGHT MAIN' position. Impact damage to the inboard leading edge of the right wing indicated that the cable linkage to the fuel selector valve could have been disrupted during the impact sequence.

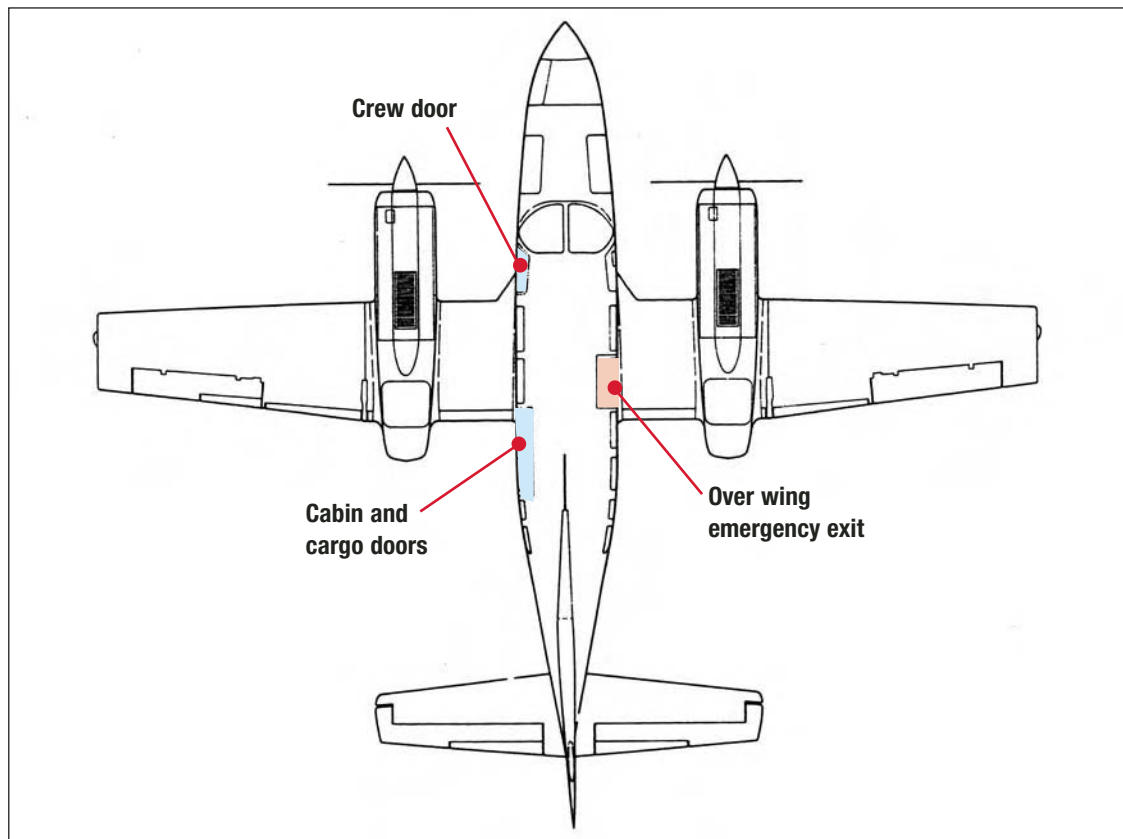
FIGURE 8: Location of aircraft exits

There were three potential exit paths from the aircraft (see Figure 8). The pilot and three of the passengers reported vacating the aircraft via the door at the rear of the passenger cabin, and recalled that the interior of the aircraft cabin was not significantly affected by fire immediately after the aircraft came to rest. The passenger seated immediately behind the equipment boxes reported that although the upper equipment box moved slightly during the accident, it remained secured to the lower box. The pilot also reported that his egress through the cabin was not impeded. There was no evidence from other passengers that equipment in the cabin had impeded their egress from the aircraft. The passenger who opened the cabin door recalled intense heat with flames in the immediate vicinity of that door. The occupants vacating the

It was reported that the passenger who was seated in the copilot's seat, and who died subsequent to the occurrence, vacated the aircraft by kicking out a window on the right side of the aircraft²¹ and that '... smoke and fumes ...' had prevented egress through the passenger cabin.

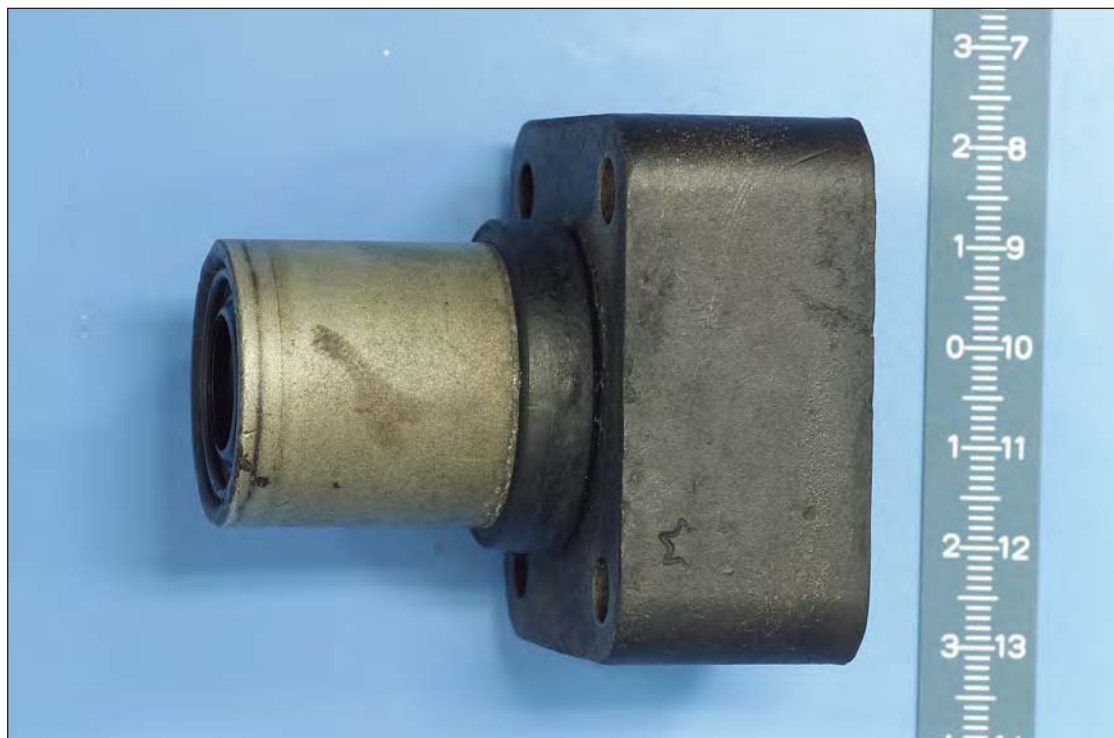
FIGURE 2: Body assembly showing surface discolouration from the post-accident fire

Externally, the pump body displayed staining and discolouration consistent with the effects of the post-impact fire (see Figure 2). Where protected by its connection to the engine, the pump bearing housing was comparably free from the visible effects of the fire, with the flexible shaft end seal intact (see Figure 3).

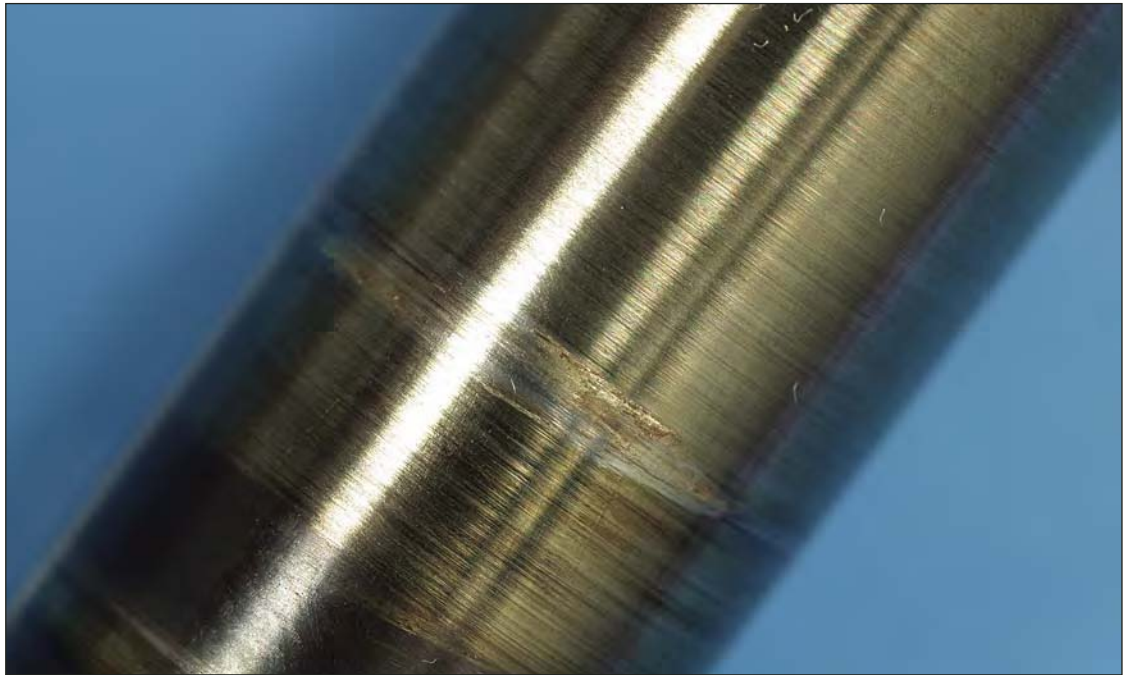
FIGURE 15: Right EDFP spindle shaft damage corresponding to the area shown in Figure 14

The localised areas of galling damage shown by the spindle shaft and sleeve bearing were examined optically and under the SEM. Under the optical stereomicroscope, the galled regions of the spindle shaft exhibited the circumferential ductile flow of adherent material and were typical of the damage incurred during shaft rotation (figures 14, 15).

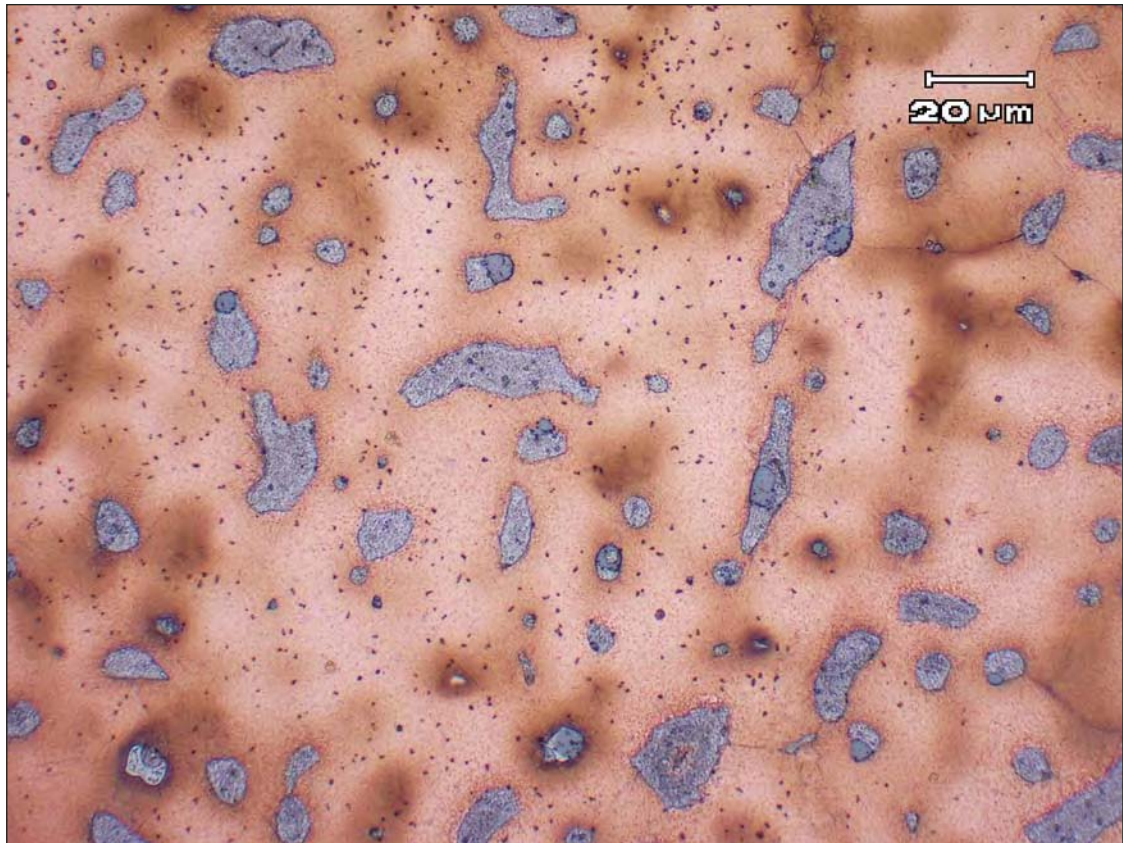
FIGURE 19: Characteristic microstructure of the high leaded bronze material making up the sleeve bearing for the left pump⁵¹

Both spindle shafts were dimensionally comparable, with both within or only marginally below the new part specifications. In contrast, the sleeve bearings exhibited an appreciable difference and variability in bore diameters. The left pump sleeve was up to 0.0088" (0.22 mm) above the maximum specified diameter along the full length, whereas the right pump sleeve was 0.00035" (0.0089 mm) above specification in one location.

In the unetched condition, the sleeve alloy from the left pump exhibited a two-phase microstructure consisting of coarse distributed islands of lead within a copper-tin matrix. Etching in an acidified alcoholic ferric chloride solution revealed a dendritic morphology within the matrix; typical of the alloy being produced as a cast product (see Figure 19).

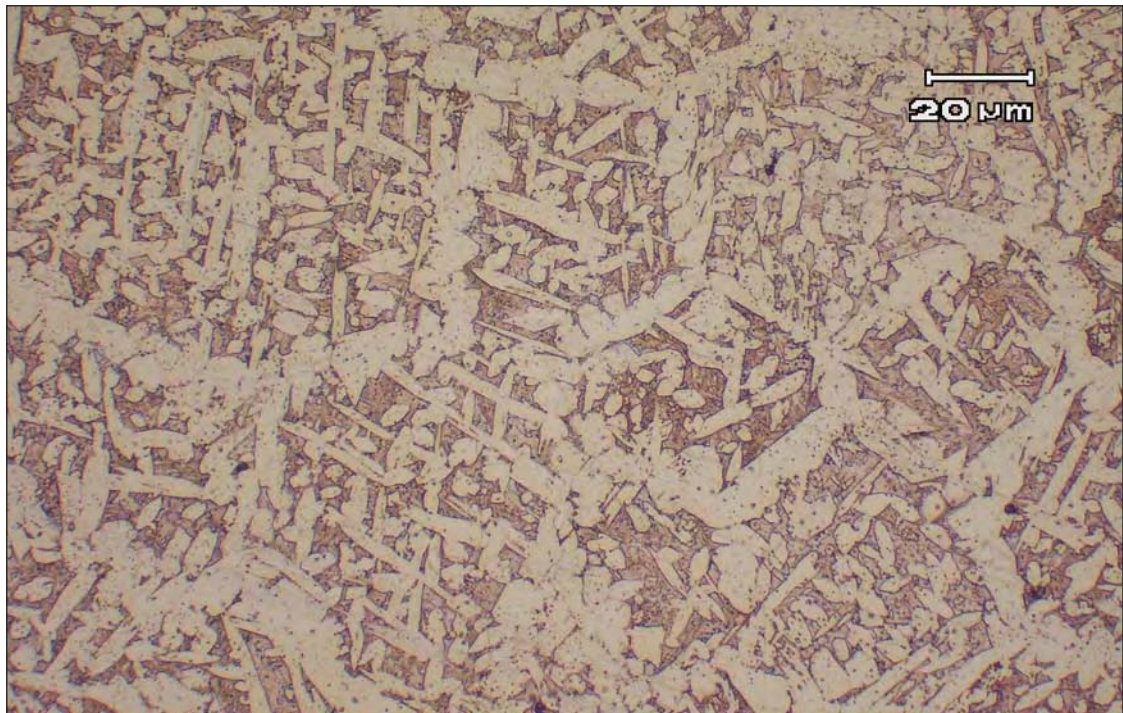
FIGURE 20: Characteristic microstructure of the aluminium bronze material making up the sleeve bearing for the right pump⁵²

As suggested by the differences in chemical composition between the two bearing sleeves, the sleeve alloy from the right pump presented a characteristically different microstructure. When etched in acidified alcoholic ferric chloride, the microstructure showed a moderately coarse distribution of widmanstatten alpha phase (α), within a beta phase (β) matrix (see Figure 20). The structure was uniform throughout and typical of an as-cast aluminium bronze alloy of the composition identified.

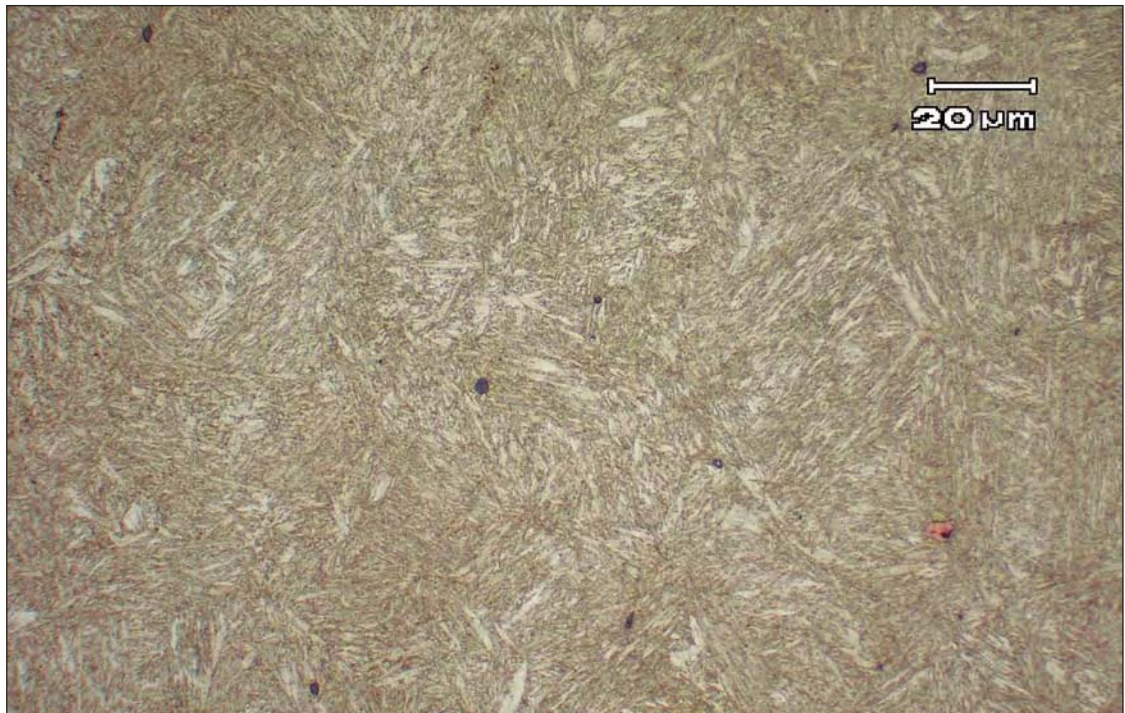
FIGURE 22: Core microstructure of the right EDPF spindle shaft⁵⁴

Transverse and longitudinal metallographic specimens were taken from the right pump spindle shaft to characterise the effects of the galling damage and the general nature of the shaft production. The bulk (core) of the shaft presented with a uniform tempered bainitic microstructure (see Figure 22), which transitioned to a shallow darker etching surface layer with fine intermittent grain boundary networks of a second phase (see Figure 23). The structures observed were consistent with the shaft having undergone a nitriding or similar surface hardening heat treatment.

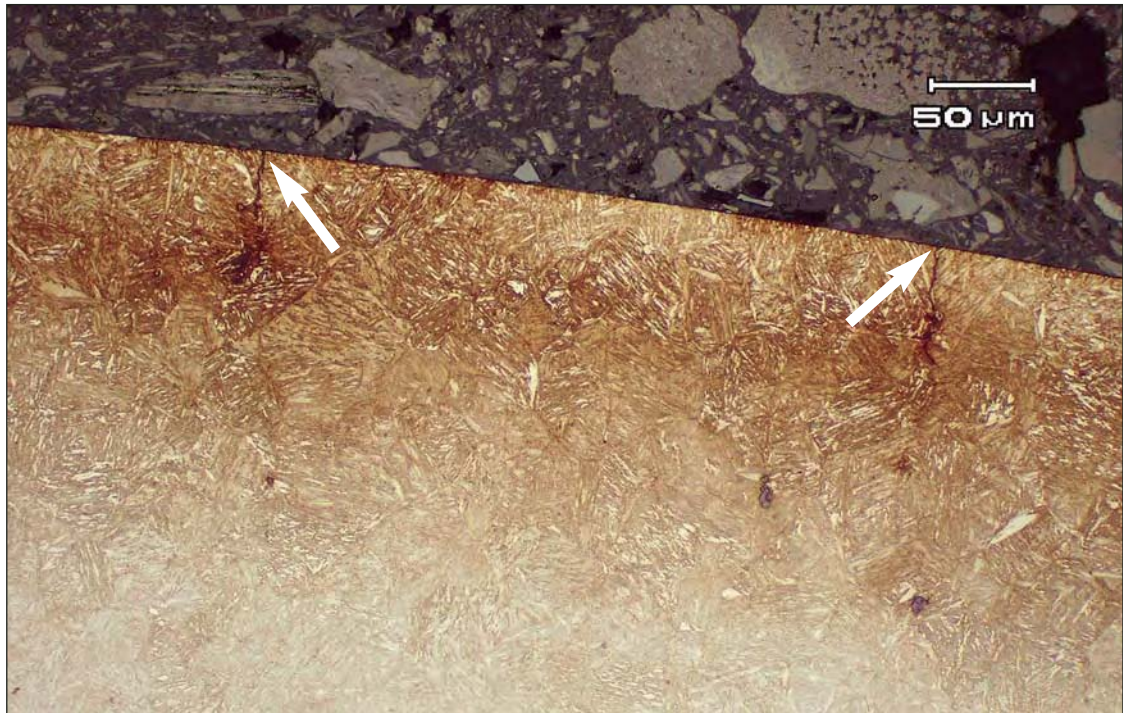
FIGURE 25: Etched cross section through the area of thermal cracking on the surface of the right EDFP spindle shaft⁵⁷

The transverse section through the galled surface areas confirmed the presence of the surface cracking as observed under the SEM. Several shallow cracks were observed (see Figure 24), extending to a typical depth of around 40 to 50 μm . Those cracks were contained entirely within the darker etching, surface-hardened layer (see Figure 25). In some areas, the cracking showed intergranular propagation.
