ATSB TRANSPORT SAFETY INVESTIGATION REPORT

Aviation Safety Incident Report – 200403110

**Engine failure - Melbourne Airport, Victoria
25-Aug-2004
Boeing Company 777-312
9V-SYB**

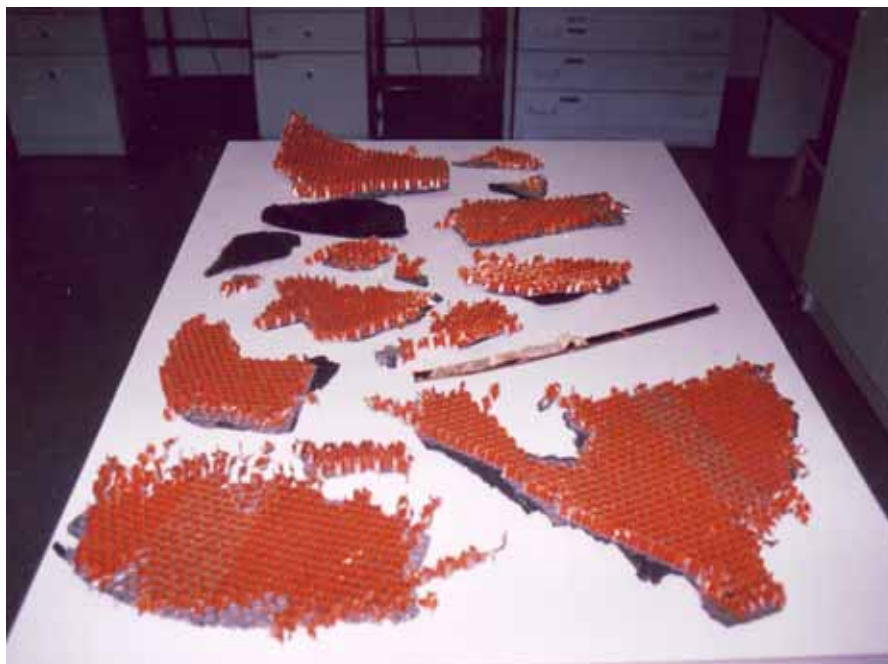
Figure 3: Composite panel remnants recovered from runway

An amount of debris was liberated from the separated left engine core composite panel and was recovered from the departure runway (Figure 3).

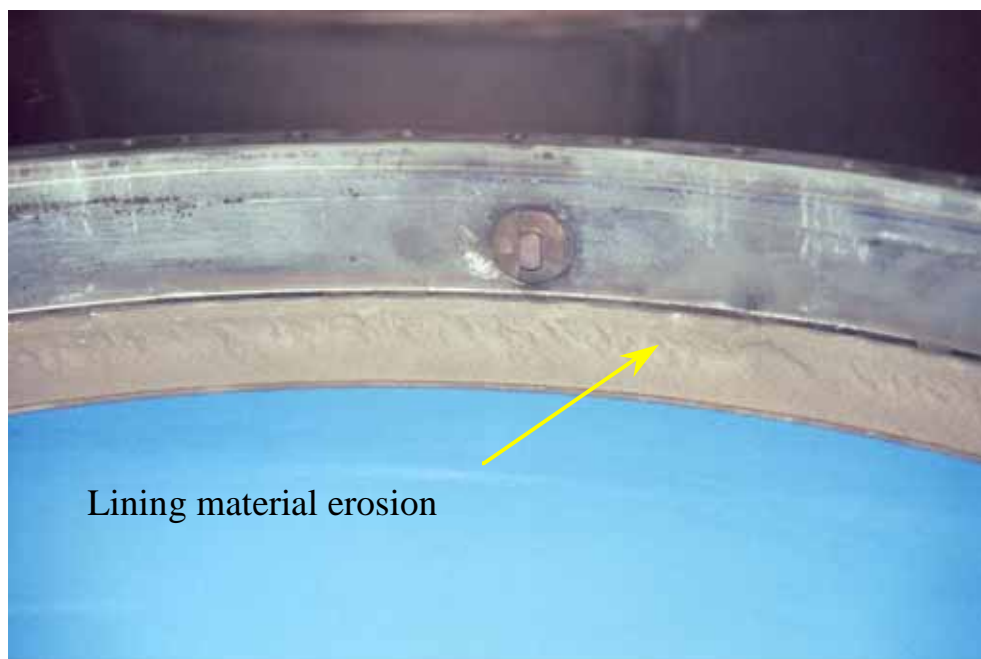
Figure 5: Detail of HPC stage 6 casing abrasion liner erosion

The engine examination revealed that the high pressure compressor (HPC) casing abrasion linings had deteriorated in service. There was a visible loss of abrasion rotor lining on several of the HPC compressor casings (Figures 4 and 5). The engine manufacturer advised that the HPC stage-6 casing-to-rotor clearance was critical to engine airflow control at the take-off thrust setting.

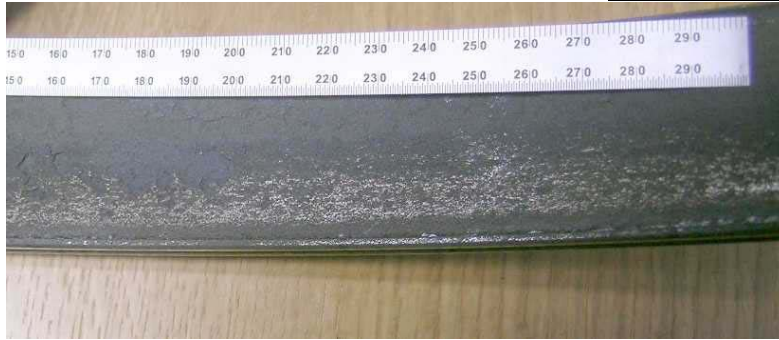
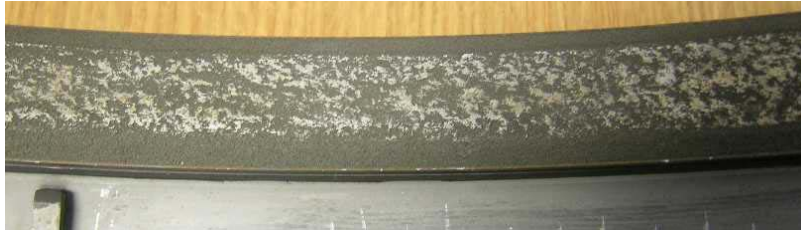
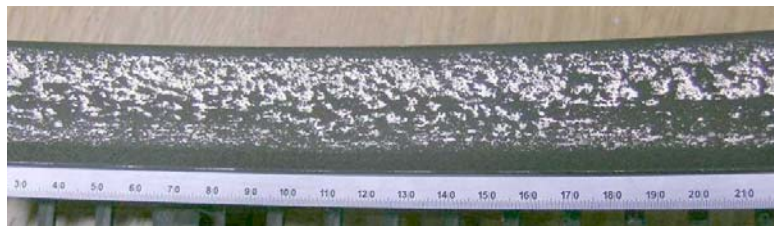
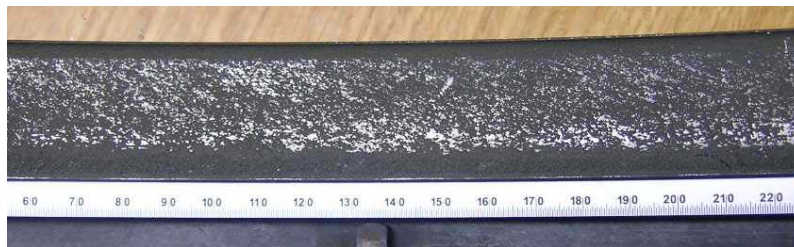
Figure 2 Examples of the smearing on stages 1, 3, 4 and 5

Figure 1 General view of the HPC casings

Smearing on the Stage 1 abrasible surface

Stage 3 smearing

Stage 4 smearing

Stage 5 smearing

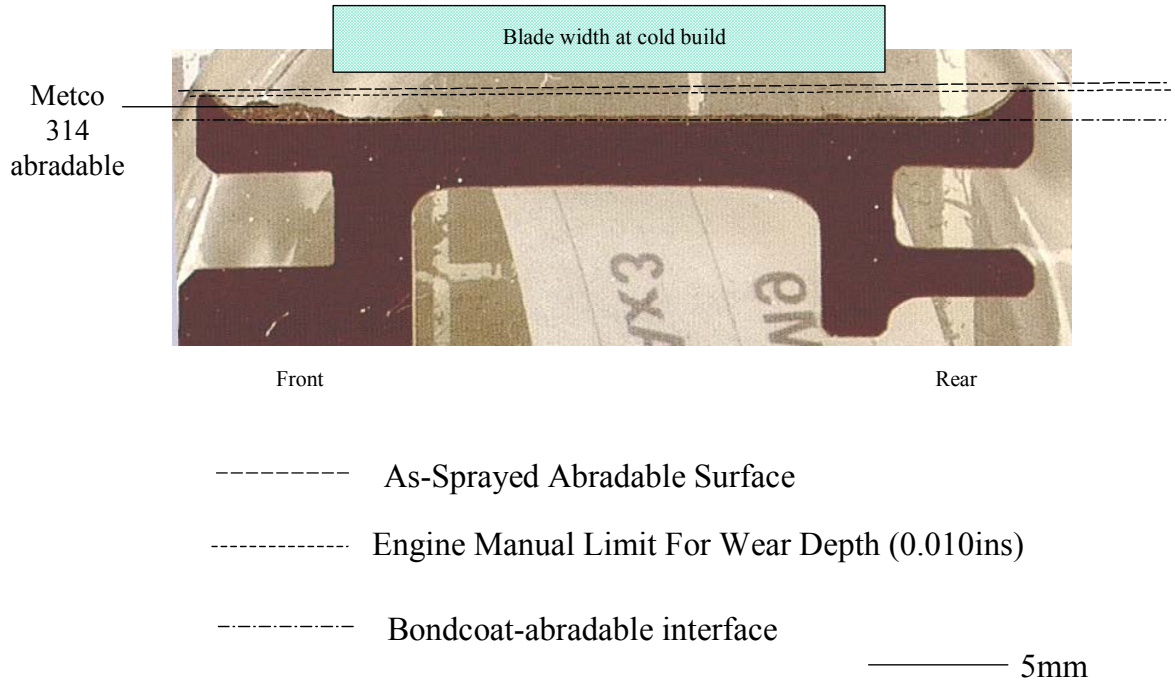
Figure 5

Stage 5 Rotor Path –Typical Cross-Section

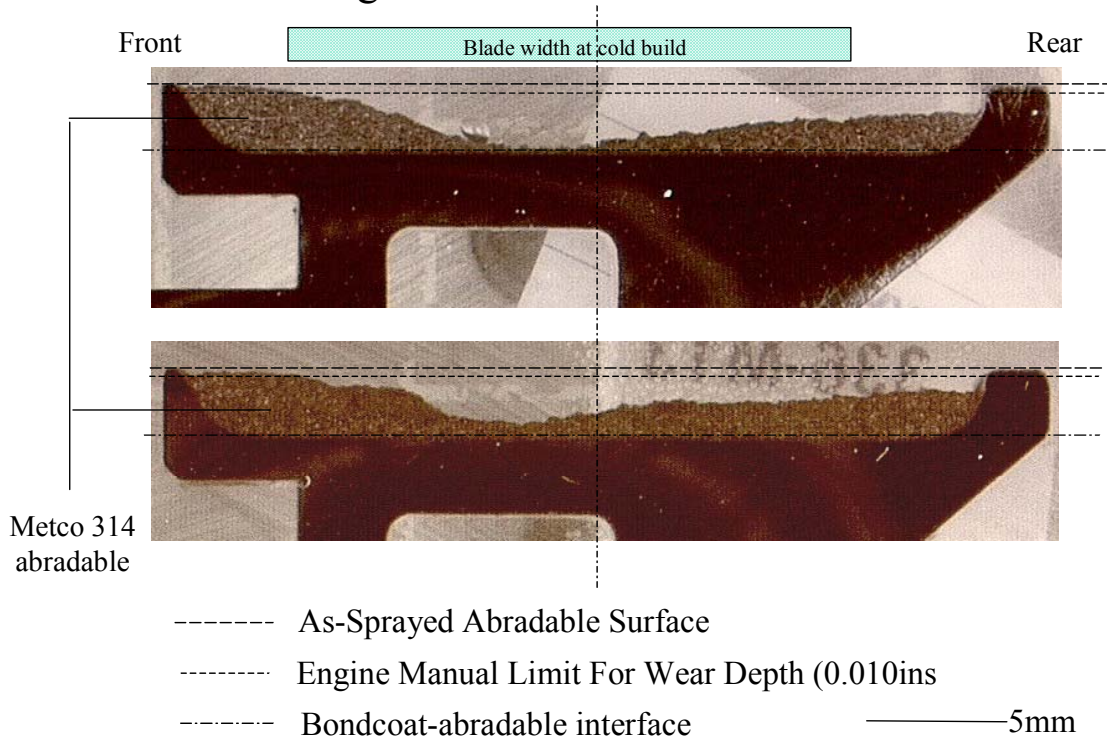
Figure 6

Stage 6 Rotor Path Cross-Section

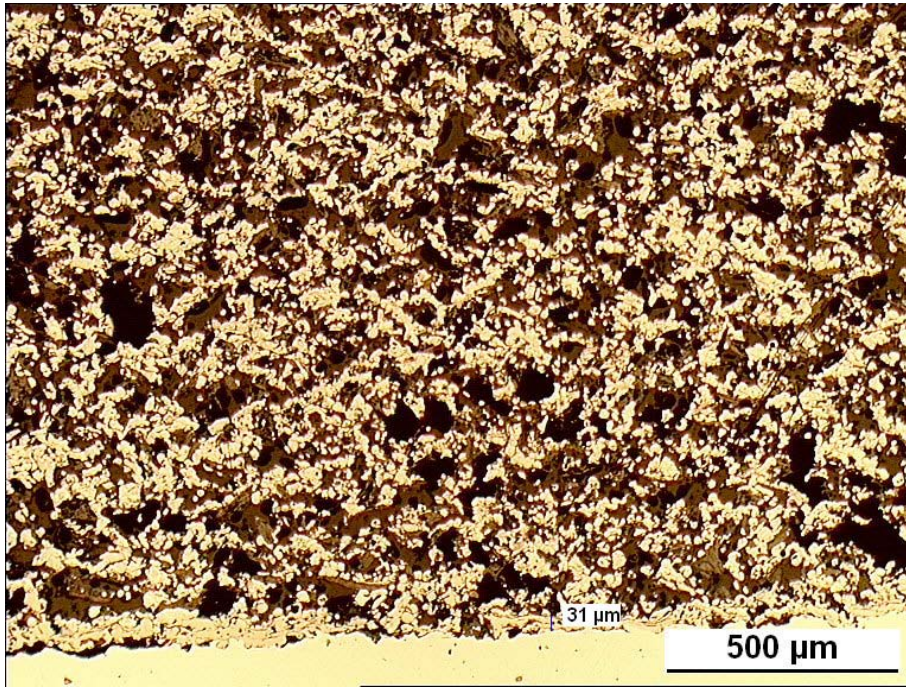
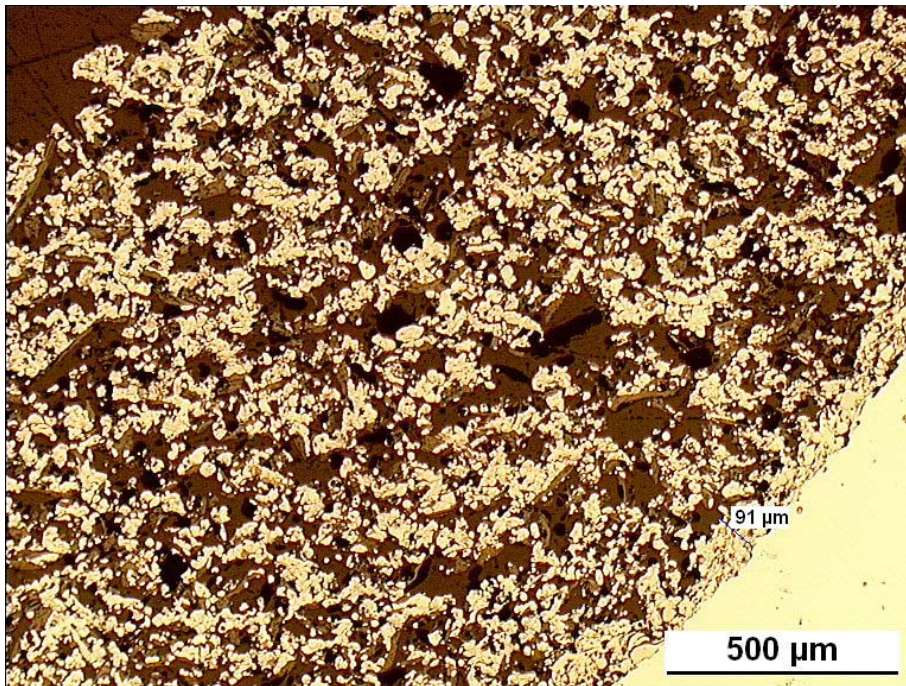
Figure 8 Stage 1 Sherritt Gordon Coating

a)– Axial cross-section - typical microstructure

b) The Sherritt Gordon Coating in the curved corner at the edge of the casing

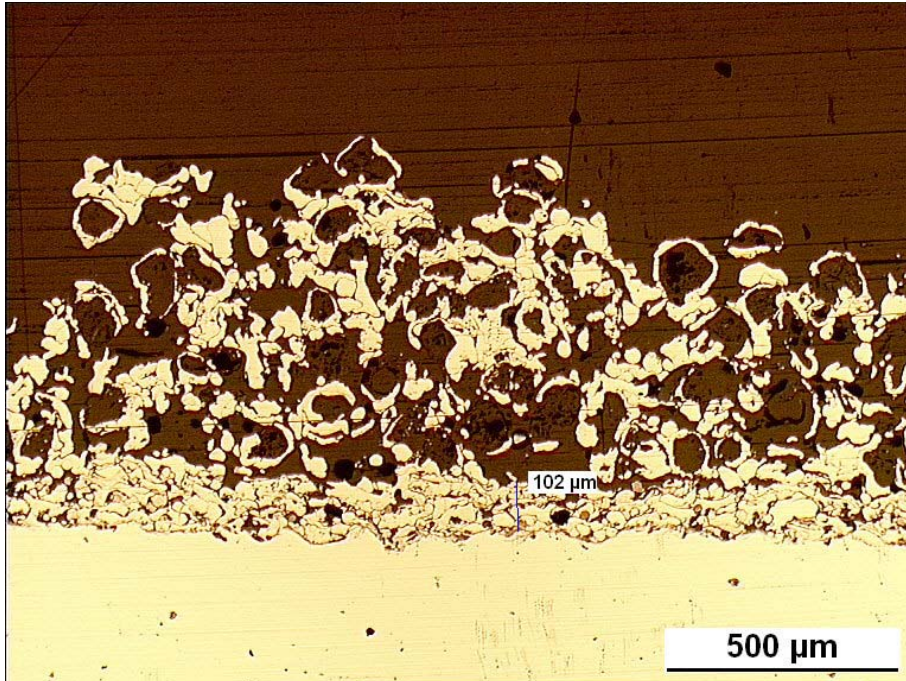
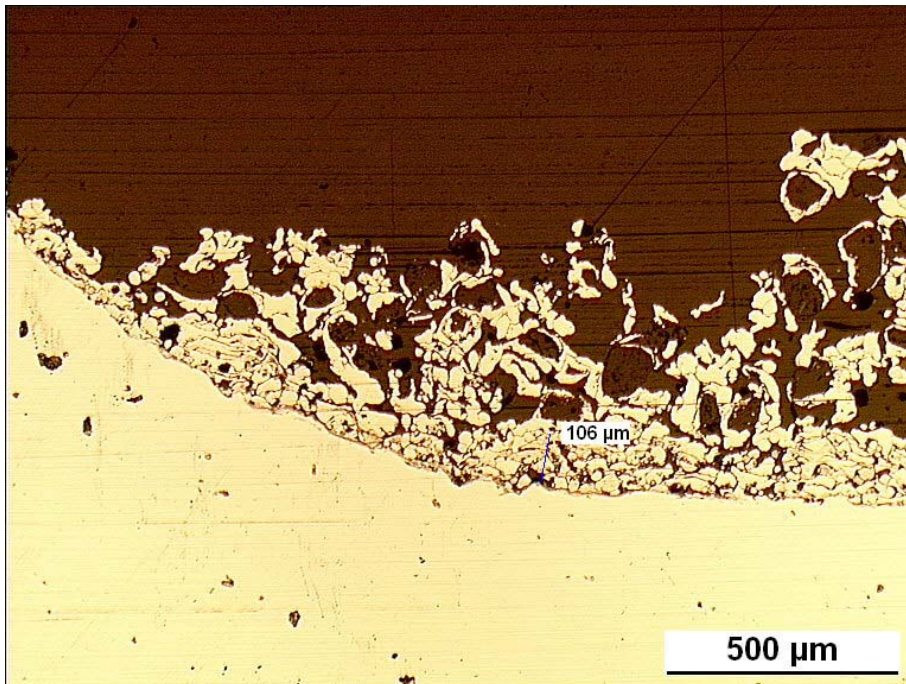
Figure 9 Stage 4 Abrasion-resistant Coating

a) Axial section through the abrasion-resistant coating towards the middle of the casing. The bondcoat is 0,1mm thick (specified range is 0.08 to 0,13mm)

b) Axial section through the abrasion-resistant coating at the edge of the casing

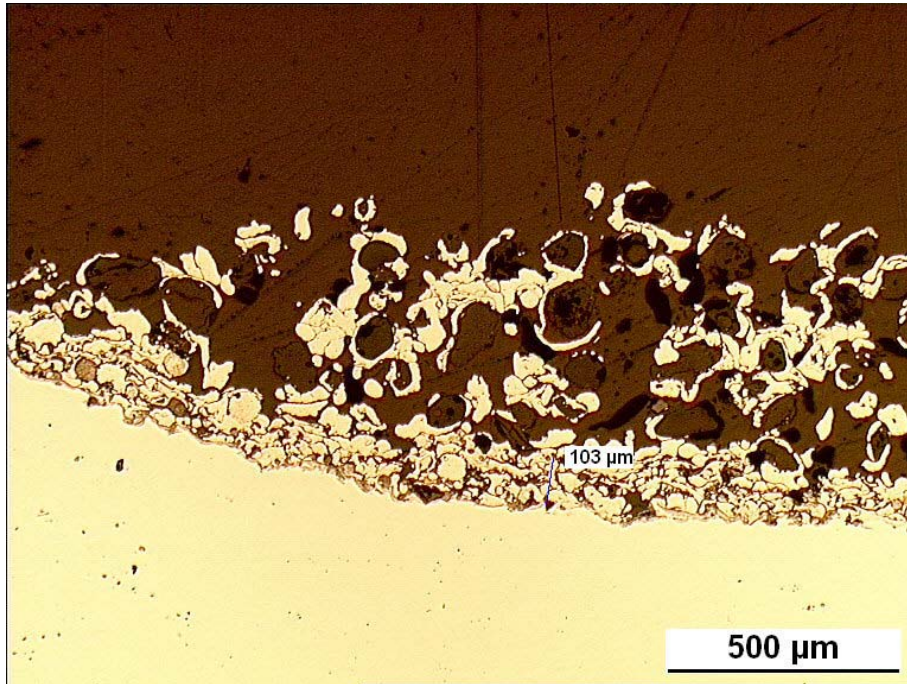
a) Axial cross-section through the abradable at the edge of the casing

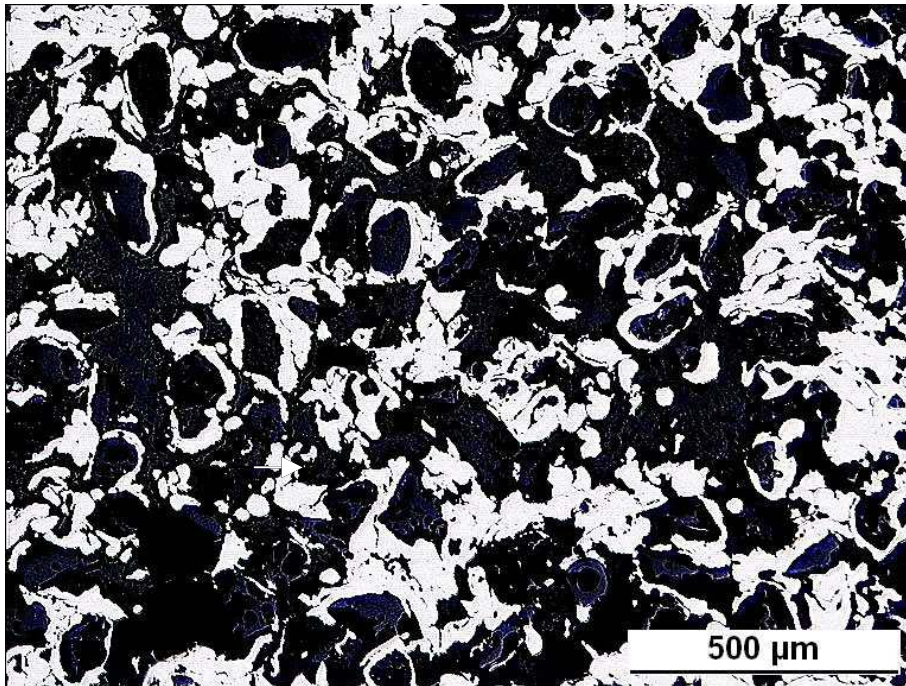
Figure 12 company B Metco 314 Test Sample (~40% metal content)

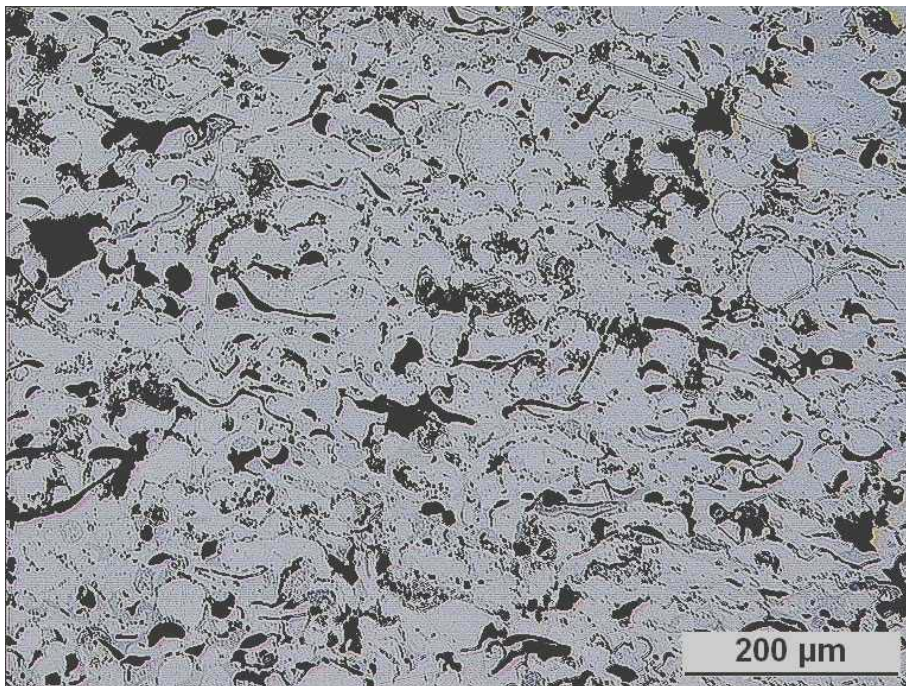
Figure 13 company B Bondcoat Test sample. Isolated unmelted particles are visible and porosity is reduced compared to the HPC casings

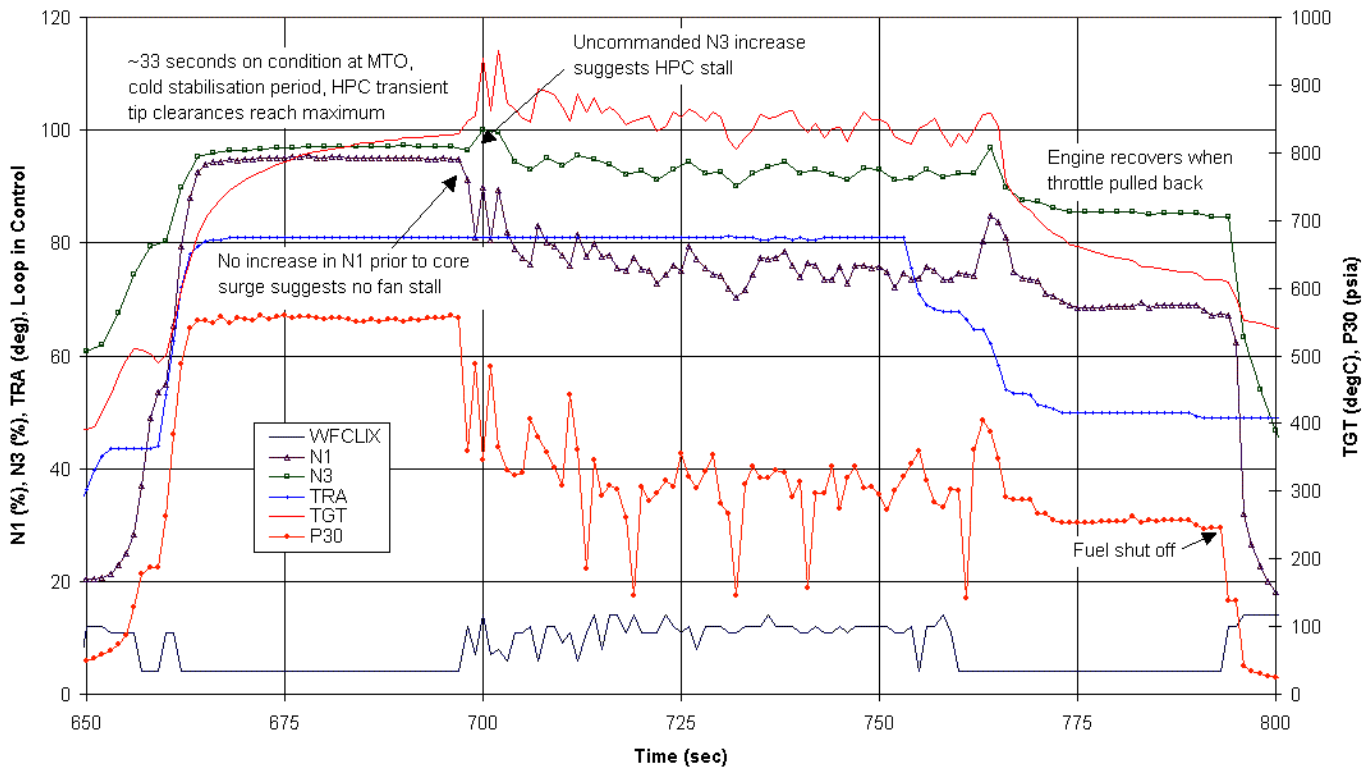
51067 Take-off Surge Events

Fig 15 Take-off data taken from the DFDR

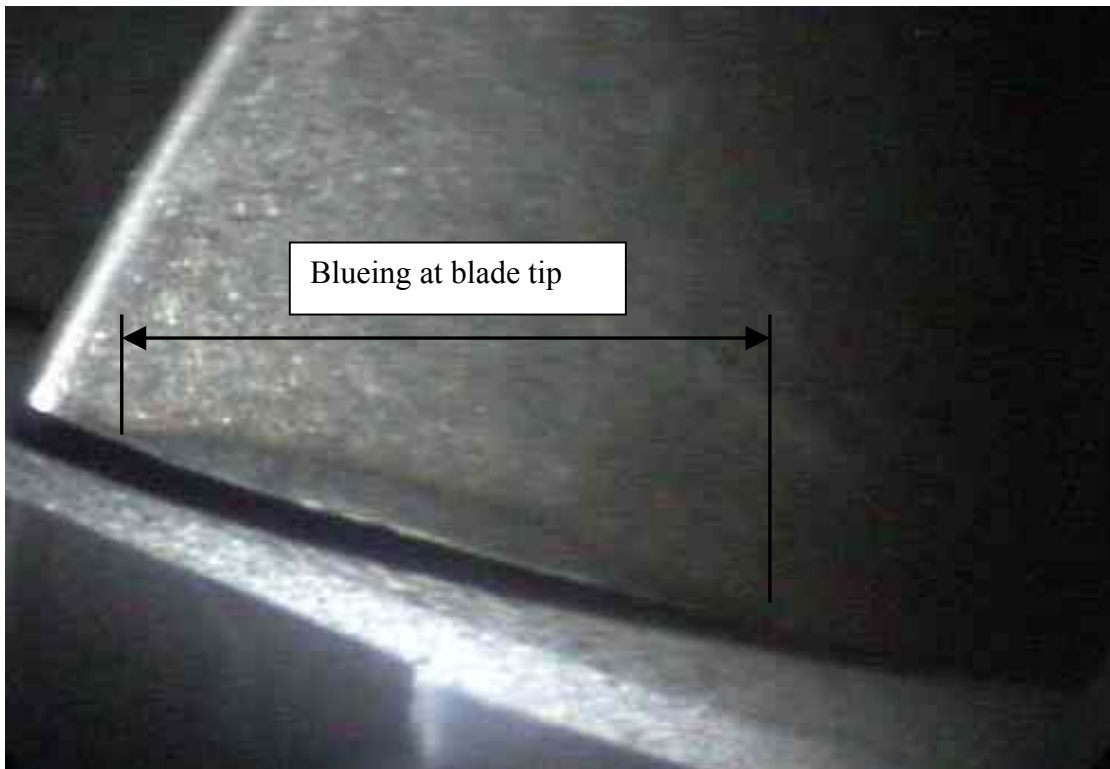
Figure 16 shows an example of a HP compressor stage 3 blade with blueing at the tip

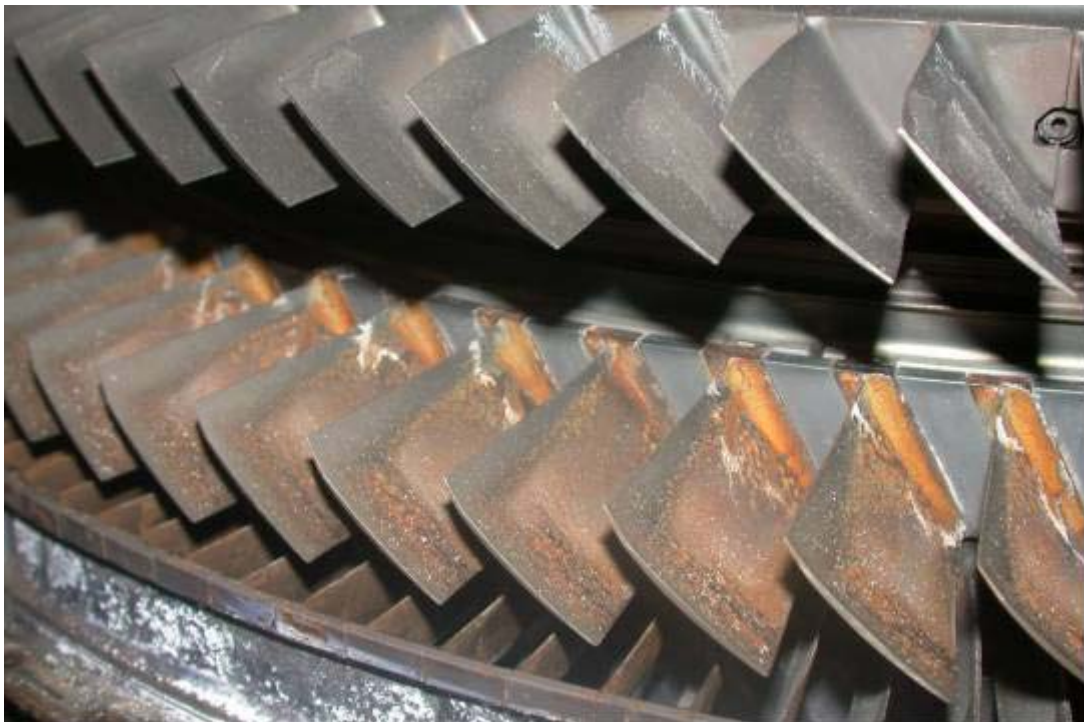
Figure 17 shows no discolouration on the HP compressor stage 2 and 3 blade tips from ESN51067

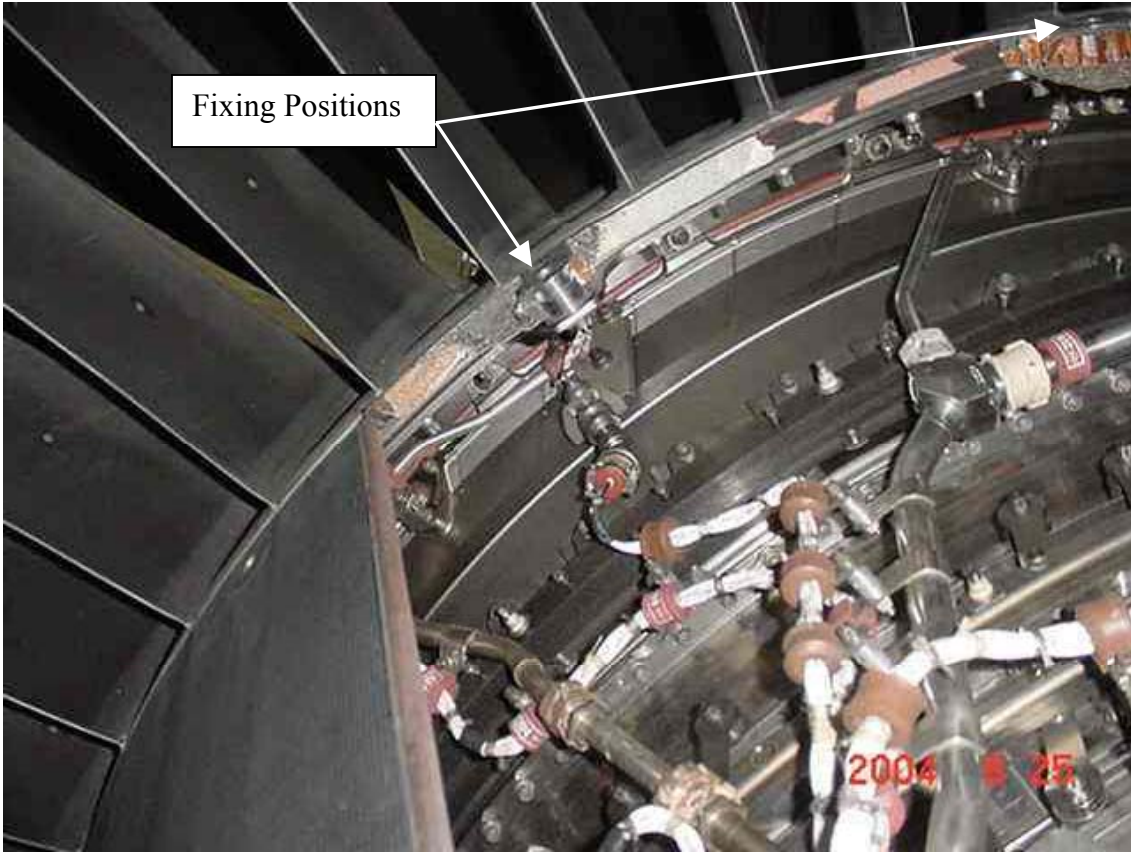
The failed engine core composite panel was secondary to the engine surge event and did not contribute to the engine failure.

Fig 18 showing remains of the LH Upper Fairing (front)

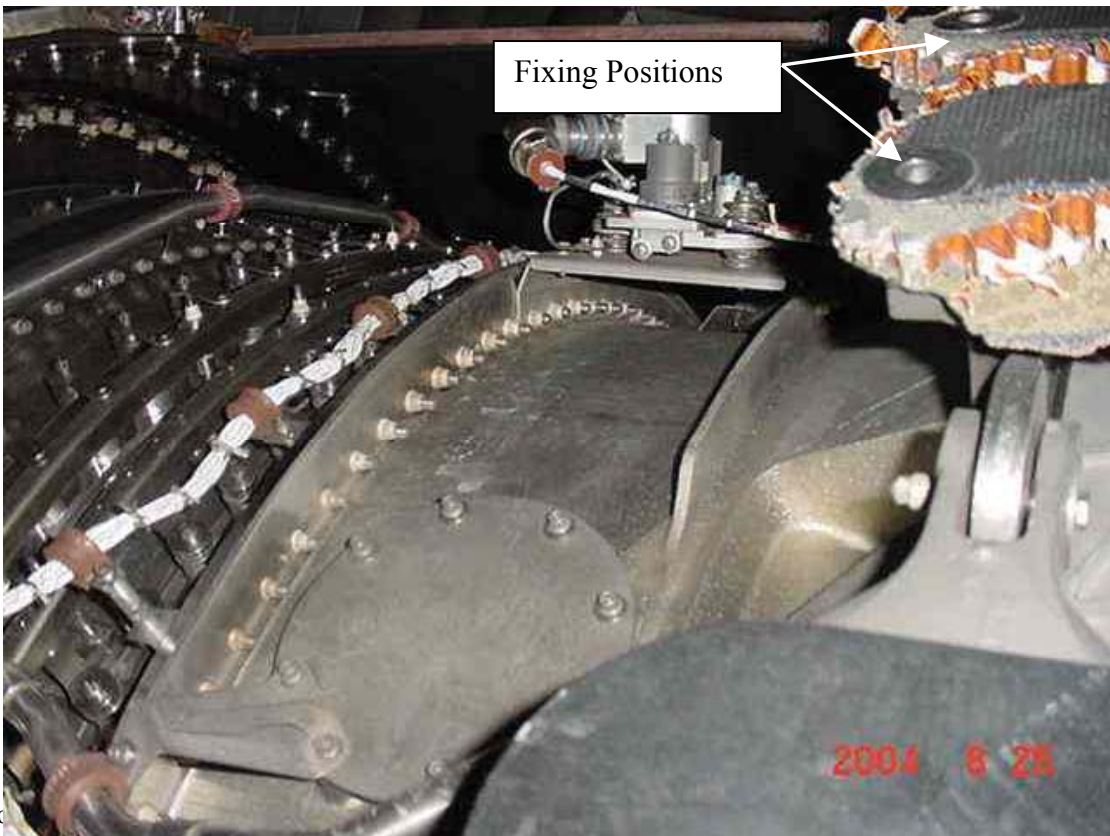
Fig 19 showing remains of the LH Upper Fairing (rear)

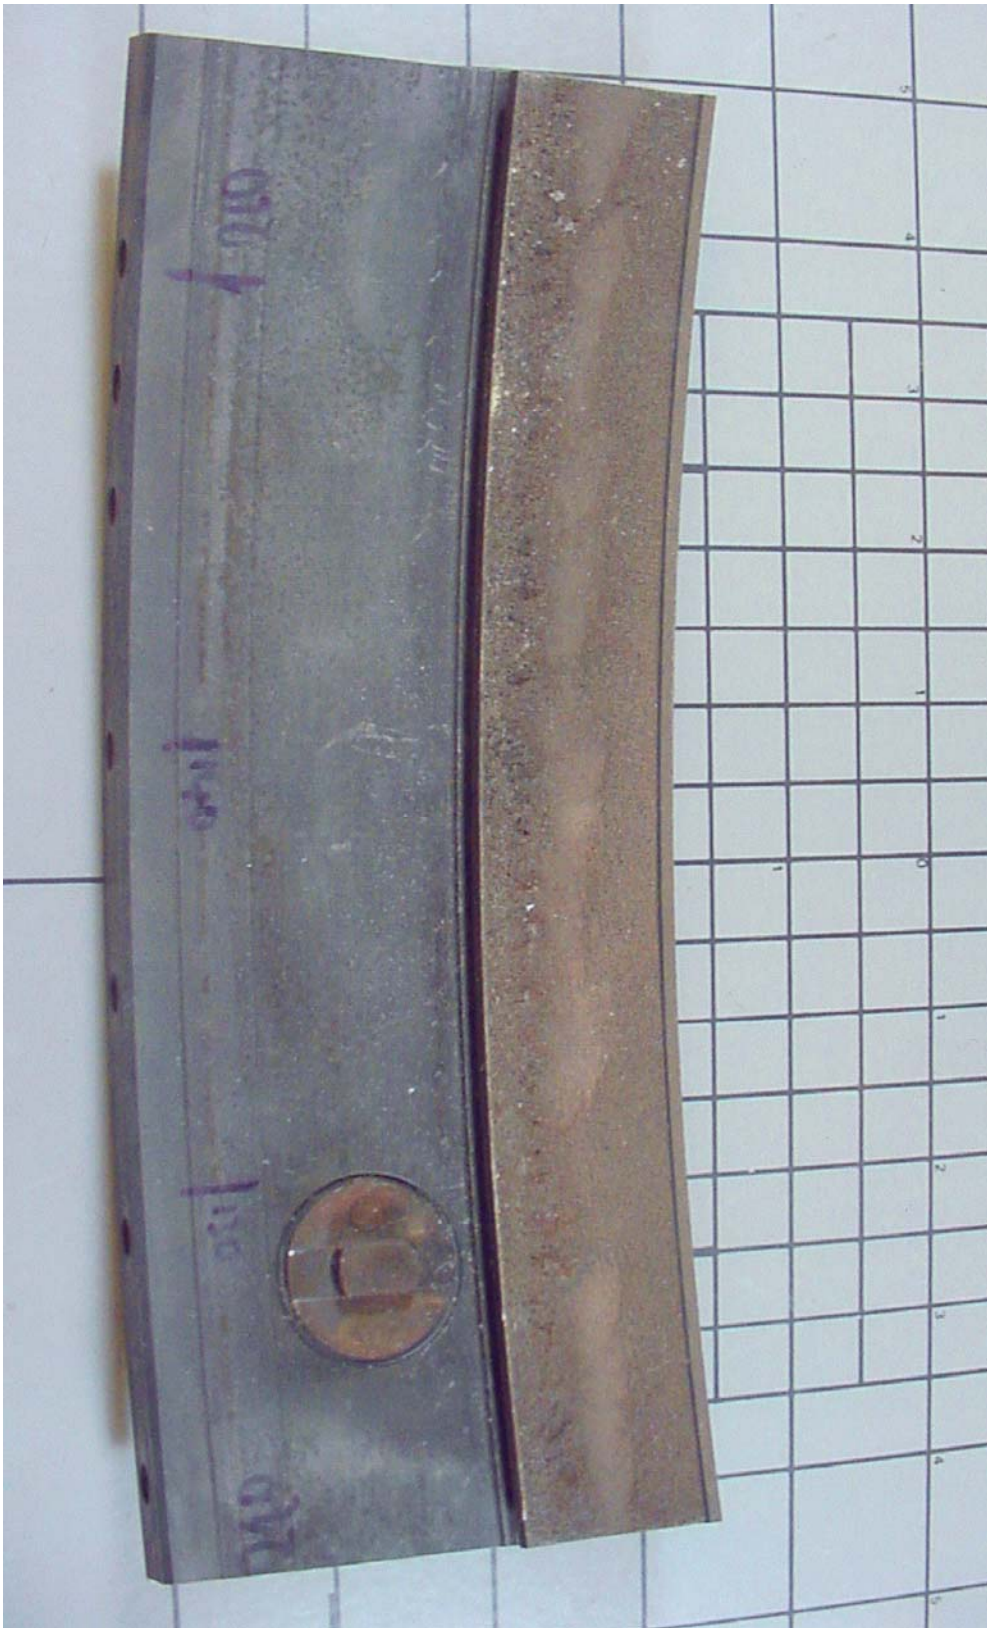
Figure 1. As-received 8.5-inch long segment of stage 6 compressor ring from #51067 Trent 800 engine after flight service with Singapore Airlines. Forward edge on left.

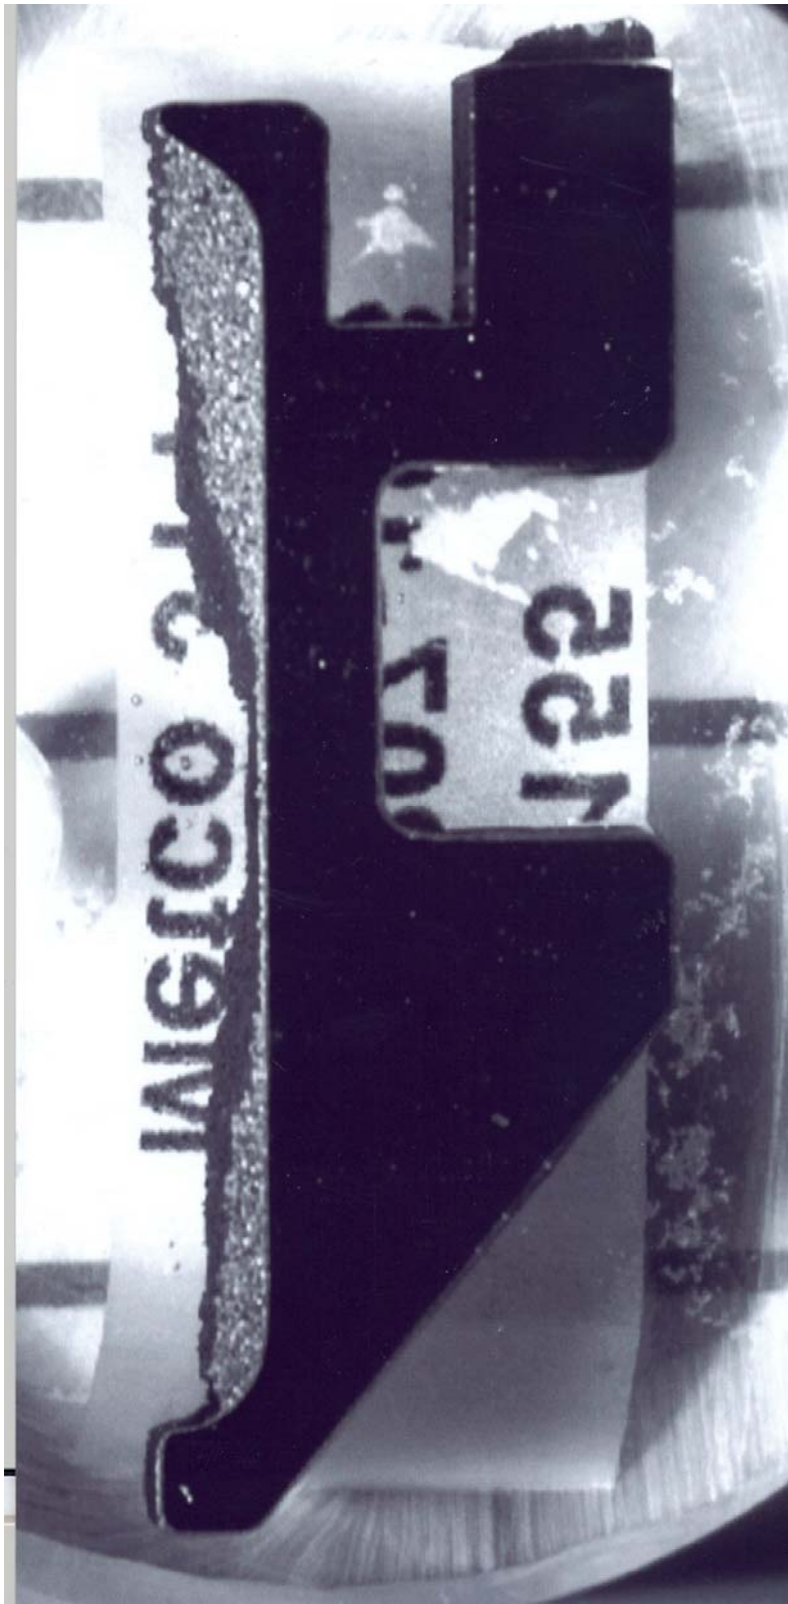
Figure 4. Macro photo of cross section slice of #51067 stage 6 ring with residual LCA-314 residing mainly on the forward edge (at top) and to the rear of center. The 314 is essentially gone in the center with only the 450 bondcoat remaining. EV 40155. 5126-207-10B. Approximately 6X magnification.

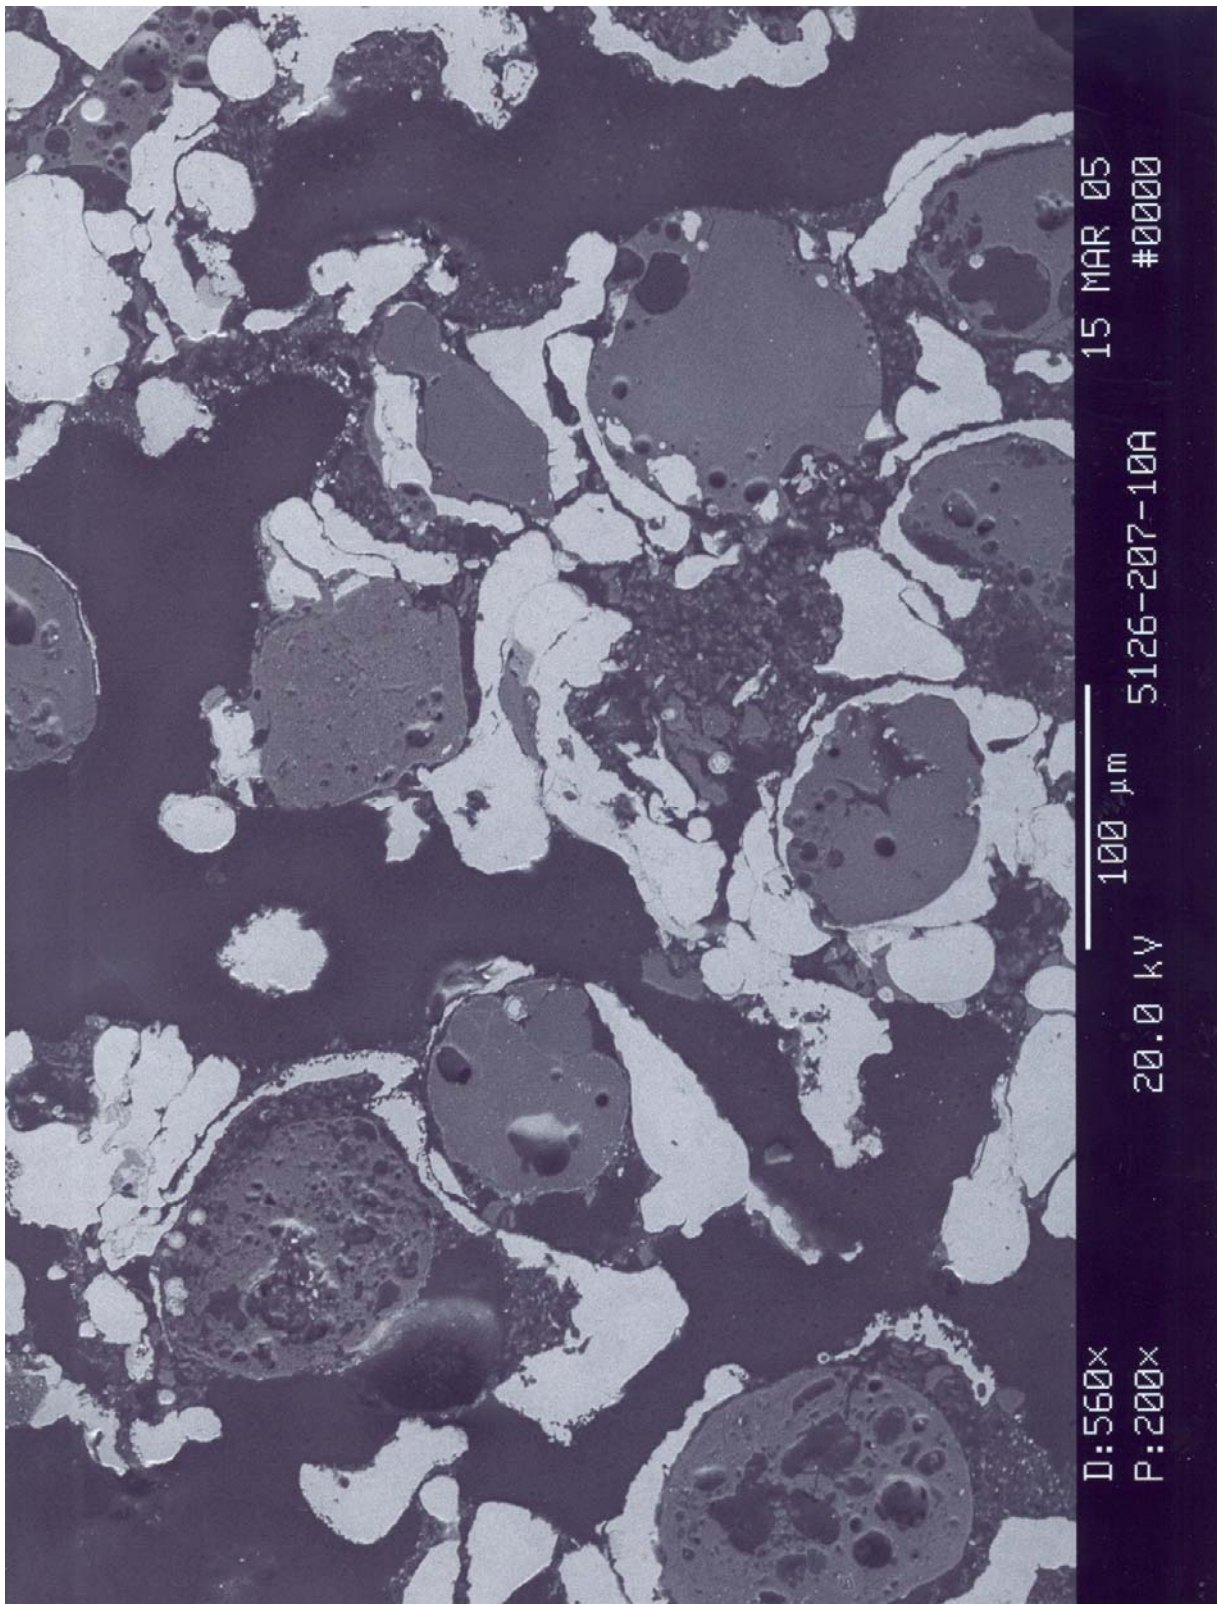
Figure 13a. SEM cross section microstructure of residual coating on #51067 stage 6 ring, “area 5”, used for measurement of percent metallic phase by the linear intercept method. EV 41020. 5126-207-10A. 340 X magnification.

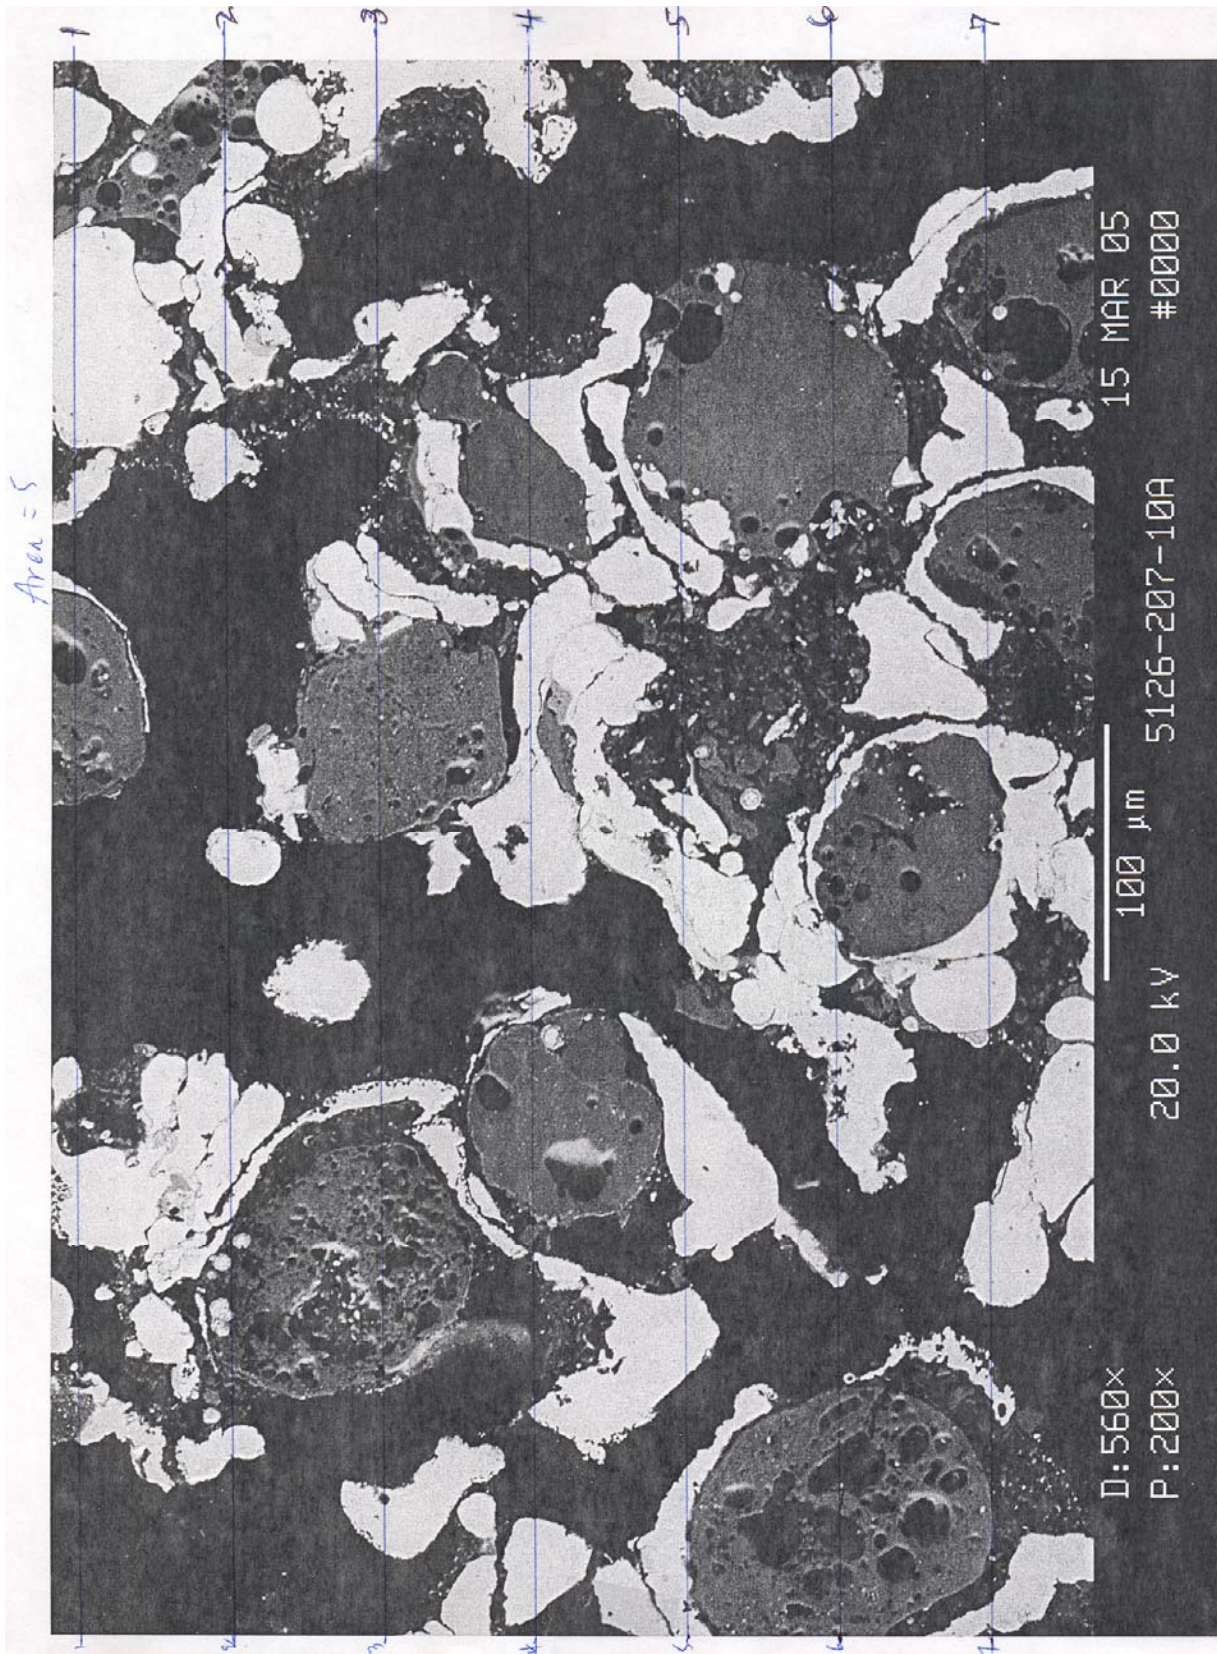
Figure 13b. Photocopy of SEM image of Fig 13a, with seven parallel lines drawn across long direction, each spaced 1-inch on original, for line-by-line measurement of metallic phase segments leading to estimate of whole-area percent metallic phase. 340 X magnification.

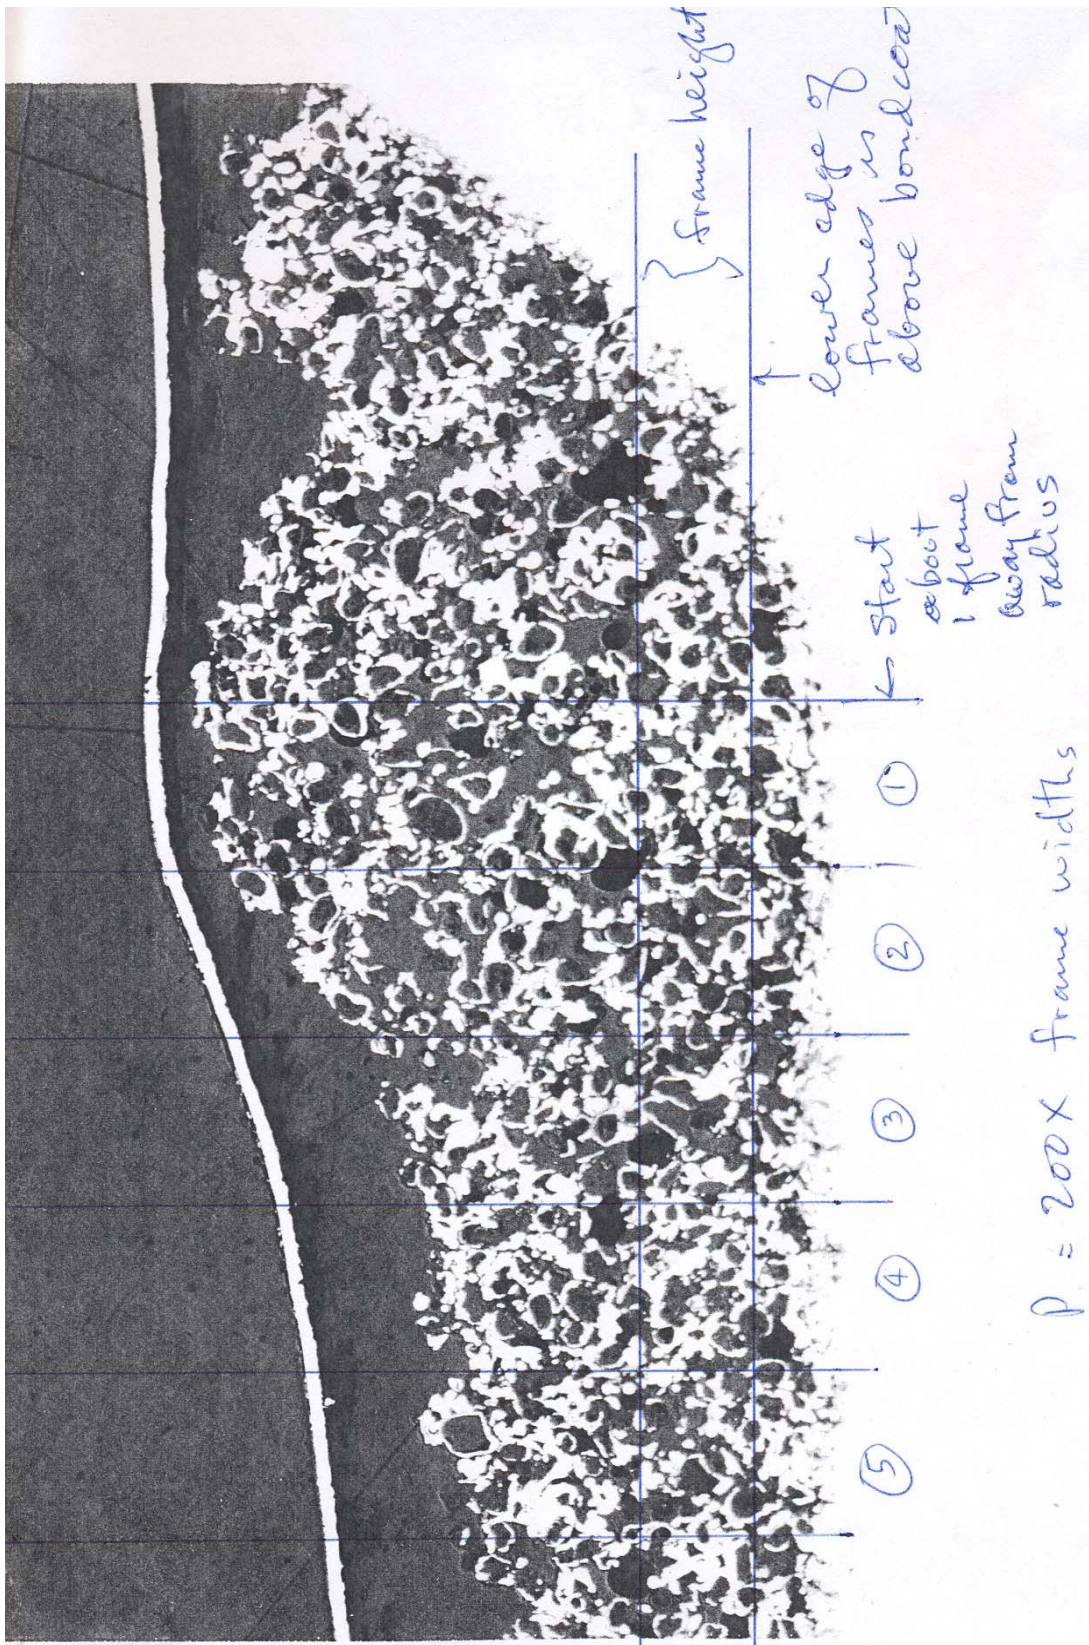
Figure 13c. Photocopy of optical microscope section of #51067 stage 6 ring, near forward edge, with drawn-on lines showing areas and frames 1 – 5 for subsequent SEM micrographs to be used in linear intercept analysis of percent metallic phase. About 50 X magnification.

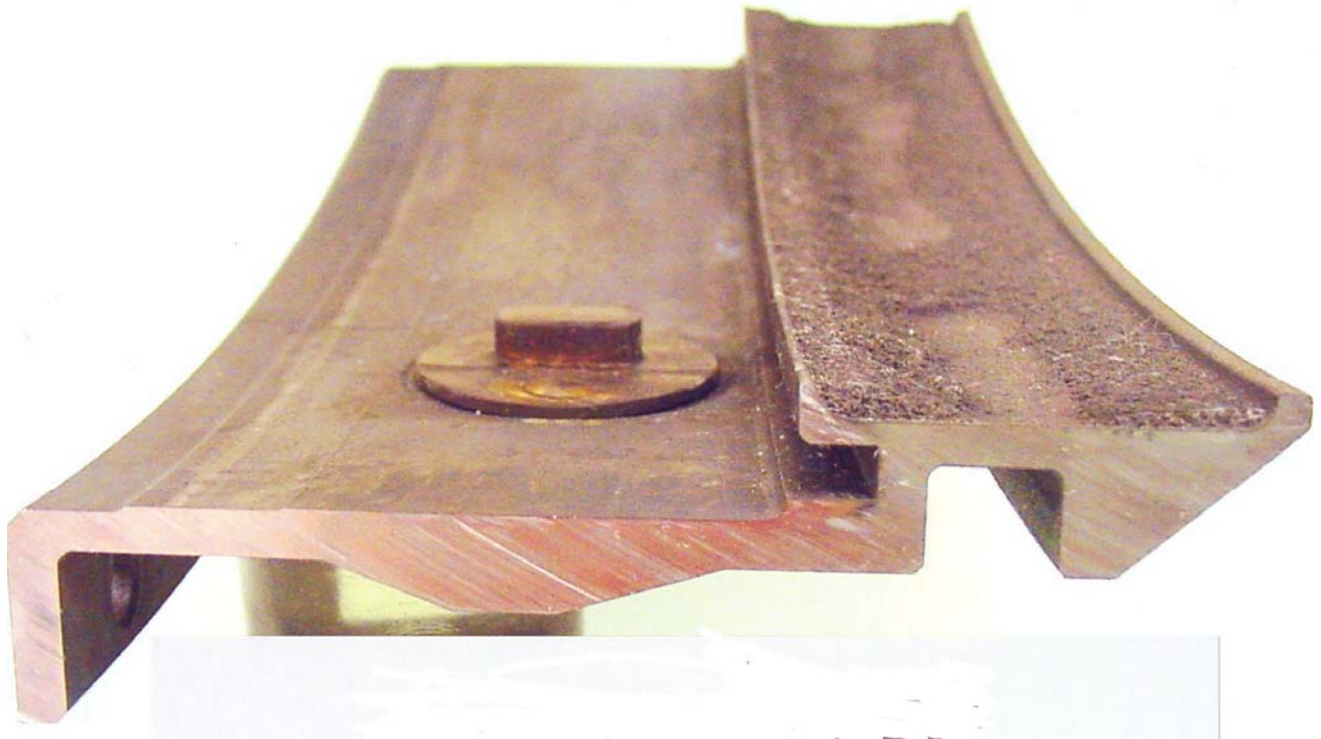
Figure 15 (View 1). Macroscopic views of the #51067 stage 6 compressor ring segment under evaluation at PST. The view shows the cross section of the IN 907 ring substrate, the location of the LCA-314 coated track and the general features of the eroded 314 relative to substrate location. Full ring width is about 3.25 inches, coated track is 1.1 inches.
