ATSB TRANSPORT SAFETY INVESTIGATION REPORT

Aviation Safety Incident Report – 200403110

**Engine failure - Melbourne Airport, Victoria
25-Aug-2004
Boeing Company 777-312
9V-SYB**

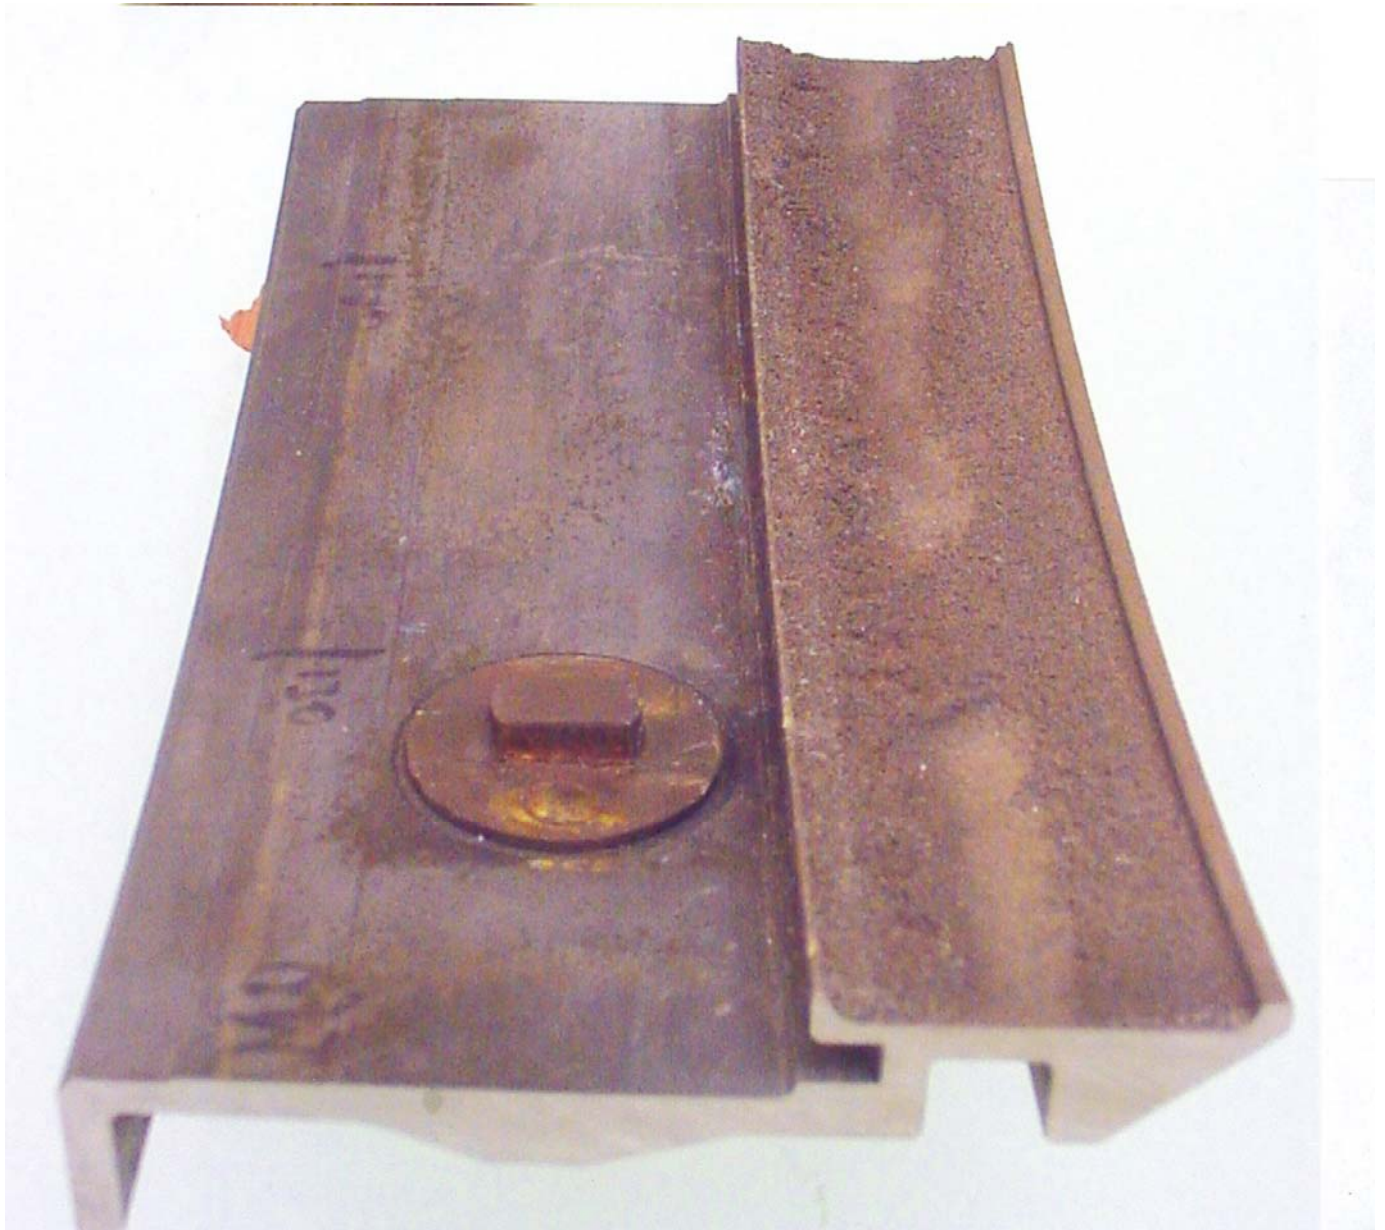
Figure 15 (View 2). Macroscopic views of the #51067 stage 6 compressor ring segment under evaluation at PST. The view shows the cross section of the IN 907 ring substrate, the location of the LCA-314 coated track and the general features of the eroded 314 relative to substrate location. Full ring width is about 3.25 inches, coated track is 1.1 inches.

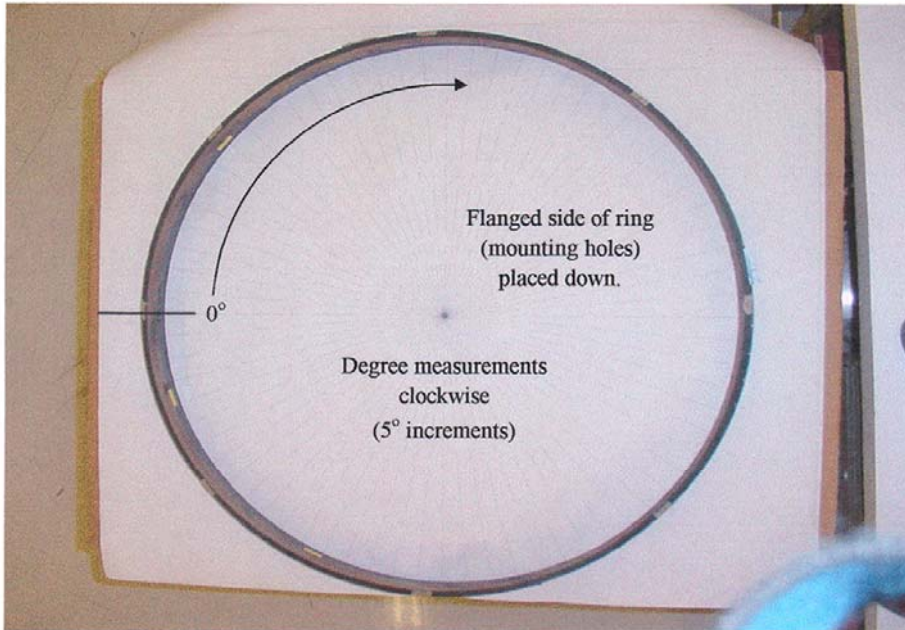
Figure 17. Photo of #51363 stage 6 ring. AST and PST location number correlation and to angular position. Measurements of spall patch dimensions of typical examples of Fig. 16.

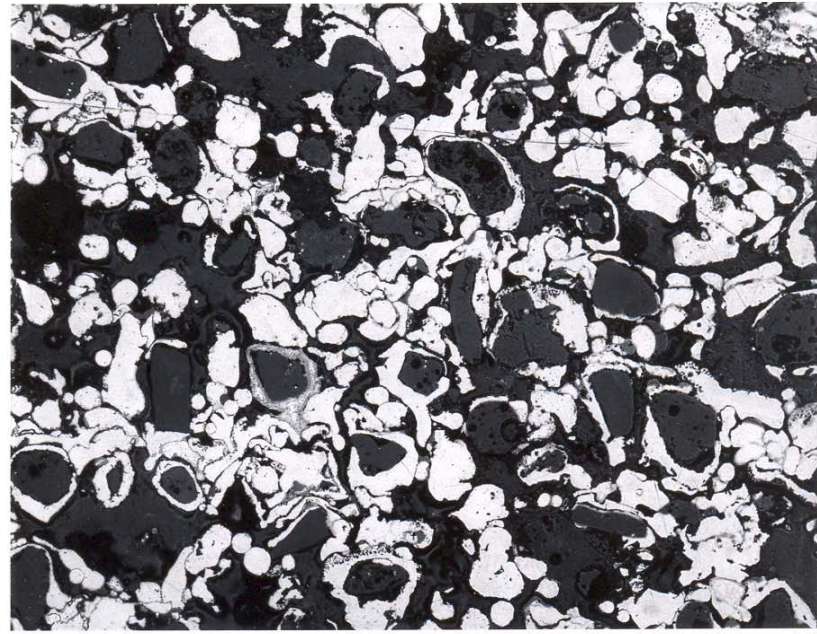
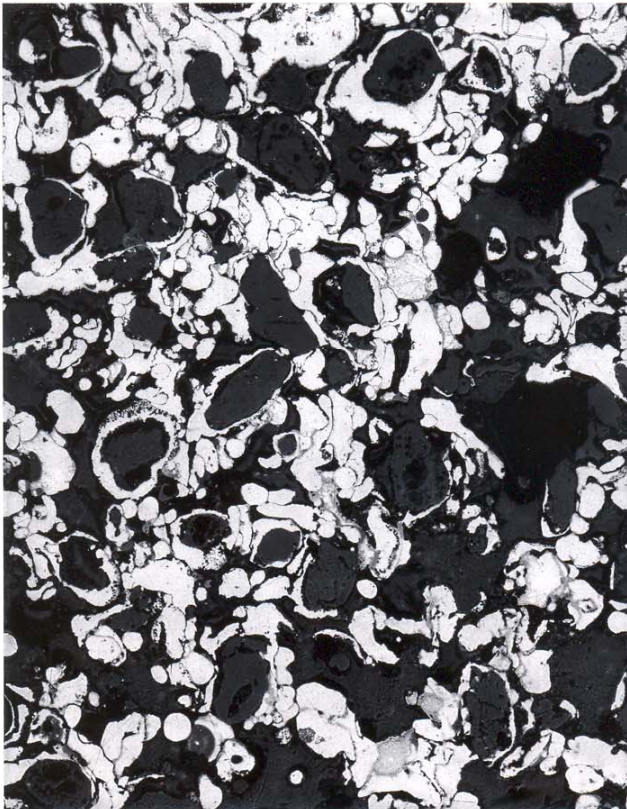
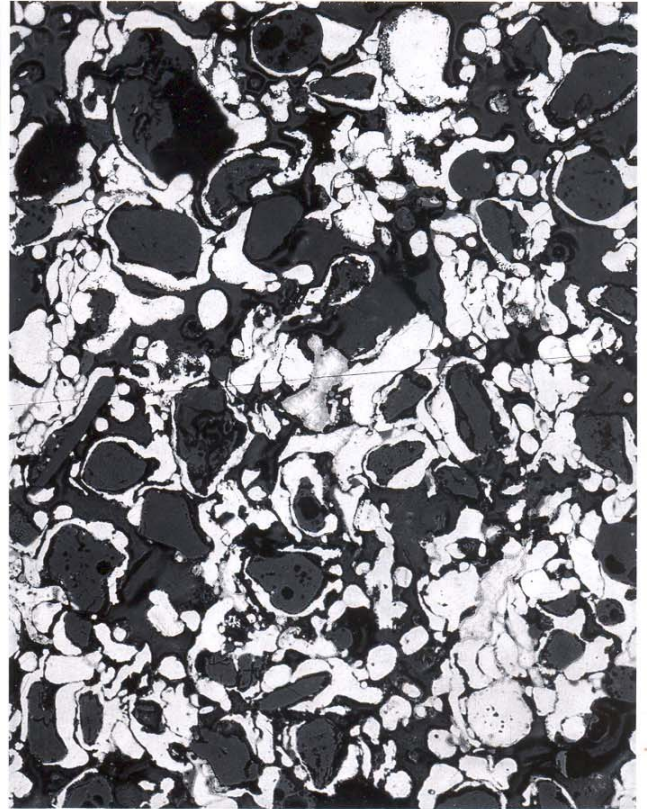
Figure 18a. Optical micrographs of LCA-314 coating chip taken from #51363 stage 6 ring. Three random areas for subsequent analysis for percent metal phase. EV 40177. 93 X magnification.

First, the percent metal measurement results. Three areas of the polished cross section of the chip were photographed at 100X in the optical microscope, and these micrographs are shown in Figure 18a. These 4 x 5-inch micrographs were enlarged on the photocopy machine to about 7 x 9 inches, and these enlargements were scribed with 7 lines along the wide direction, spaced apart by 1-inch. These were measured for metal phase intercept segment lengths using a magnifying glass and steel rule (0.01 inch resolution), as was done before for the #51067 ring. The results for this LCA-314 coating chip are as follows:

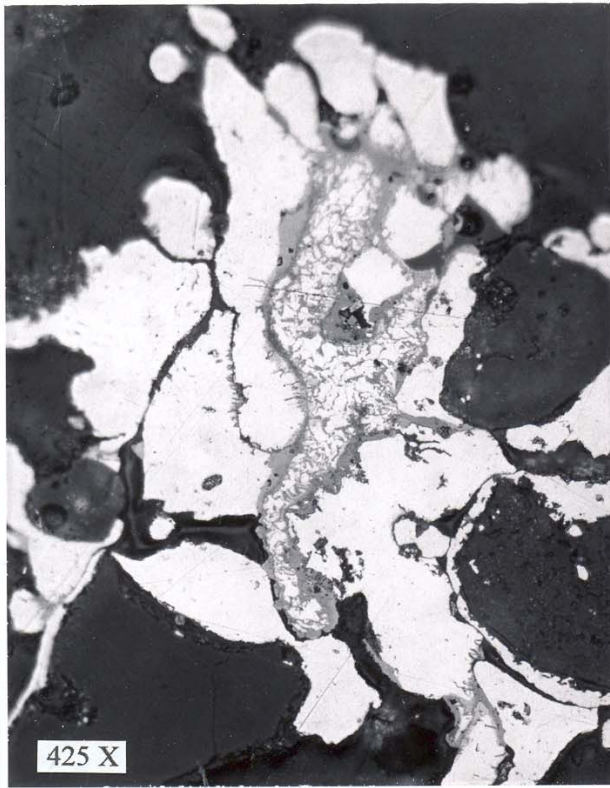
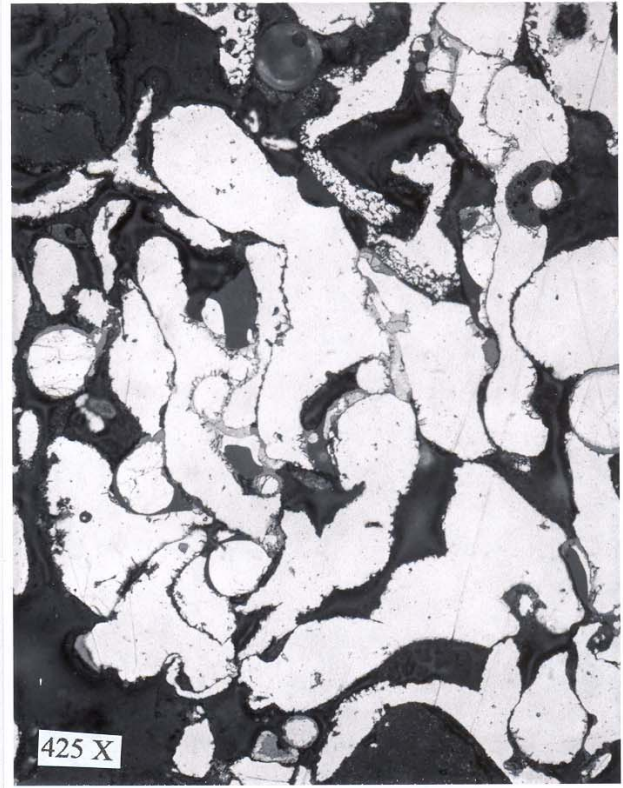
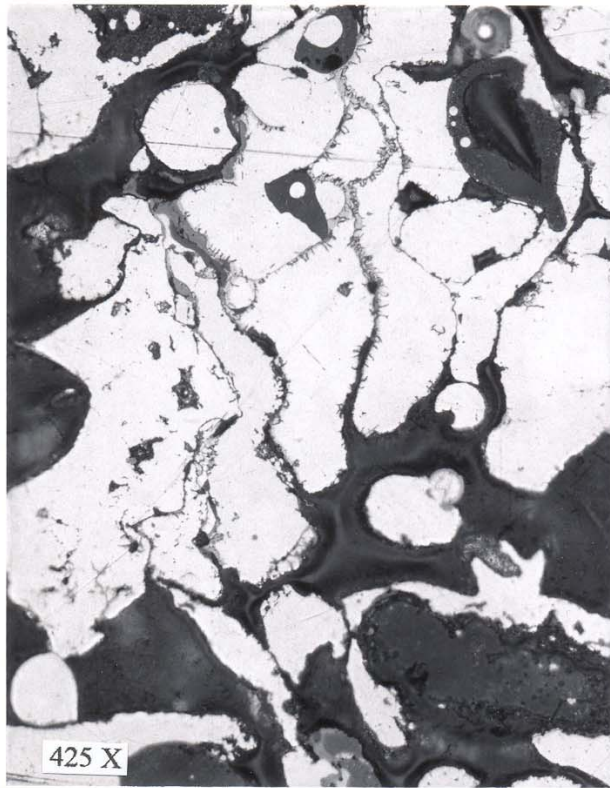
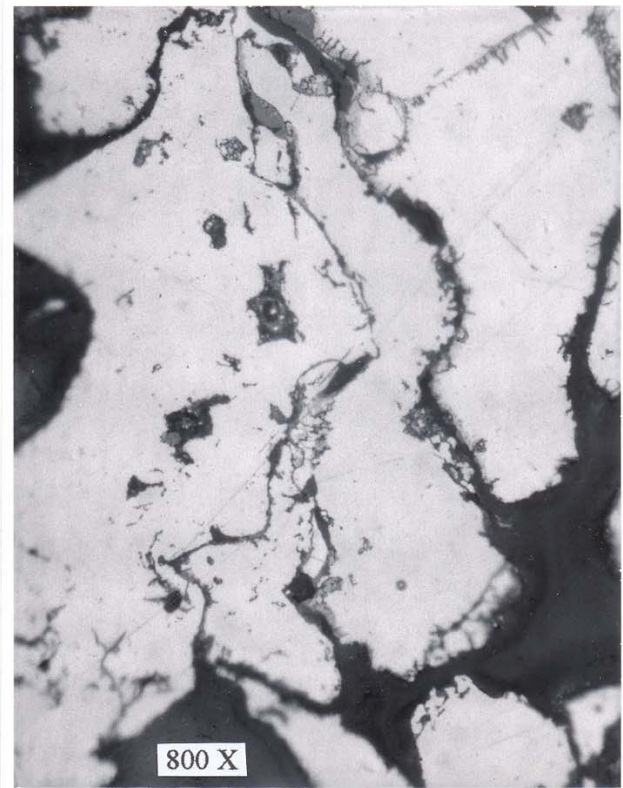
The polished cross section of the #51363 stage 6 coating chip is again shown in Figure 18b, at higher optical microscope magnification. It is seen that this coating, like the remnant LCA-314 on #51067, is very oxidized. The splat interfaces of the NiCrAl phase are all decorated with oxide and instances of cracking and separation between splats are seen.

Figure 18b. Optical micrographs of LCA-314 coating chip taken from #51363 stage 6 ring. Detail of NiCrAl phase and severe oxidation formed at splat boundaries during engine operation. Magnification as noted X 0.91.

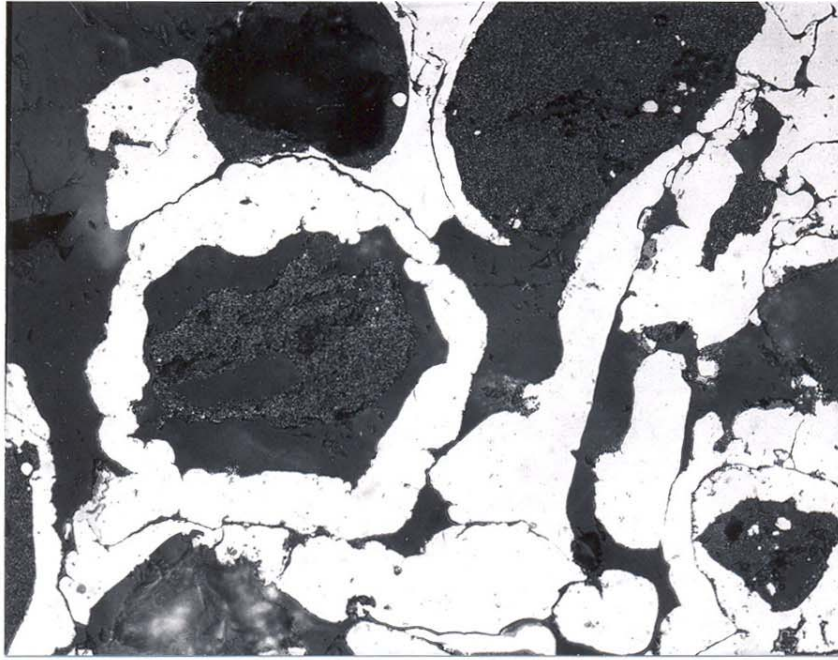
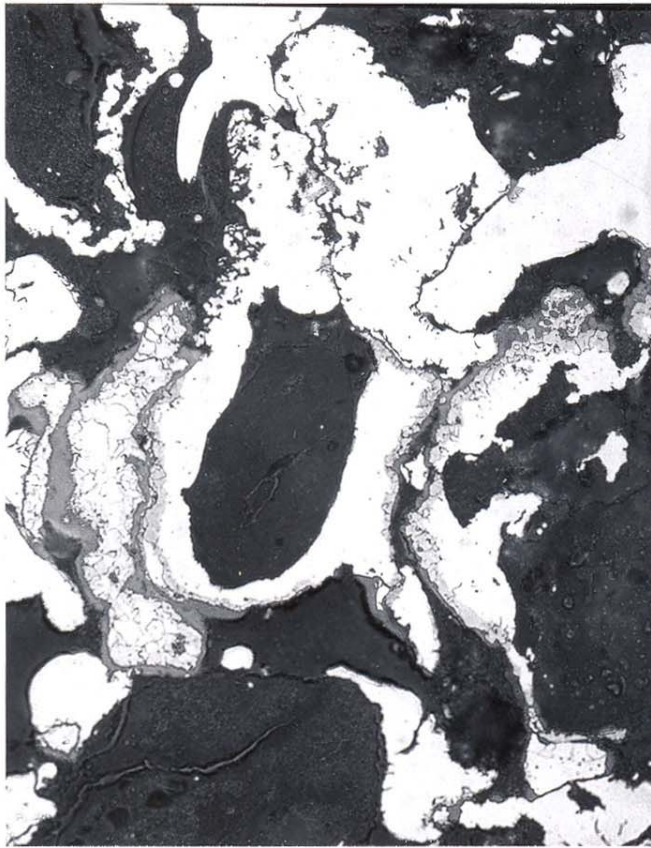
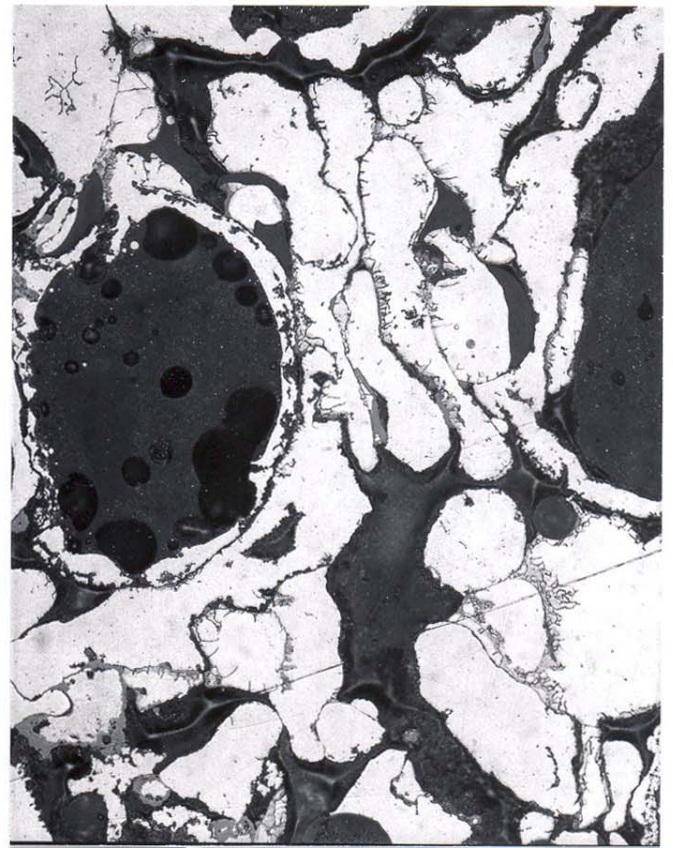
Figure 18c. Optical micrographs of LCA-314 showing degrees of oxidation present after coating (QC #864) as compared to after engine exposure. 390 X magnification.

At this point it is useful to compare the degree of oxide within the LCA-314 coating for the two engine-run samples shown above, and the as-coated QC sample from AST which was done just prior to the #51363 stage 6 ring coating. These are shown in polished cross section at a common optical microscope magnification in Figure 18c. The as-coated #864 will be discussed further below. It was found that the as-coated LCA-314 does have slight inter-splat oxide on the NiCrAl phase, as this is an oxy-acetylene flames-sprayed coating. However, the degree of oxide is very minor. The degree of oxidation from the engine-run coatings is much more extensive, even penetrating grain boundaries within the NiCrAl particles, whereas in #864 the oxide was only on the particle surface. It further appears that #51067 is at a more advanced state of oxidation than #51363.

LCA-314 QC #864
EV 40277 5119-63

Engine run LCA-314
#51067 stage 6
EV 40155 5126-207-10B

Engine run LCA-314
#51363 stage 6 (chips)
EV 40177 5119-50-27

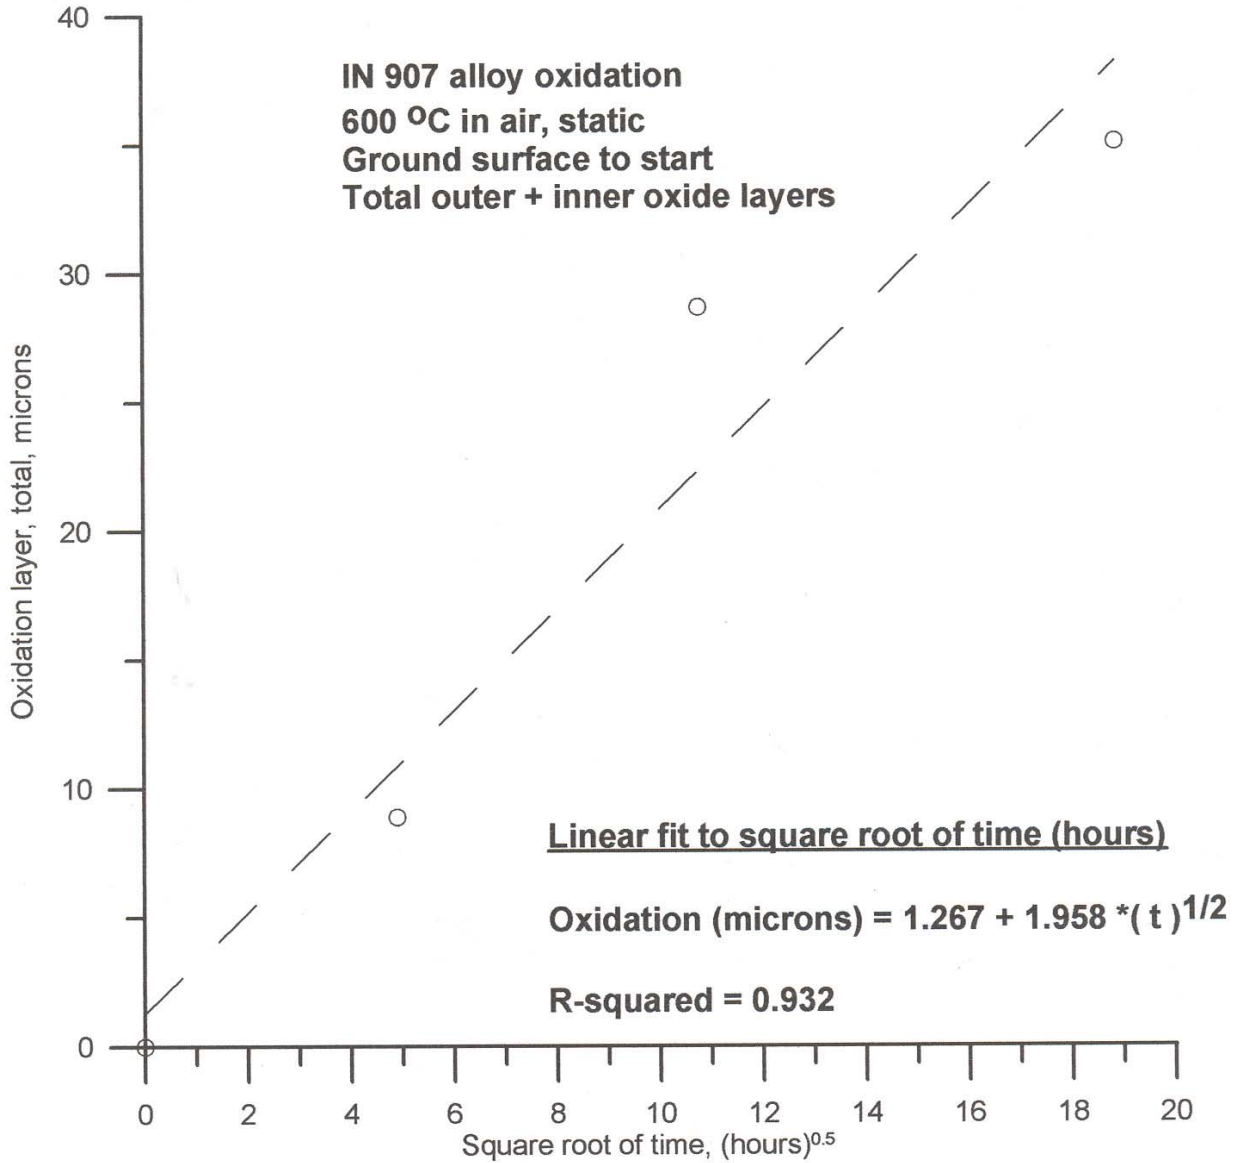
To establish some idea of the oxidation rate at 600 °C, pieces were cut of IN 907 from the scrap stage 6 ring of #51067, roughly ground clean, and exposed in furnace oxidation in static air for different times up to 356 hours. The oxidized alloy samples were mounted in cross section and the oxide layer thicknesses were measured. Figures 23 and 24 show the layer thickness data plotted as a function of square root of time, and it is seen to be a reasonable fit for both the total oxide thickness and just the internal oxidation layer thickness.

The fit equations from this data were used to estimate the time at 600 °C it would take to generate the oxide layer thicknesses found in Fig. 12 for the bare IN 907 alloy. This calculation gives about 7700 hours using the total oxide thickness or about 10,000 hours using just internal

Figure 23. Plot of oxidation data at 600 °C in air for sample of IN 907 taken from #51067 stage 6 ring, ground, and then furnace exposed at PST. Linear fit indicated to square root of exposure time for total outer + inner oxide layers.

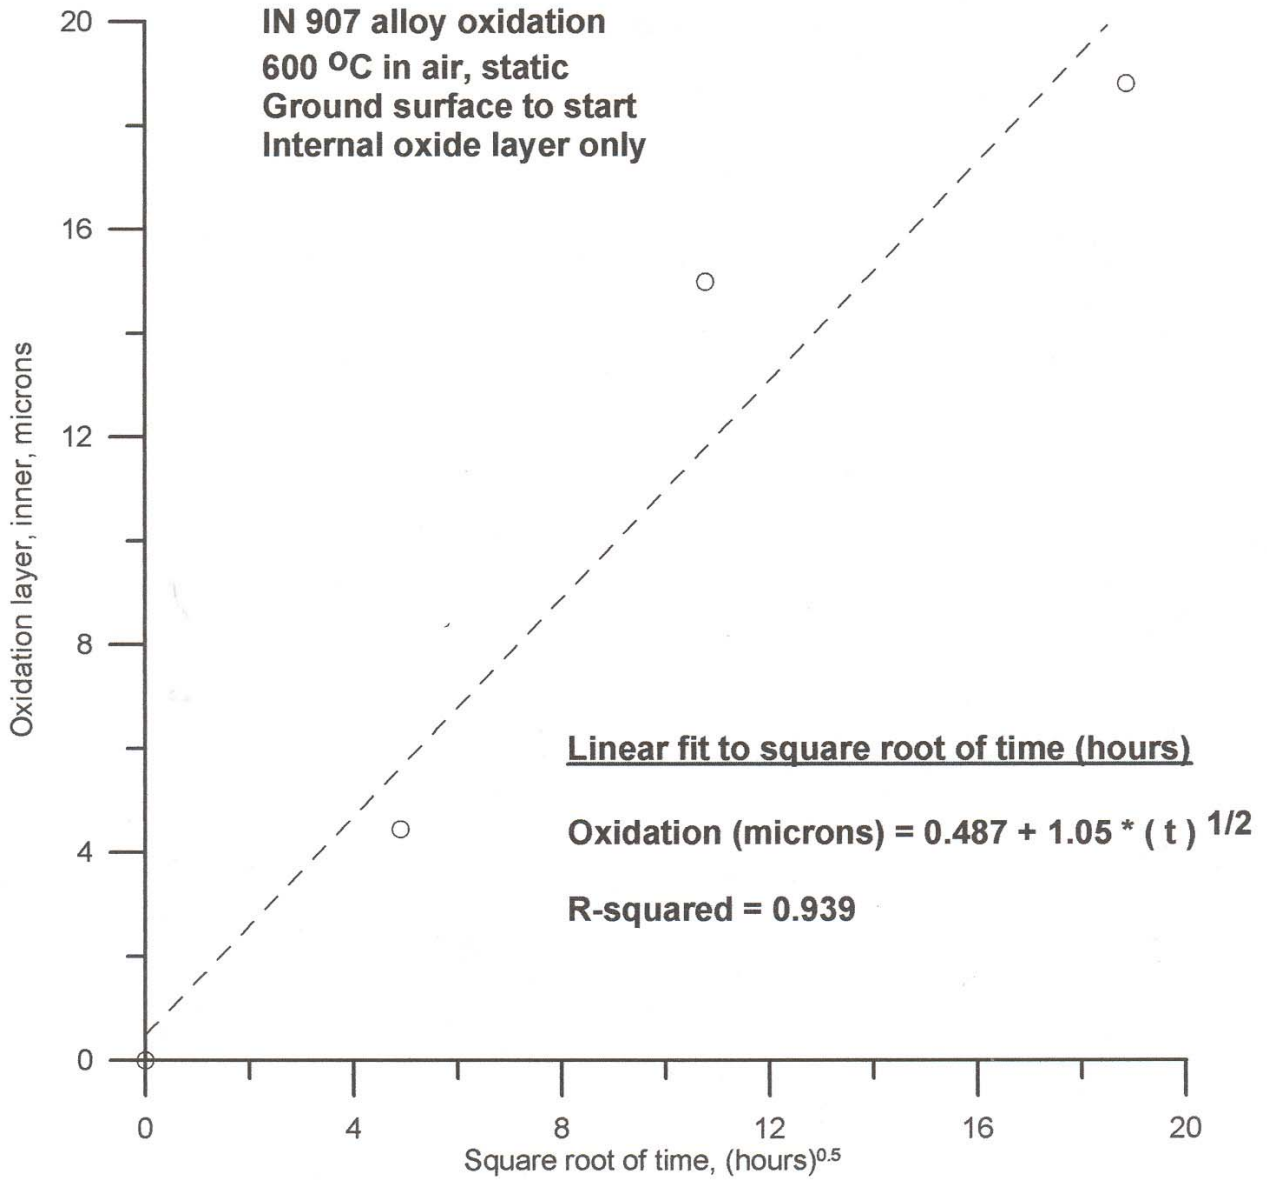
Another estimation is to examine just the internal oxidation layer under the LCA-314 / 450 coatings on the stage 6 ring sample of engine #51067. From Figs. 10, this internal oxide layer varies from 23.5 to 58.8 microns. If it is assumed that the SAESL high pressure waterjet and the AST grit blast procedures removed all pre-existing oxide on the IN 907 when the old coating was stripped, this oxide layer is then only due to the last engine run cycle. Using the equation for internal oxidation layer growth, given on Fig. 24, the measured layer thicknesses would need between 480 and 3084 hours to grow.

Figure 24. Plot of oxidation data at 600 °C in air for sample of IN 907 taken from #51067 stage 6 ring, ground, and then furnace exposed at PST. Linear fit indicated to square root of exposure time for just inner oxide layer.

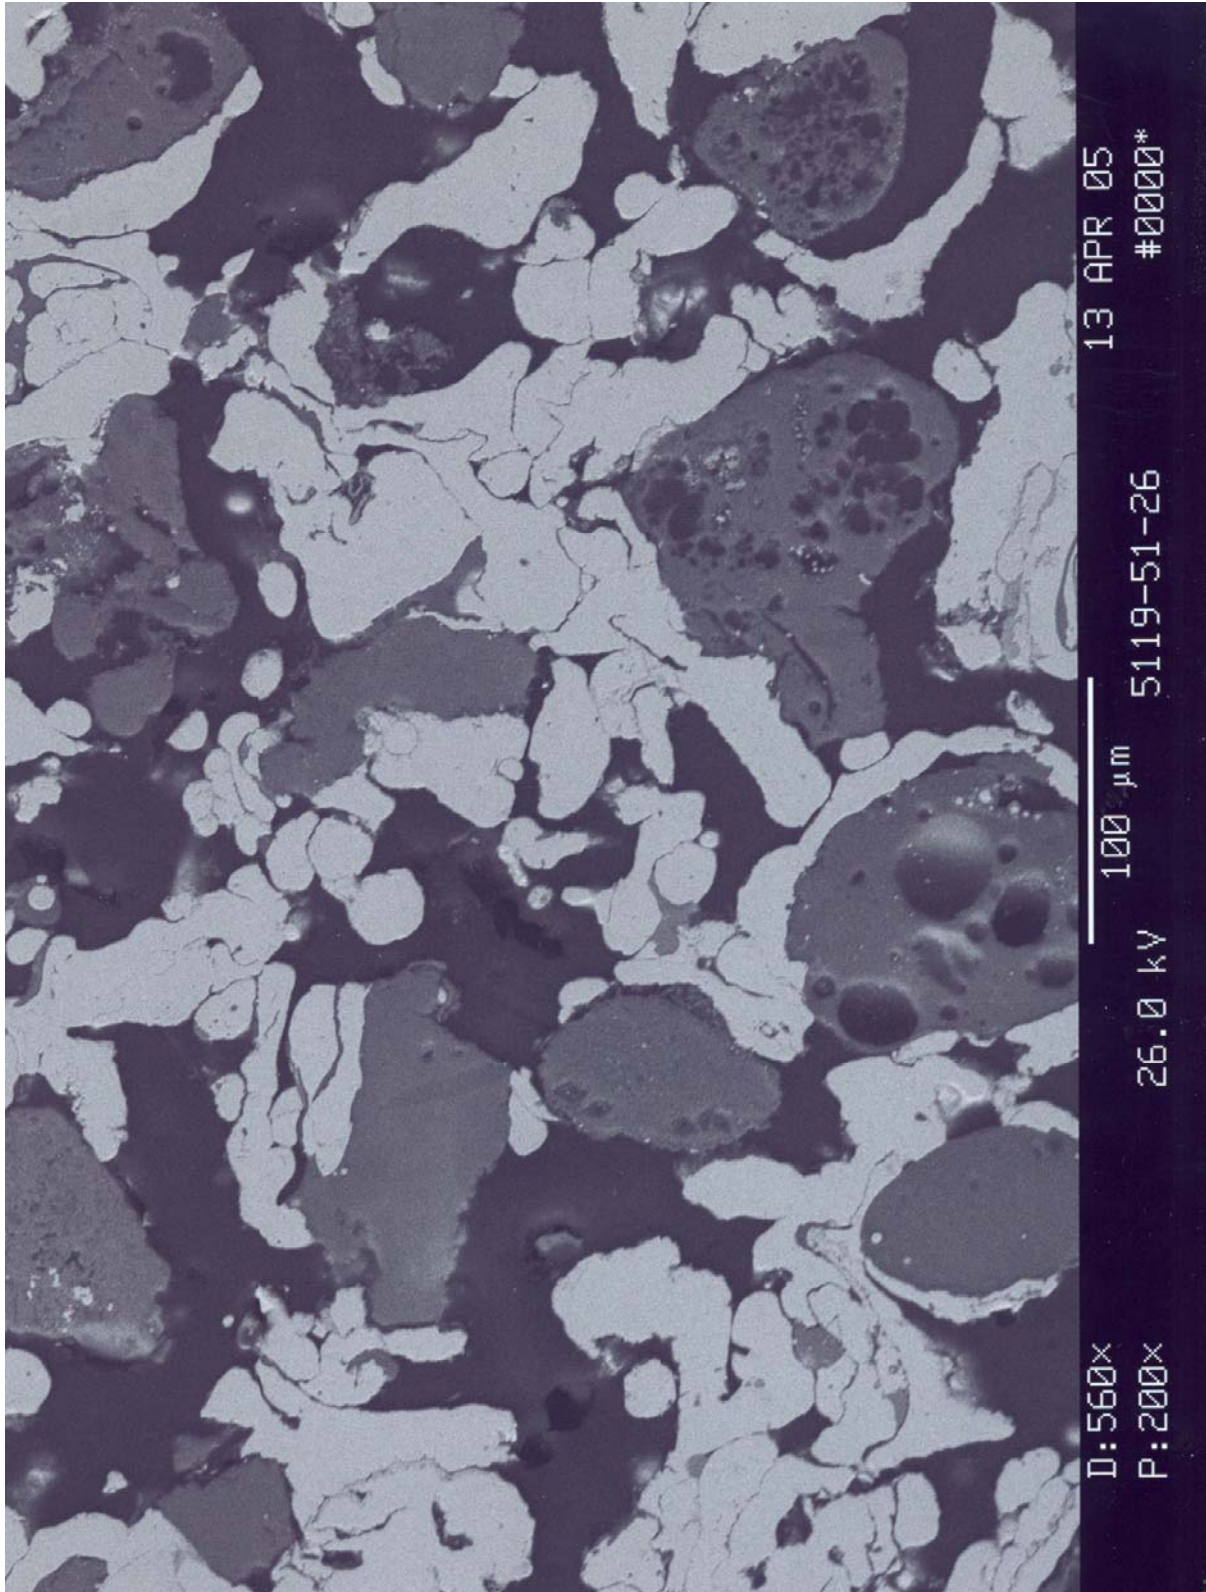
The oxidation of the NiCrAl-Bentonite coating on the #51067 stage 6 ring has been shown earlier. In an attempt to duplicate such oxidation patterns, a sample of NiCrAl-Bentonite from the PST archives was exposed to static air oxidation at 600 °C, for various times up to 453 hours. The oxidation observed in the polished cross sections was minimal, so only the longest time exposure sample will be discussed here. Figure 25 shows the SEM cross section microstructure of the 453 hour sample. This micrograph can be compared to Fig. 11a of the engine-run LCA-314 coating, taken at the same magnification. In the 453 hour sample the oxide is thin and in most cases limited to the surface of the splats or splat interfaces. In the engine-run coating, the oxide layer is wider, has penetrated all inter-splat boundaries. It would appear that the engine-run 314 coating has seen either much longer time than 453 hours at 600 °C (the expected stage 6 compressor temperature) or run at a higher temperature than 600 °C.

Figure 25. SEM micrograph of PST furnace oxidation sample of NiCrAl-Bentonite coating, exposed for 453 hours at 600 °C in air. 350 X magnification.

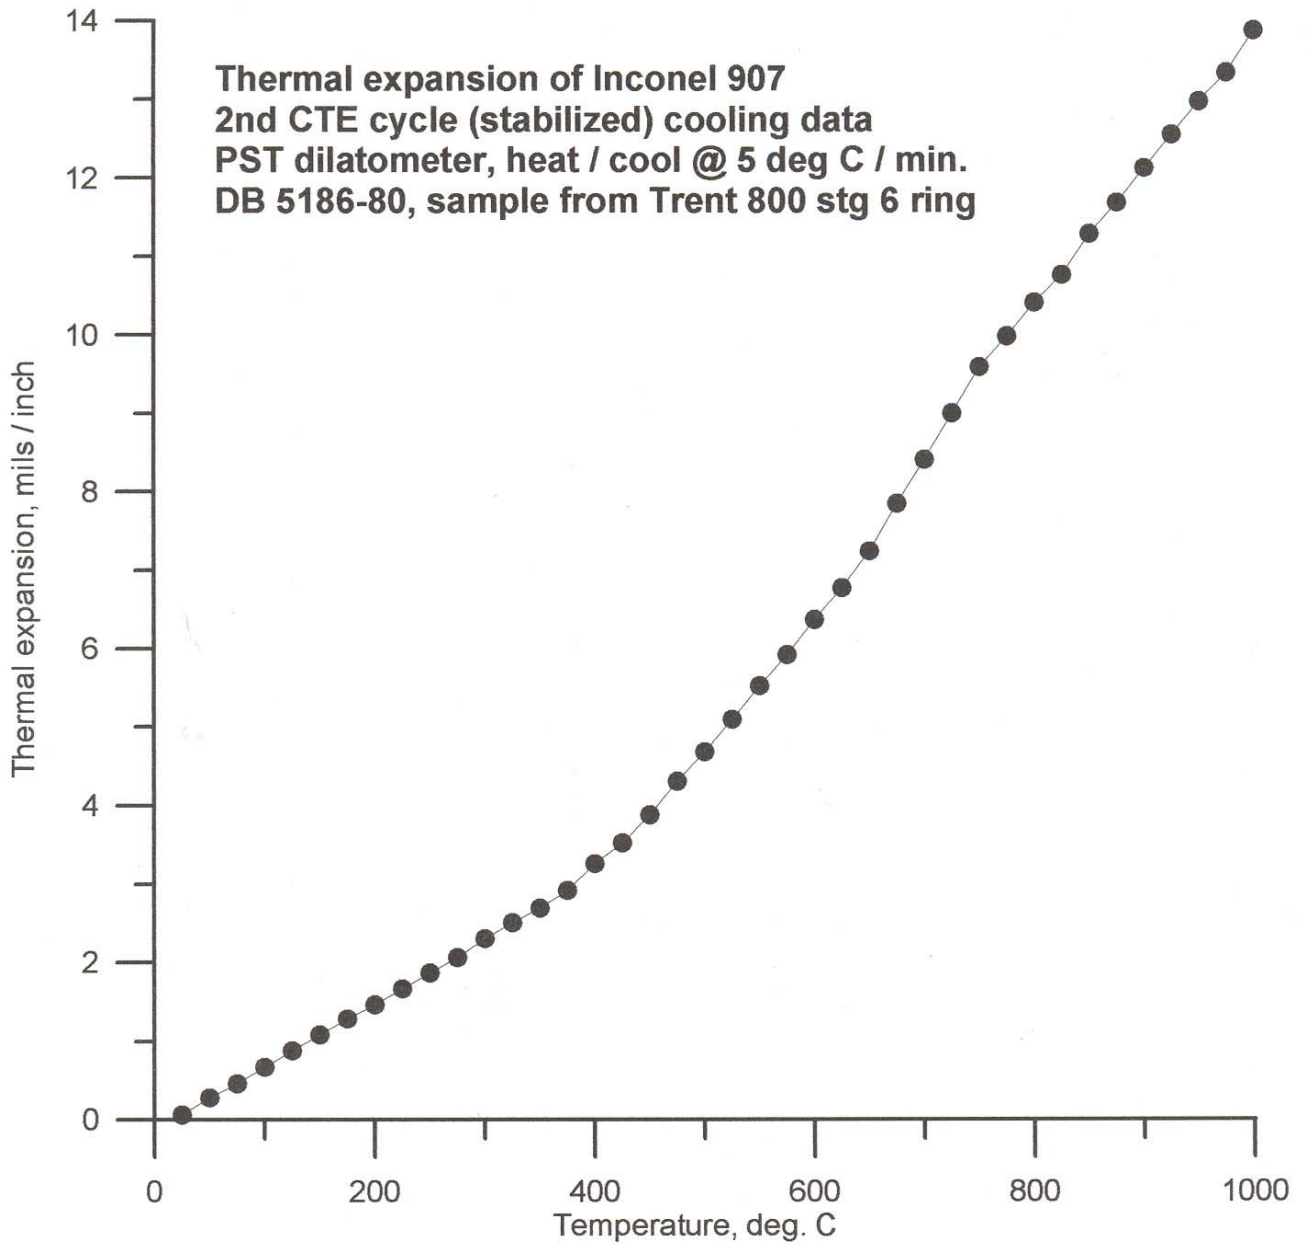
The thermal expansion curves for IN 907, NiCrAl-Bentonite and IN 718 are shown in Figures 26 to 28. IN 907 is seen to have a two-stage thermal expansion curve, very low expansion up to about 450 degrees C, then a higher expansion rate above that temperature. The

Figure 26. Stabilized thermal expansion of IN 907 alloy, sample from #51067 stage 6 ring.

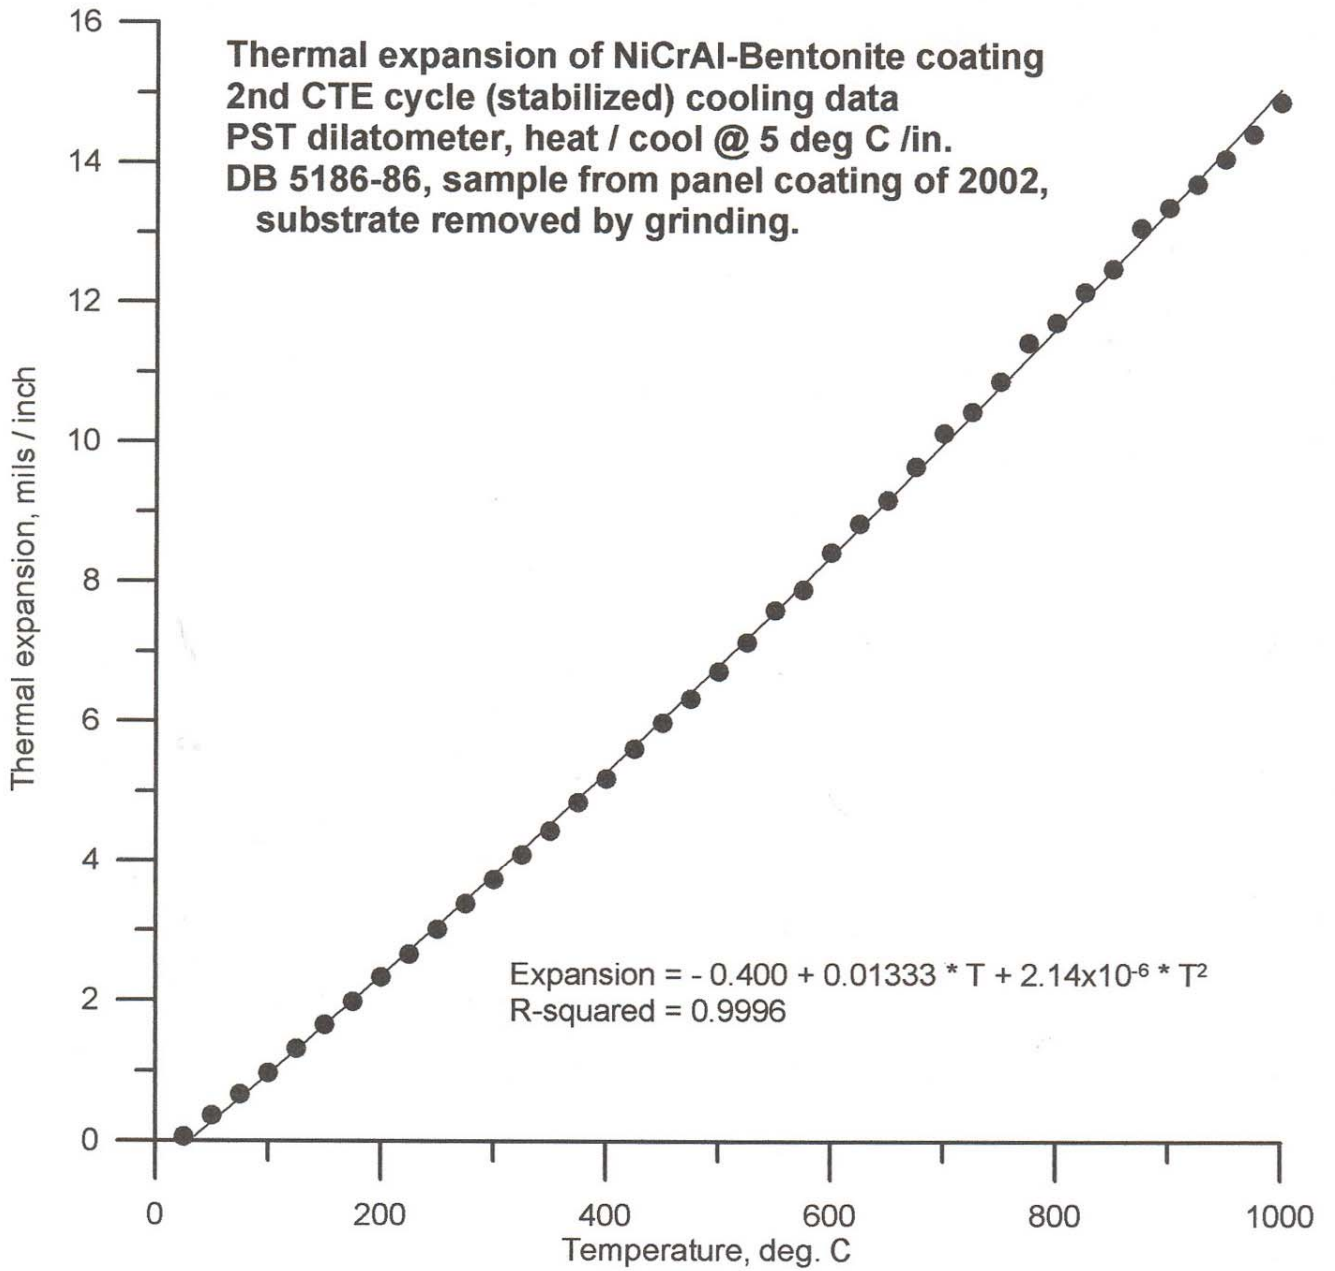
Figure 27. Stabilized thermal expansion of NiCrAl-Bentonite coating, sample from PST archives.

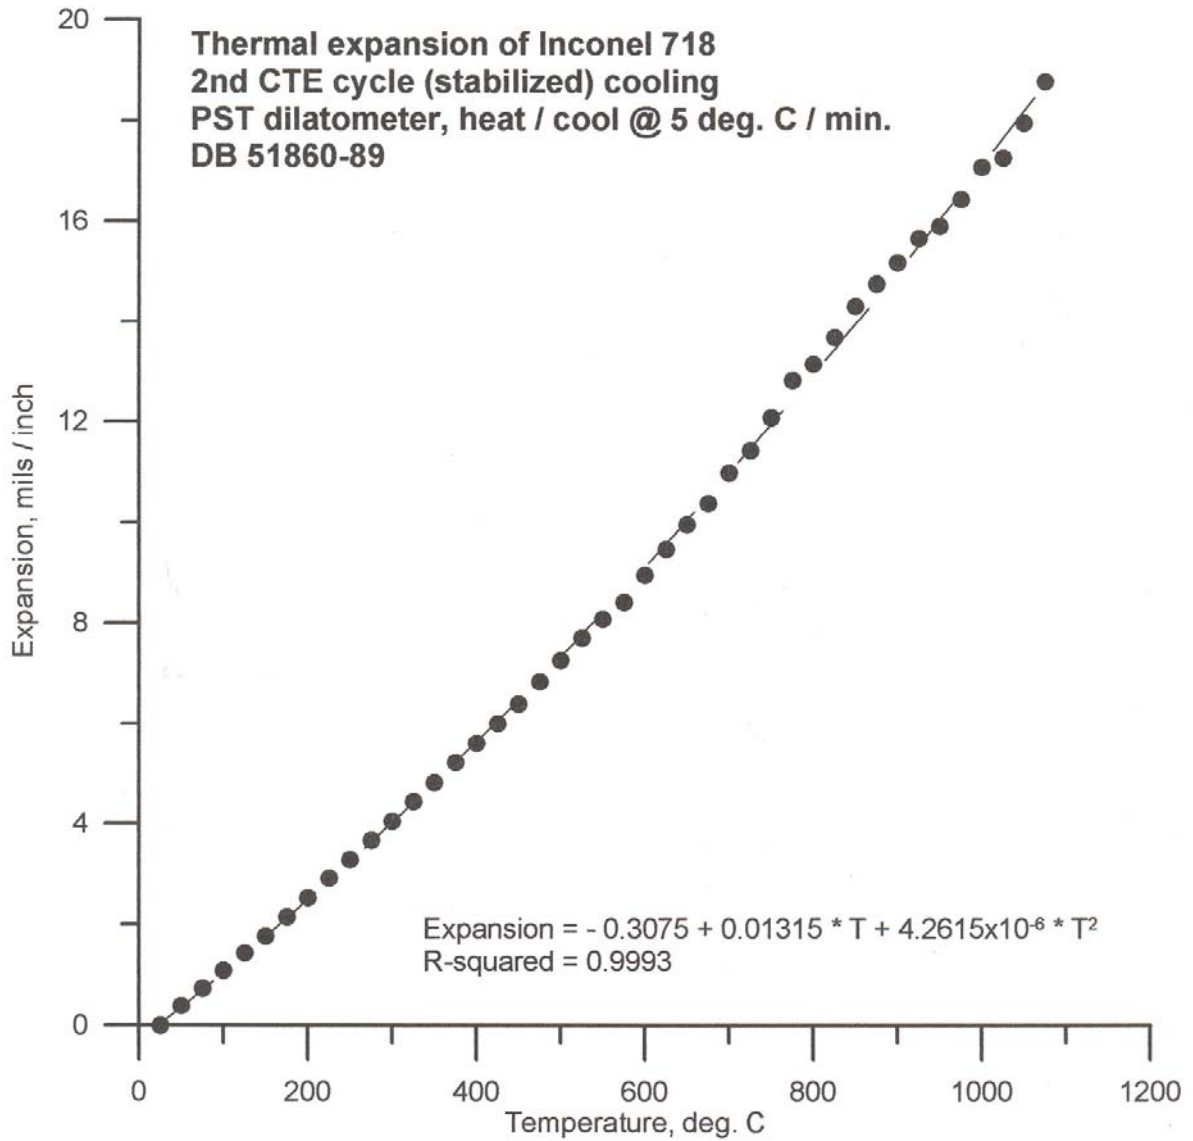
Figure 28. Stabilized thermal expansion of IN 718 alloy, sample from PST archives.

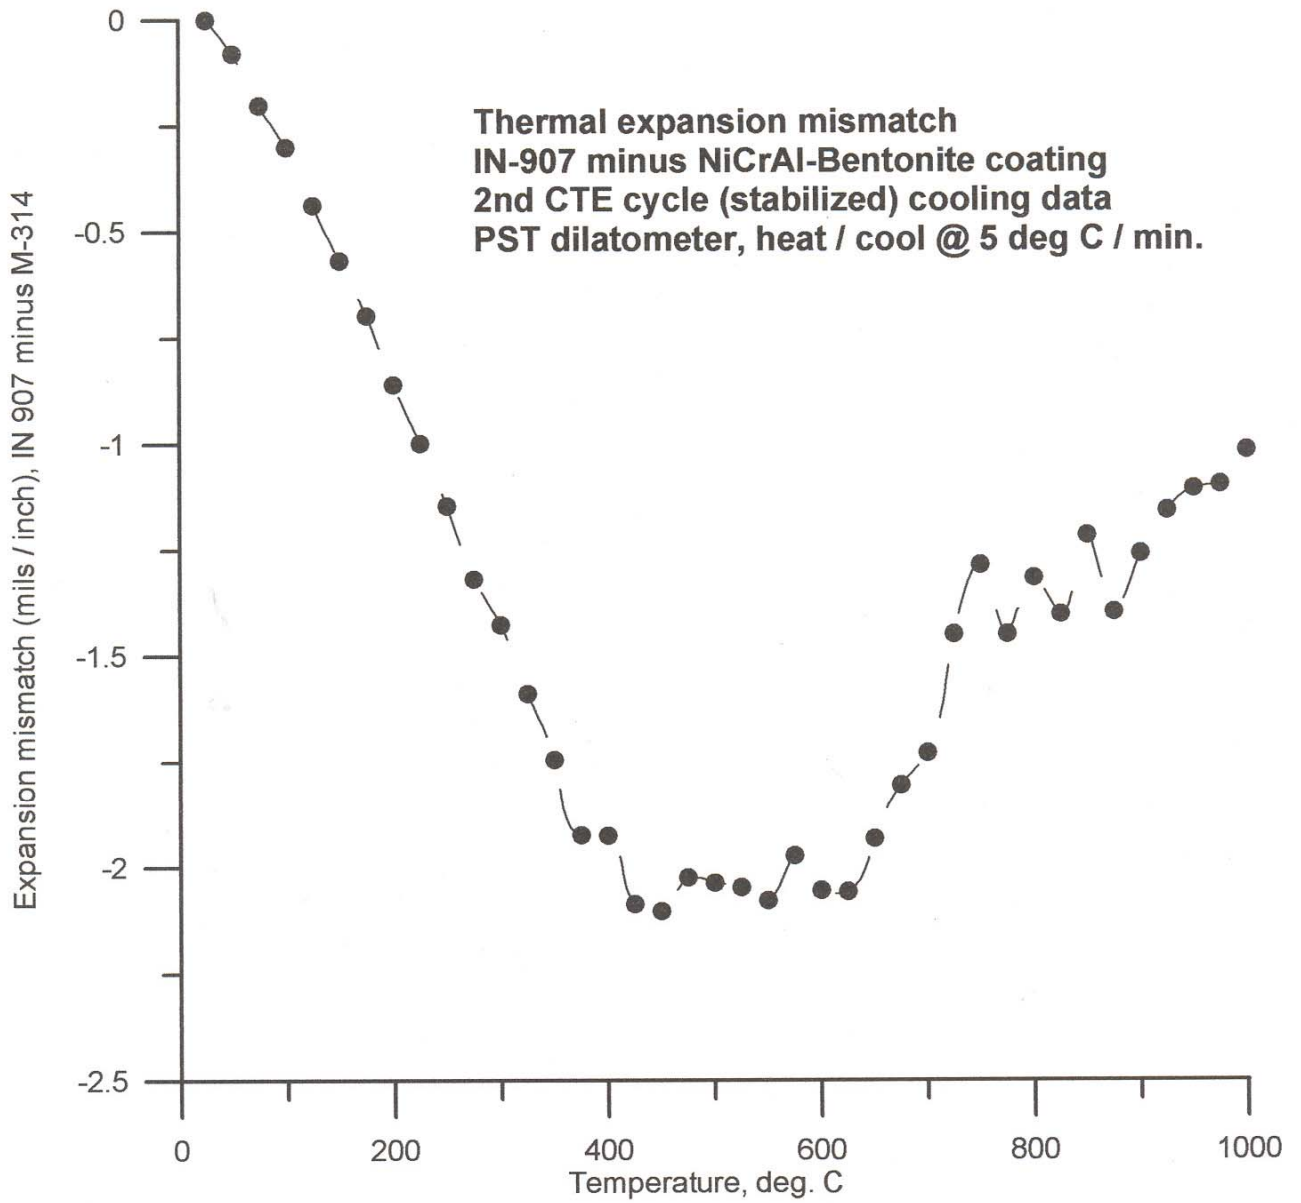
The mathematical differences between the thermal expansion curves of IN 907 and NiCrAl-Bentonite were found, as an indication of the mismatch between them. Figure 29 shows this difference plot, which reaches a maximum difference in the 400 – 600 °C range. However, without modulus data it is not possible to estimate the magnitude of the mismatch stress, or to know if it exceeds the fracture strength of the coating. The mismatch is about 0.2 percent, and if all the mismatch is born by the coating it could be beyond its yield point.

Figure 29. Difference in stabilized thermal expansion between IN 907 alloy and NiCrAl-Bentonite coating.

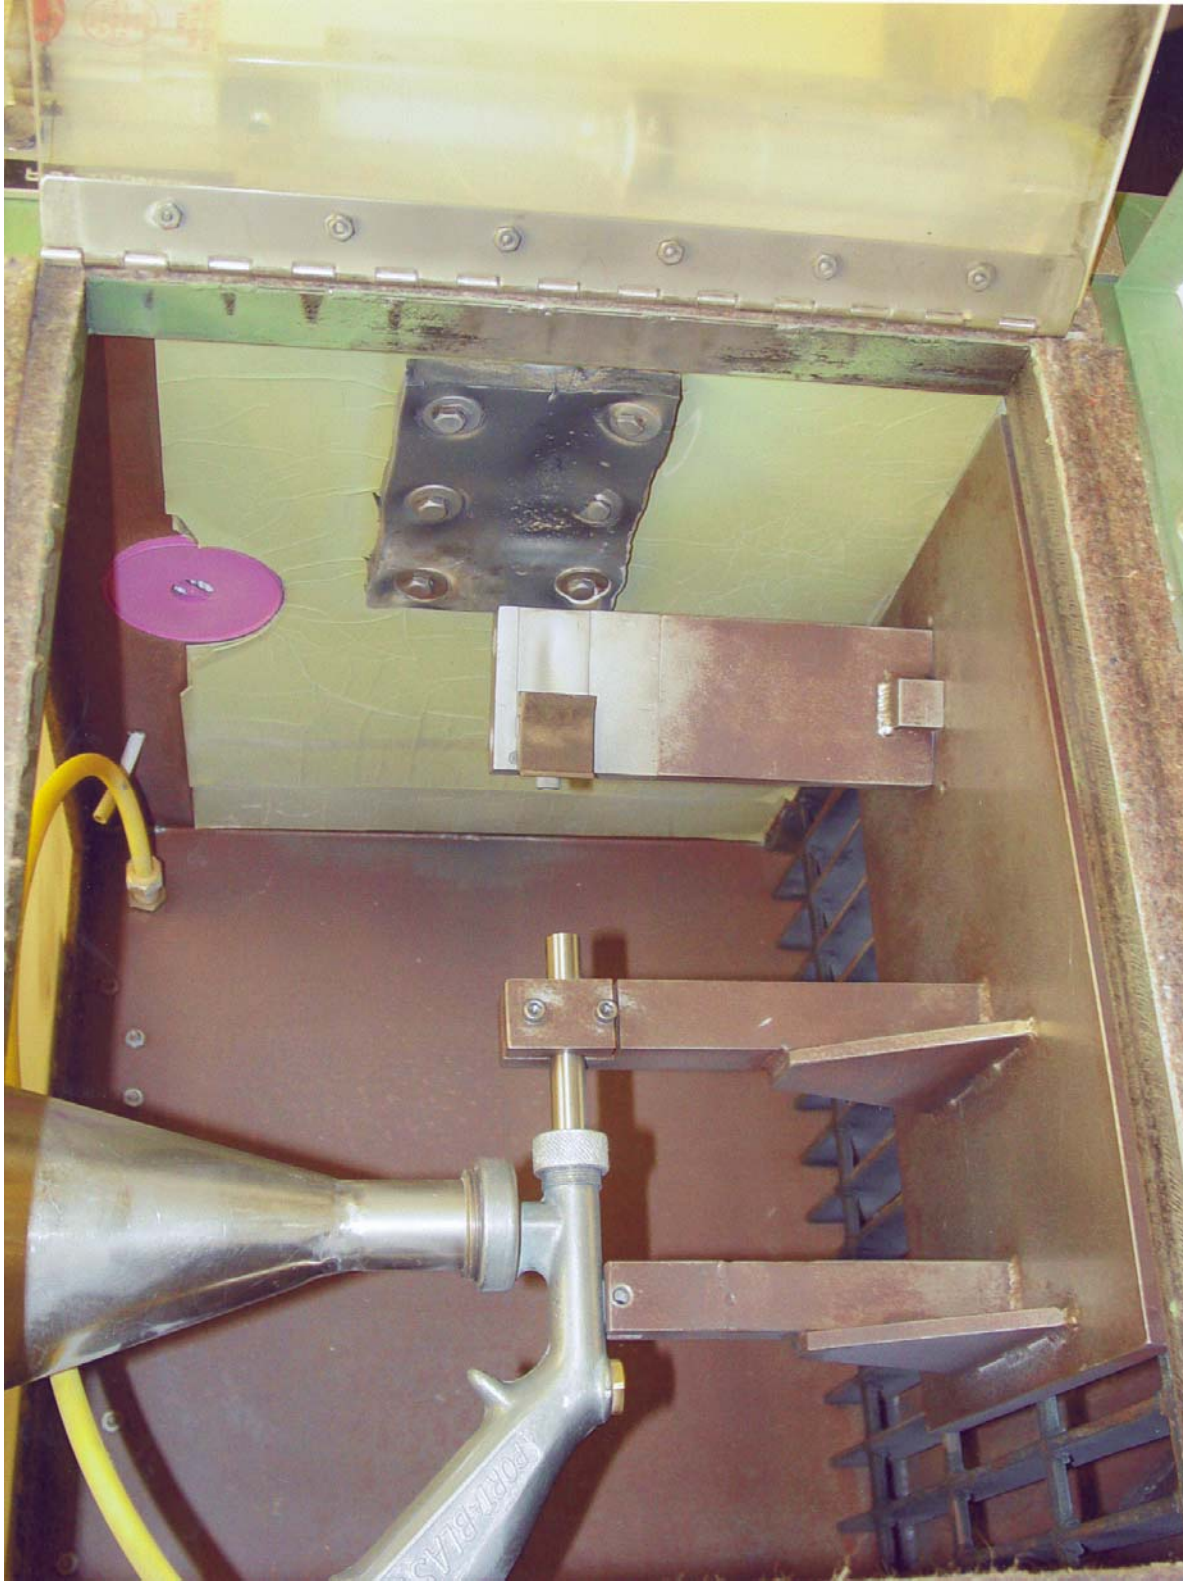
It was of interest to see if the residual coating on the stage 6 compressor ring was erodable in clean air. PST has no knowledge of the air velocity near stage 6 in the Trent 800, and so the results of the following test have no connection to the engine environment. In fact, they were at room temperature, and the stage 6 is estimated to be at about 600 °C in the engine. The PST test is based on the alumina particle erosion test, except in this case the unit was carefully cleaned of all alumina dust. The setup was the same in terms of standoff (3.5 inches), impingement angle (20 degrees, low angle), as shown in Figure 30. The air was run at 60 psig through a 0.185 inch diameter orifice (340 cfh) giving a calculated 500 ft./ sec. gas velocity. The impingement spot on the sample is approximately ¼-inch by a 1-inch oval. The sample was cut from the 51067 stage 6 ring, and had 1.1 x 1.1 inch of residual coated area. The weight loss was measured on a Mettler microbalance after several incremental clean air erosion exposures. The sample did erode as shown in Figure 31. After testing up to 240 seconds, the same sample was placed in a 600 °C furnace for 4 hours in air, and then tested again in the erosion test. This oxidation appeared to increase the early erosion rate, which then became somewhat constant. The appearance of the erosion sample before and after the first test is shown in Figure 32. The central section of the coating did brighten up somewhat. The main impingement area also coincides with the area where most of the coating was already lost due to engine exposure, and there may be different erosion rates found if more of the engine-exposed LCA-314 coating were in the central jet of erosion.

Figure 30. Low angle erosion test rig at PST, with segment of wear track of #51067 stage 6 ring with remnant LCA-314 still adhered after flight exposure. Pure air erosion at 500 ft./sec., 340 cfh flow, 20 degree impingement. In this test, aft edge of coated ring was upstream, erosion spot centered on piece is oval.
