ATSB TRANSPORT SAFETY INVESTIGATION REPORT

Aviation Safety Incident Report – 200403110

**Engine failure - Melbourne Airport, Victoria
25-Aug-2004
Boeing Company 777-312
9V-SYB**

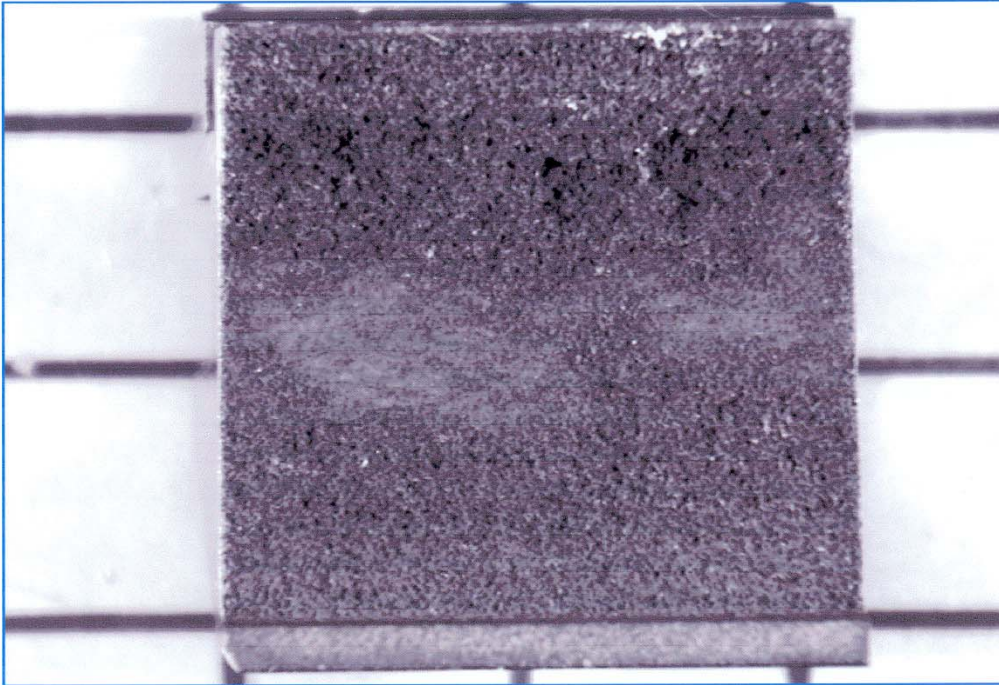
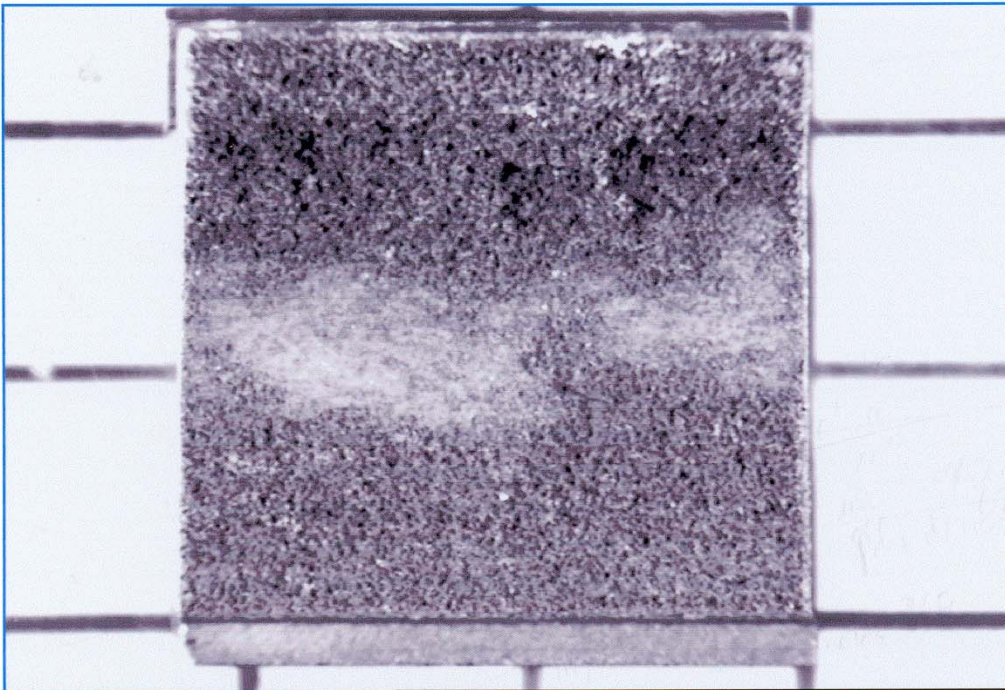
Figure 32. Macrophotos of erosion sample of Figs. 30 and 31, before test and after first as-received erosion exposure.

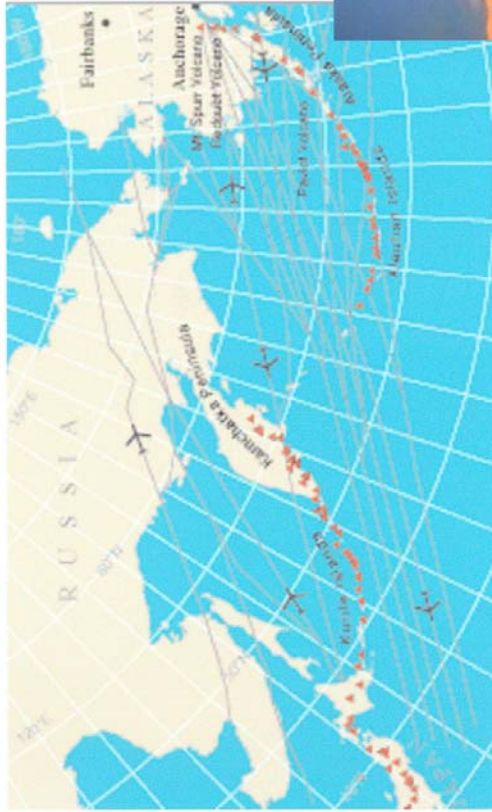
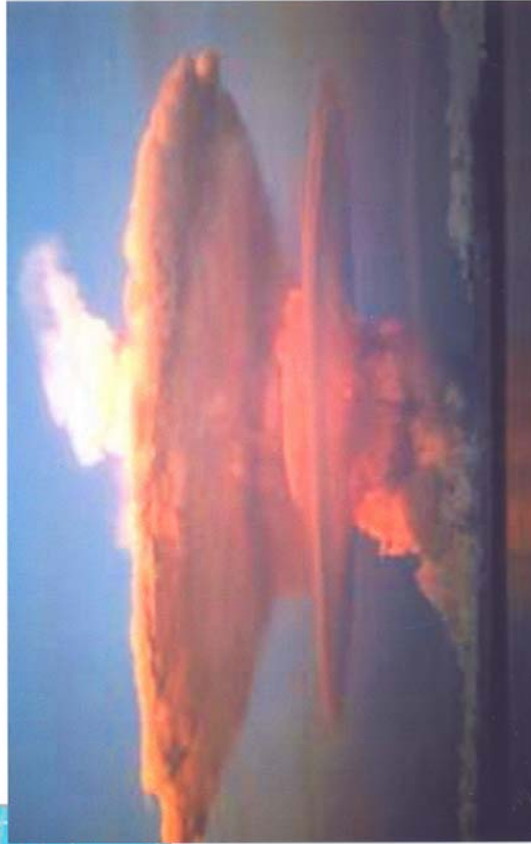
Where does CMAS come from? It could be airborne volcanic ash, and Figure 33 shows that some areas in the Pacific are currently active. Mt. Saint Helens in Oregon was active in 1980, and may become active again. Sand and dirt are everywhere, and the fine particle fraction can easily become airborne or it can even be drawn up to the engine during runway take-off as seen in Figure 34.

Figure 33. Map of active volcanoes in the North Pacific region.

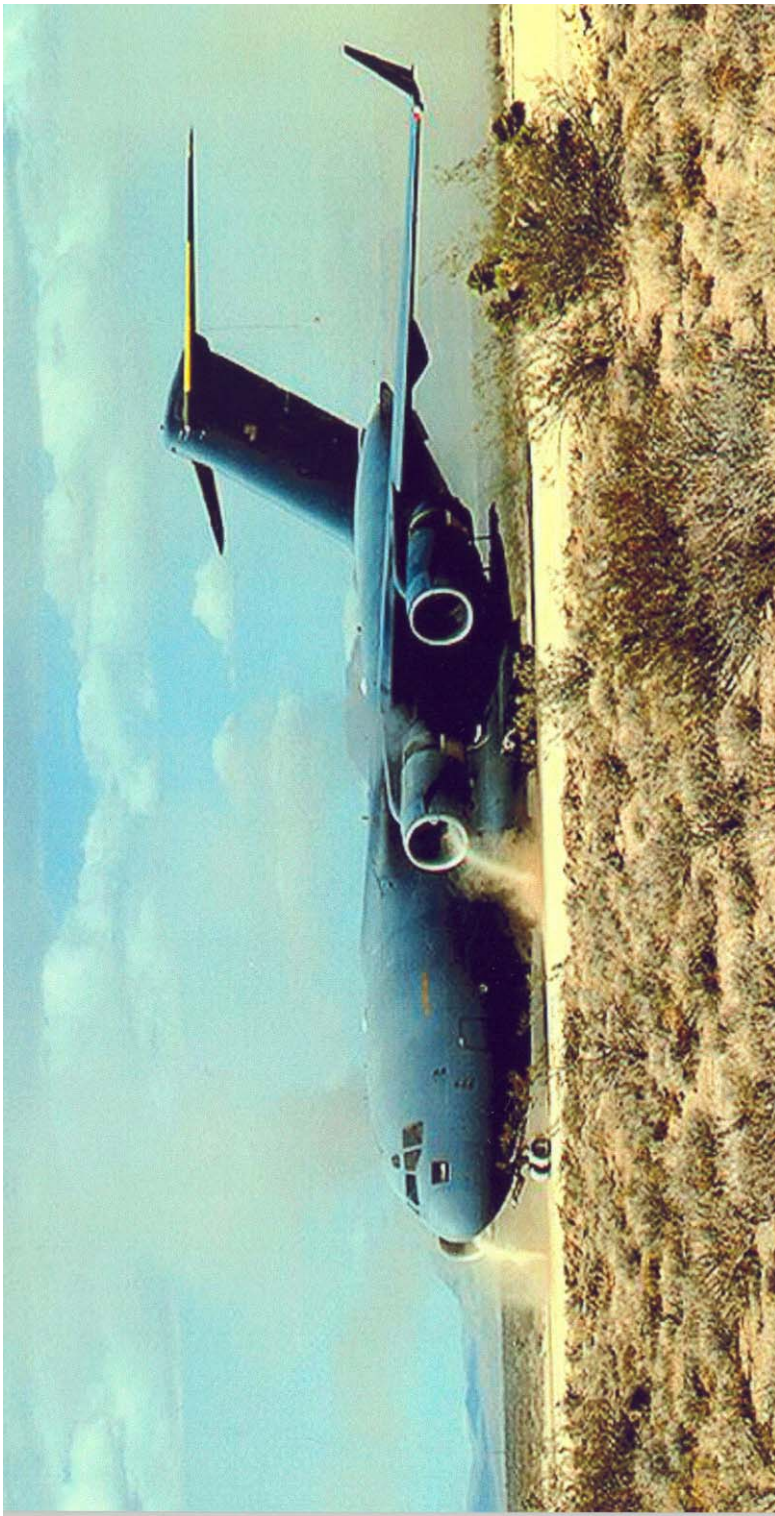
Figure 34. Military aircraft pulling dust into engines while on the runway in unknown desert area.

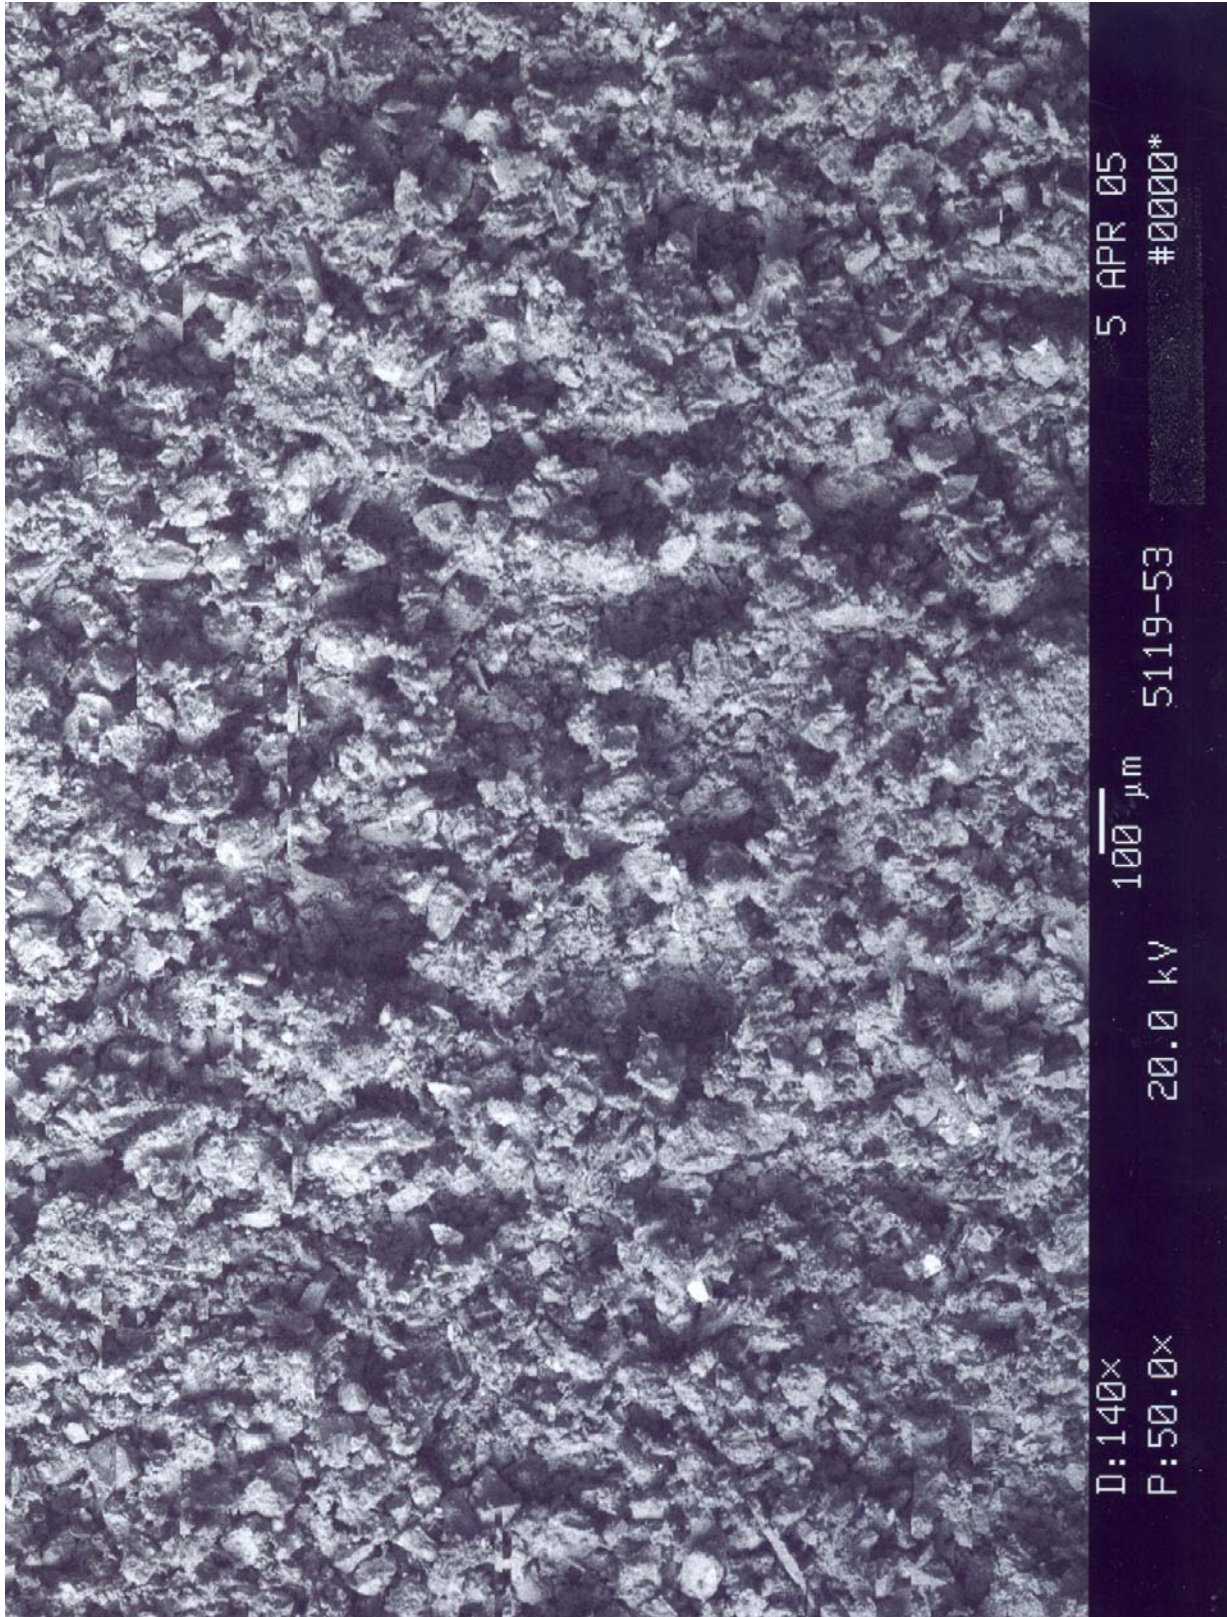
PST has no sample or information on the volcanic ash material that might be present in the southeast Asia area. However, the author does have a sample of ash from the Mt. St. Helens eruption of 18 May 1980, which was collected in Portland, Oregon which is over 50 miles away from the eruption. For the analysis here, the ash was tamped lightly into a small DTA alumina cup then imaged in the SEM (Figure 35) and analyzed using EDS. The EDS analysis is as follows:

Figure 35. SEM micrograph of surface of powder from Mt. Saint Helens volcanic eruption of May 1980. Particle size appears to be roughly 5 to 30 microns. 90 X magnification.

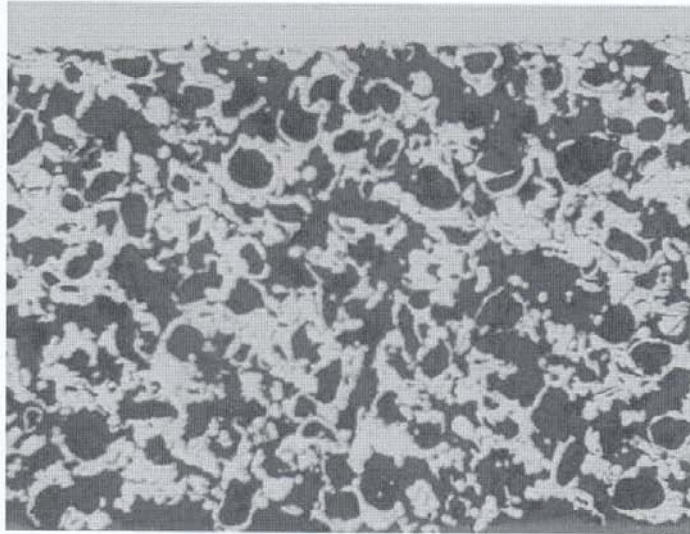
FIGURE 1 - Typical microstructure LCA 314, 50X, Brightfield
 AST Singapore Sample# 314NS#2

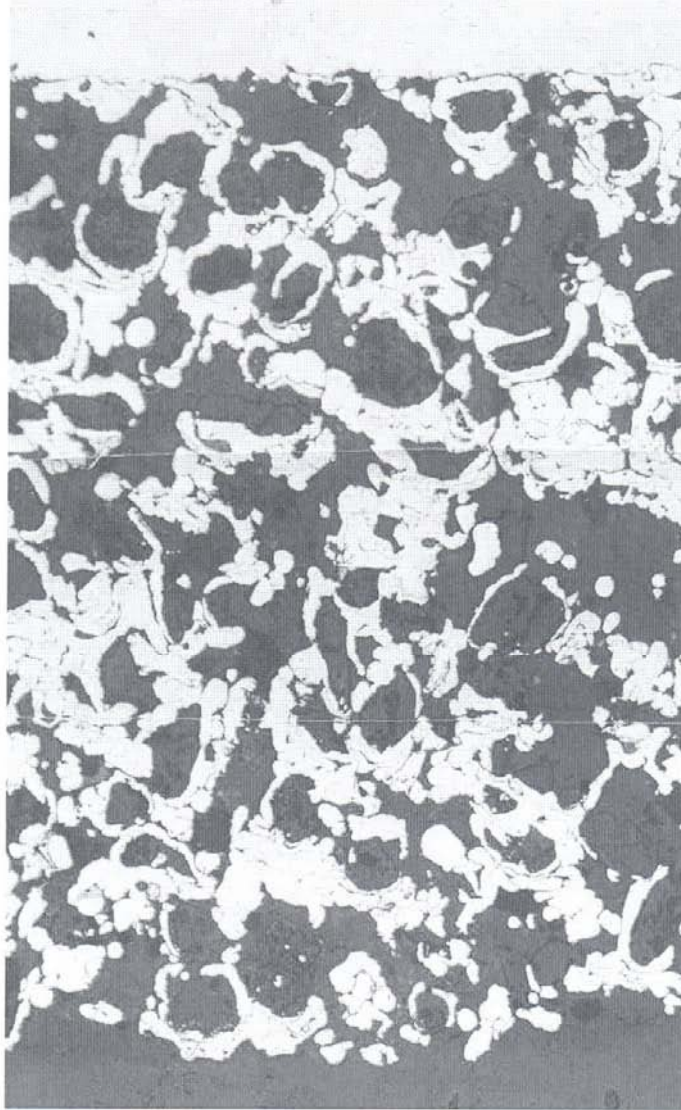
FIGURE 2 - Typical microstructure LCA 314, 100X, Brightfield
 AST Singapore Sample 314NS#2

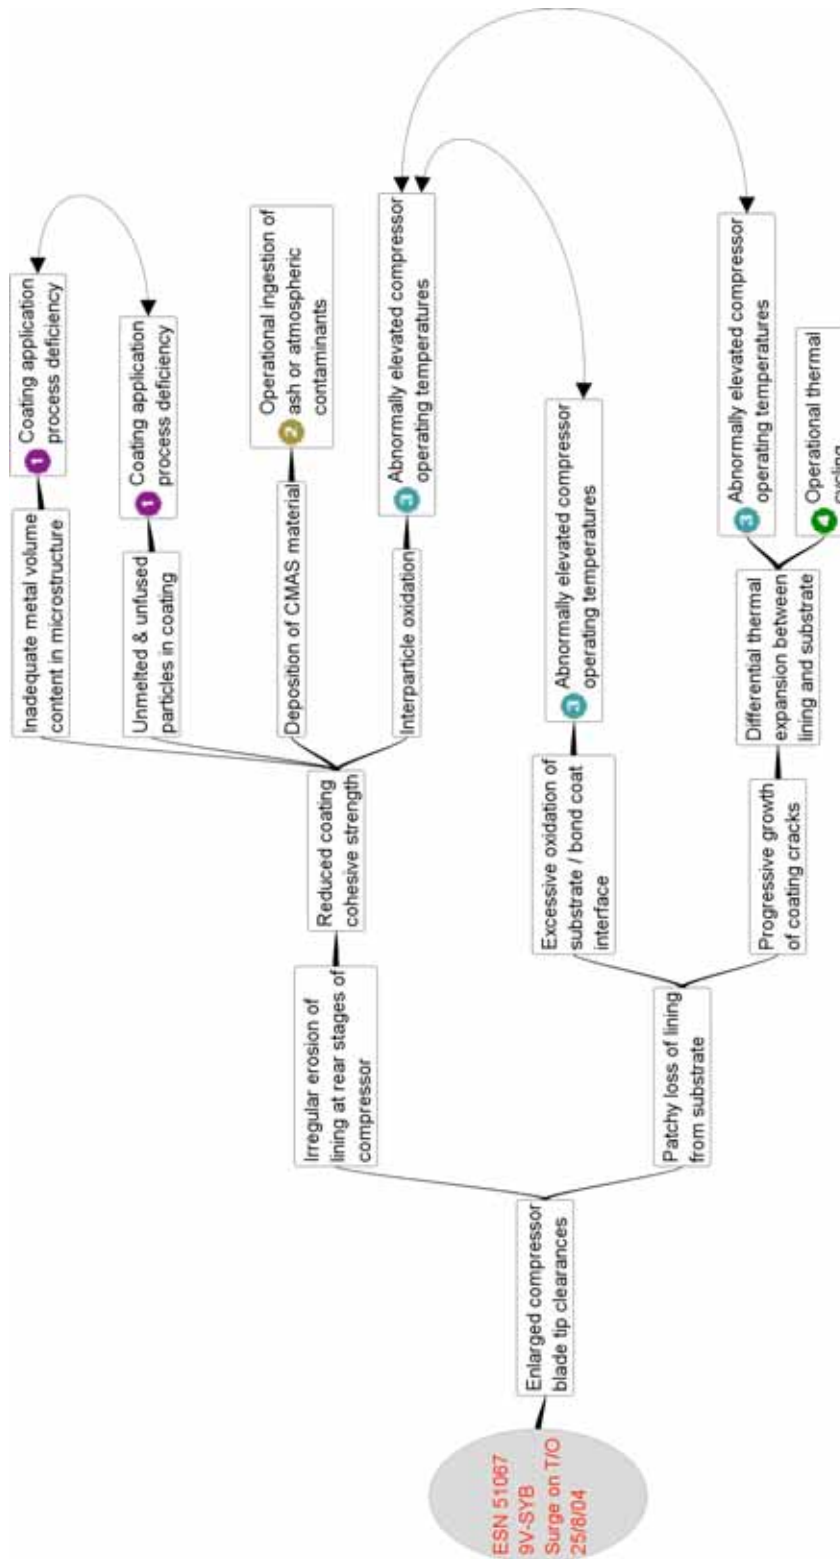
An assessment of the established factual material associated with the damage sustained by ESN 51067 was conducted and a logic tree (figure 1) was prepared to highlight the possible factors contributing to the coating damage and hence the engine surge events. From that assessment, four possible contributors were identified.

On the balance of the evidence presented by Rolls Royce and PST from their investigations, the ATSB considers that the coating metal density and particle interdiffusion issues hold as the most probable factors contributing to the premature degradation of the lining and the engine surge event. While acknowledging the possibility that oxidation may have weakened the coating particle cohesive strength, the significance of this effect had not been quantified in respect of the performance of the coating in service. Other proposed contributors such as CMAS ingestion, extended elevated temperature operation and the effects of thermal cycling were not substantiated by evidence.

Figure 1: Logic tree developed for the examination of the ESN 51067 surge event
