**ATSB TRANSPORT SAFETY INVESTIGATION REPORT**

Aviation Occurrence Report – 200501000

Final

**Loss of control  
7 km WSW of Tamworth Airport, NSW  
7 March 2005  
VH-FIN  
Cessna 310R**

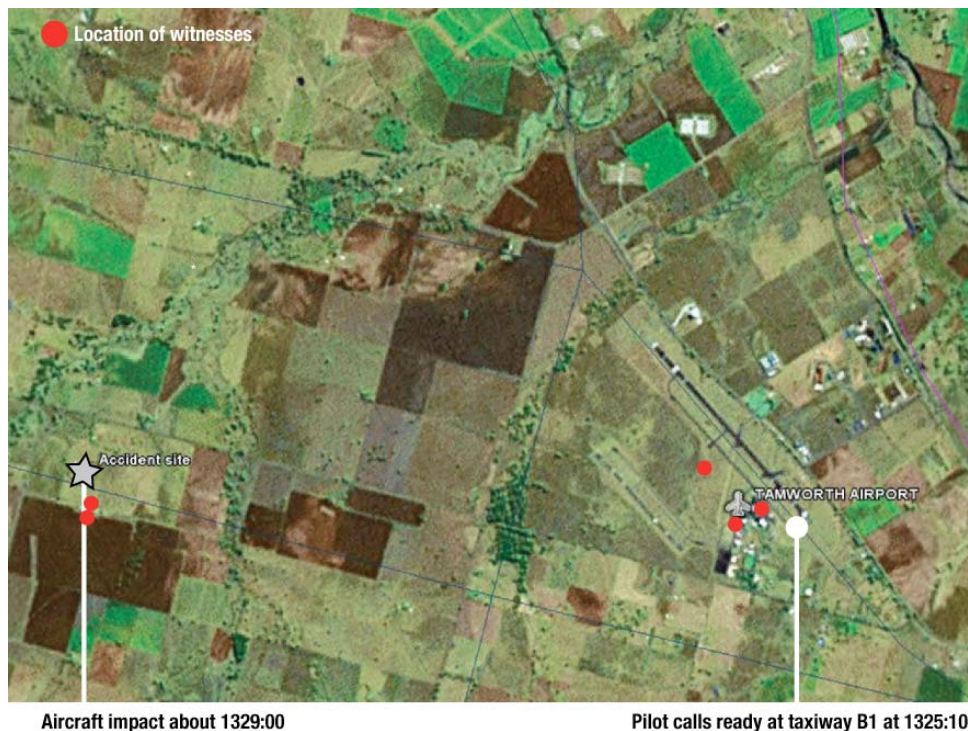
**Figure 1: Takeoff and accident location**

At about 1326 Eastern Daylight-saving Time<sup>1</sup> on 7 March 2005, the pilot of a twin-engine Cessna Aircraft Company 310R, registered VH-FIN, took off from runway 30 Right (30R) at Tamworth Airport for Scone, NSW. Approximately 1 minute after becoming airborne, the pilot broadcast to air traffic control (ATC) that he was experiencing flight control difficulties. At about 1329, the aircraft impacted the ground in a cleared paddock about 7 km west-south-west of the airport (Figure 1), fatally injuring the pilot. The aircraft was destroyed by the impact forces and post-impact fire (Figure 2).

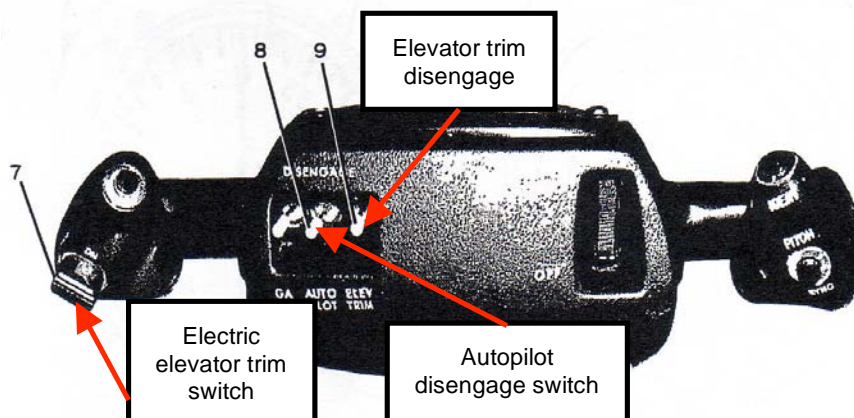
Figure 4: Cessna 310R control wheel arrangement applicable to VH-FIN

The aircraft was equipped with an electric elevator trim system. The system provided the pilot with the means to electrically operate the elevator trim by activating a 'momentary on' two-way switch on the left control wheel (Figure 4).
