ATSB TRANSPORT SAFETY INVESTIGATION REPORT

Aviation Occurrence Report – 200504768

Fuel exhaustion – 18 km SW Bundaberg Airport, Qld

Fairchild Metro III

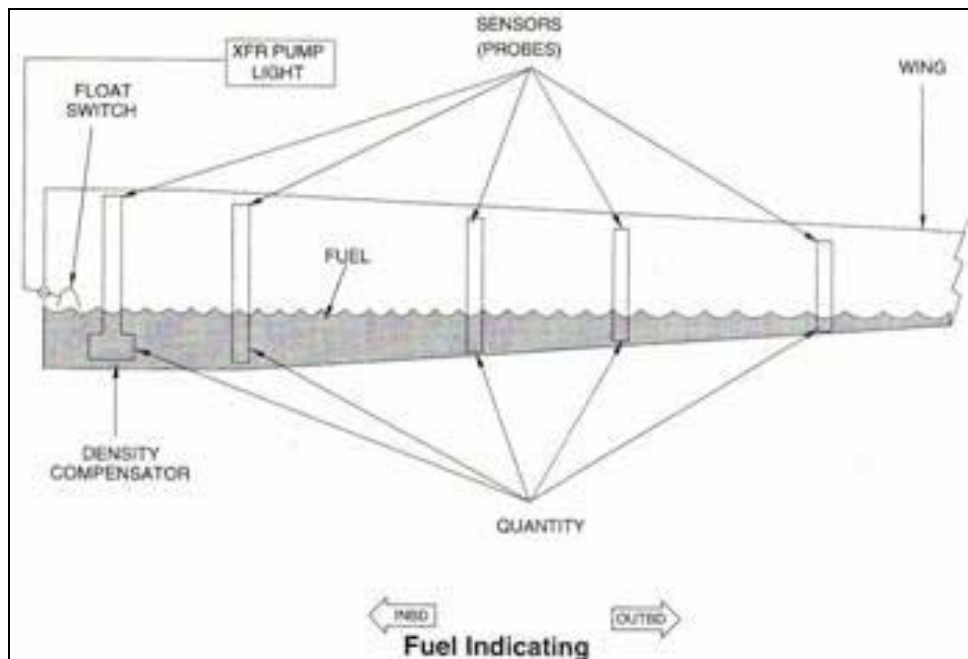
Figure 1: Schematic showing fuel tank probe arrangement

The Metro III was equipped with a capacitance⁹ type fuel quantity measurement system. The system consisted of sensors (fuel probes), indicators, float valve switches, a transfer light system, and associated electrical wiring and connectors. Each wing of the aircraft included an integral fuel tank. Five fuel probes in each tank (numbered from 1 inboard to 5 outboard) provided input to the fuel quantity indicating system (Figure 1). The capacitance of each probe depended on the depth of fuel covering the probe. Since the density of fuel, and therefore its weight, varied with temperature, the system included a density compensator that formed part of the number-1 probe.

The fuel probes were made of two concentric tubes of aluminium material and had two wires carrying impedance¹⁰ to the internal section of the unit. Those wires passed through holes in the aluminium outer tubing material.

The capacitance value of the fuel quantity indicating system depended upon factors such as the length of wiring, proper grounding of the wire shielding, and the condition of the probes, wiring and connectors. Any anomalies in the wiring harness linking the probes and the indicator could alter the capacitance values of the circuitry from those established by the aircraft manufacturer. Further, any disturbance of fuel quantity indicating system components could alter capacitance values. The aircraft maintenance manual contained procedures for calibration of the system, including guidance on when calibrations should be conducted.

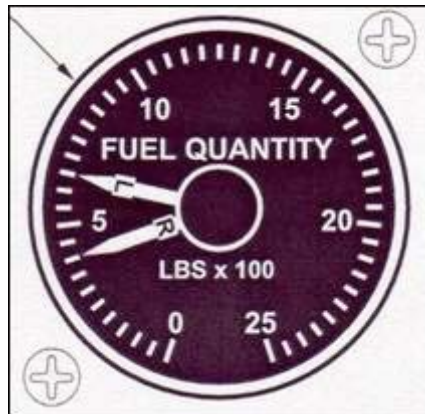
Figure 2: Fuel quantity indicator

A 5-cm (approximately) diameter dual pointer indicator (Figure 2) displayed left and right tank fuel quantity in hundreds of lbs. It was located low in the centre

section of the instrument panel. Because of the size of the indicator face and the markings, the quantity could be read to about the nearest 20 lbs.

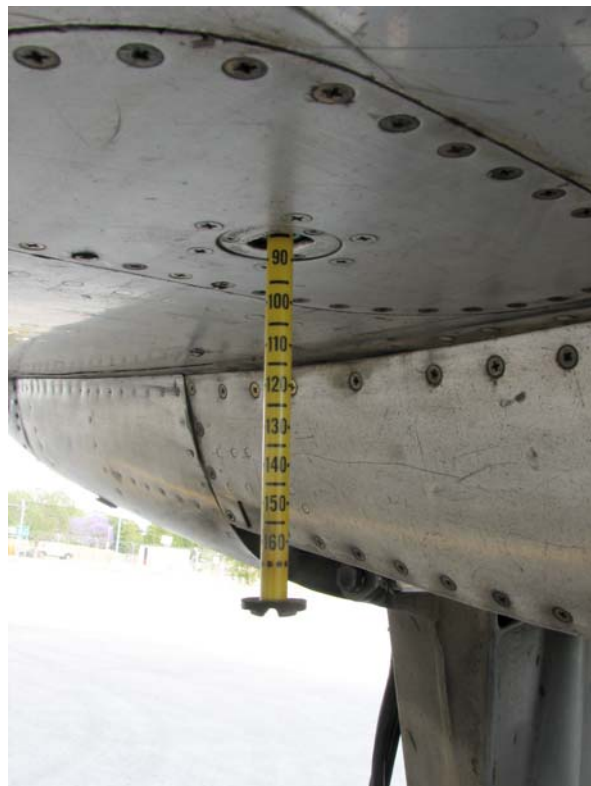
Figure 3: Magna stick in lowered position indicating 85 US gallons

A Magna-stick was located under each wing, inboard of the engine nacelle. Magna sticks allowed checking of the fuel quantity, in 5 US gallon graduations, of each wing tank, provided the tank contained between approximately 30 and 155 US gallons (114 L to 586 L). Readings were taken by releasing a lock tab on the under surface of the wing, and allowing the indicating scale to extend below the wing (Figure 3). Because Magna sticks measured the level of fuel in the tank by means of a float attached to the top of the stick, accurate readings were obtainable only when the aircraft was on a near level surface.

According to the aircraft flight manual, there were inherent errors in the Magna stick system. With equal amounts of fuel in each tank, there could be up to 27 US gallons (180.9 lbs/130 L) difference between the left and right Magna stick

indications. Further, there could be up to 16 US gallons (107 lbs/61 L) difference between the cockpit fuel quantity indicator and the respective Magna stick indications.

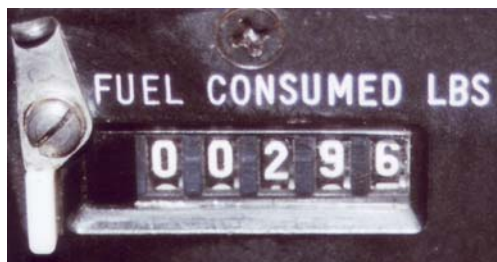
Figure 4: Fuel totaliser display

A fuel consumed totaliser received input from a fuel flow transmitter on each engine. The totaliser displayed, in the cockpit, the total amount of fuel consumed by both engines since the counter was last set to zero. Company policy was to zero the counter before each flight. Figure 4 shows the fuel totaliser display indicating that 296 pounds of fuel has been consumed since the last reset.
