ATSB TRANSPORT SAFETY INVESTIGATION REPORT

Aviation Occurrence Report – 200505236

Aircraft loss of control - Ballidu, WA

Air Tractor Inc AT-602

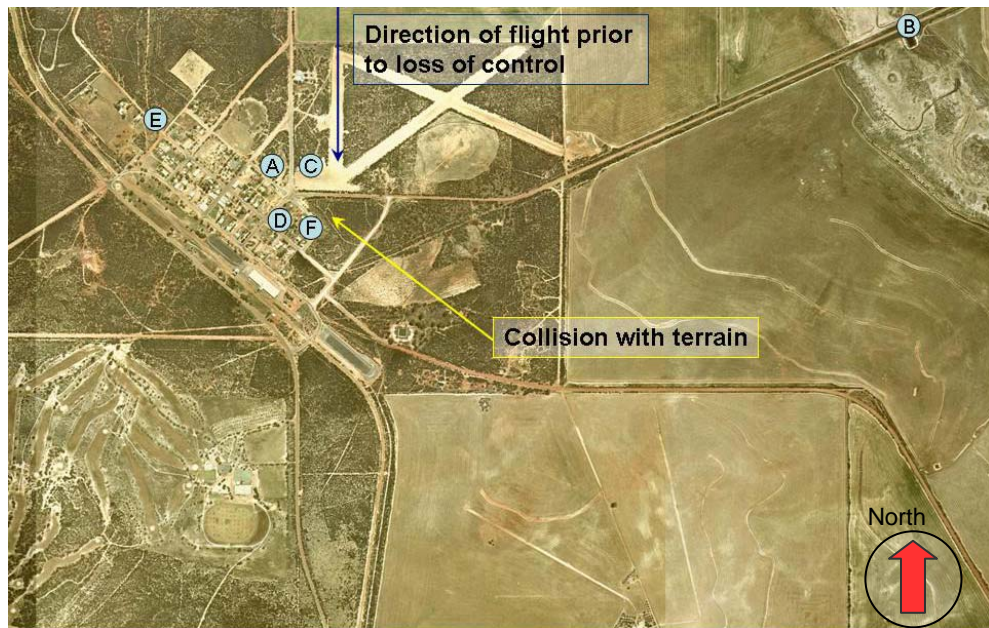
Figure 1 depicts the township of Ballidu, the aerodrome, the location of witnesses and the approximate track of the aircraft during the final stages of the flight.

Figure 1: Ballidu townsite and aerodrome, accident site and position of witnesses⁵

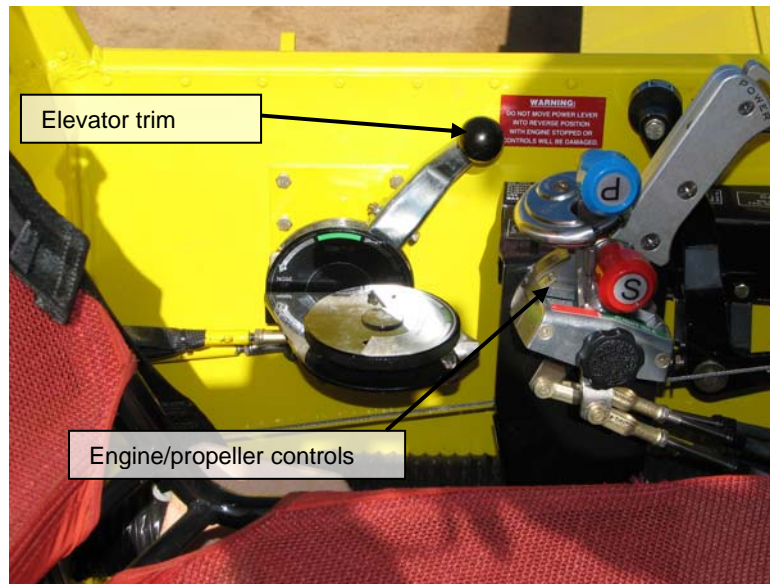
Figure 2: AT-602 engine/propeller controls and elevator trim lever

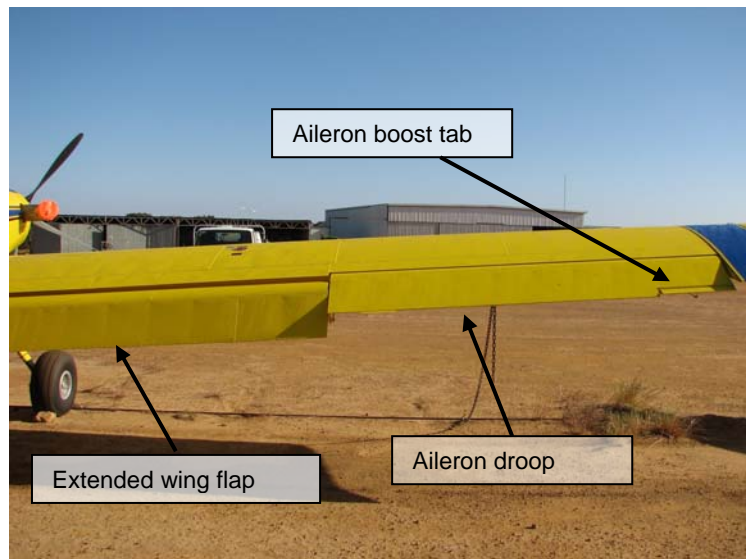
In addition, the AT-602 was equipped with an electrically-operated Fowler flap system. That system incorporated an aileron interconnection, which symmetrically drooped the ailerons as the flaps extended.¹³ The motion of the aileron interconnection was non-linear, in that most of the aileron droop occurred during the first 15 degrees of flap extension. Full flap extension was 30 degrees, with an associated aileron droop of 10 degrees. Figure 3 illustrates the flap extension and aileron droop.

Figure 3: AT-602, showing extended wing flap and aileron droop

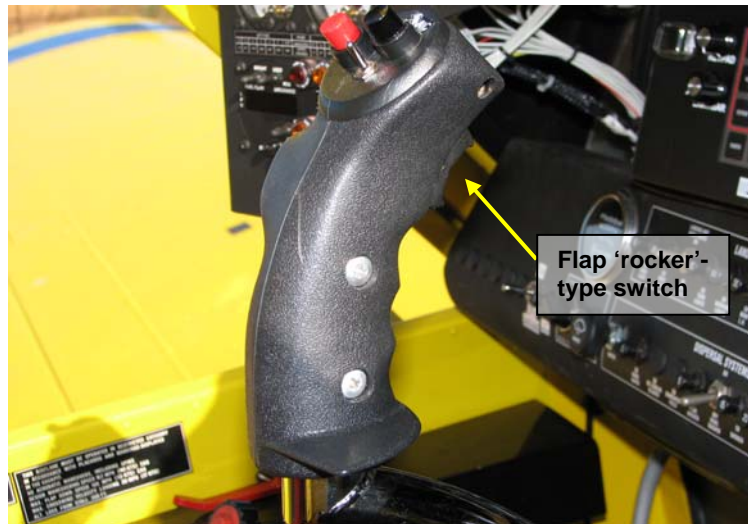
The flaps were actuated by a finger-operated ‘rocker’-type switch¹⁴ on the control stick (Figure 4). That switch enabled the pilot to extend the flaps between 0 and 30 degrees. The flaps could also be activated by a control switch mounted adjacent to the engine and propeller control levers on the left side of the cockpit (Figure 5).

Figure 4: Control stick for a similarly-equipped AT-602, showing the finger-operated flap ‘rocker’ switch

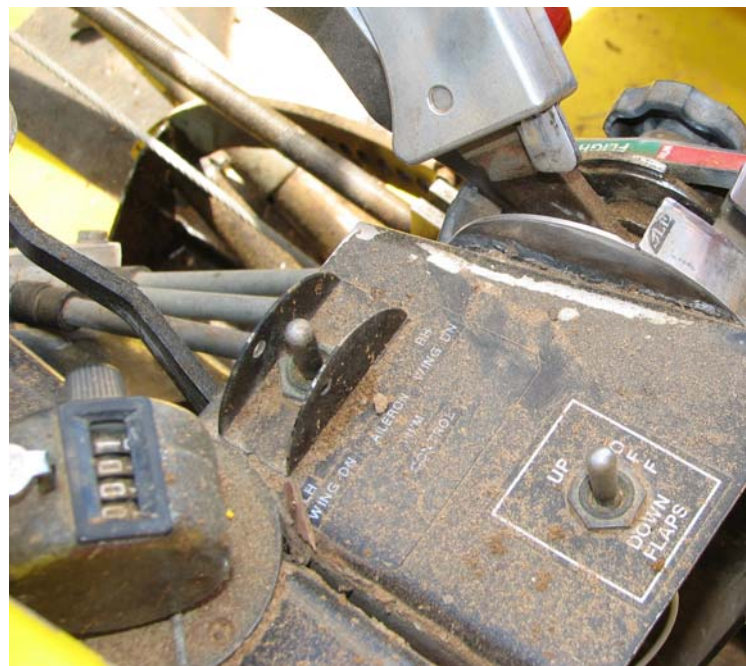
Figure 5: Flap control switch adjacent to the engine controls
