ATSB TRANSPORT SAFETY INVESTIGATION REPORT

Aviation Occurrence Report – 200600523

Wirestrike
15 km east of Parkes Aerodrome, NSW
2 February 2006
VH-MFI
Bell Helicopter Co 206B (III)

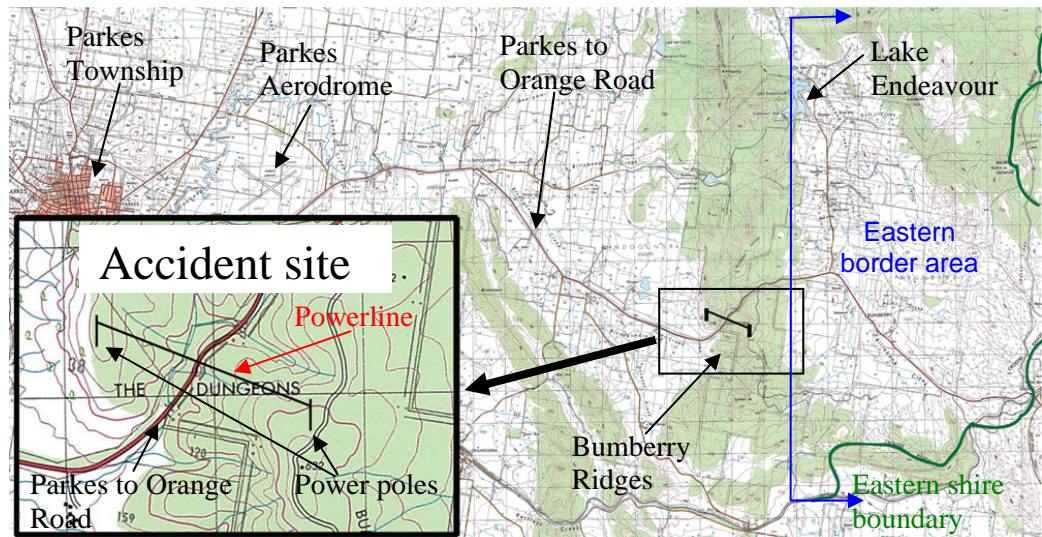
Figure 1: Eastern border area, including the accident site

One of the council's managers indicated that the survey was to be conducted in the eastern border area of the council's area of responsibility. That was defined as the area to the east of a north to south line that passed through Lake Endeavour (Figure 1). The survey was planned to be conducted in a general south to north direction, before progressing to the north-west along the Bogan River.
