**ATSB TRANSPORT SAFETY INVESTIGATION REPORT**

Aviation Occurrence Investigation – 200600837

**Aircraft loss of control  
56 km S of Lombadina, WA  
15 February 2006**

**VH-OTV  
Viking Air Ltd  
DHC-3-T ‘Turbo-Otter’**

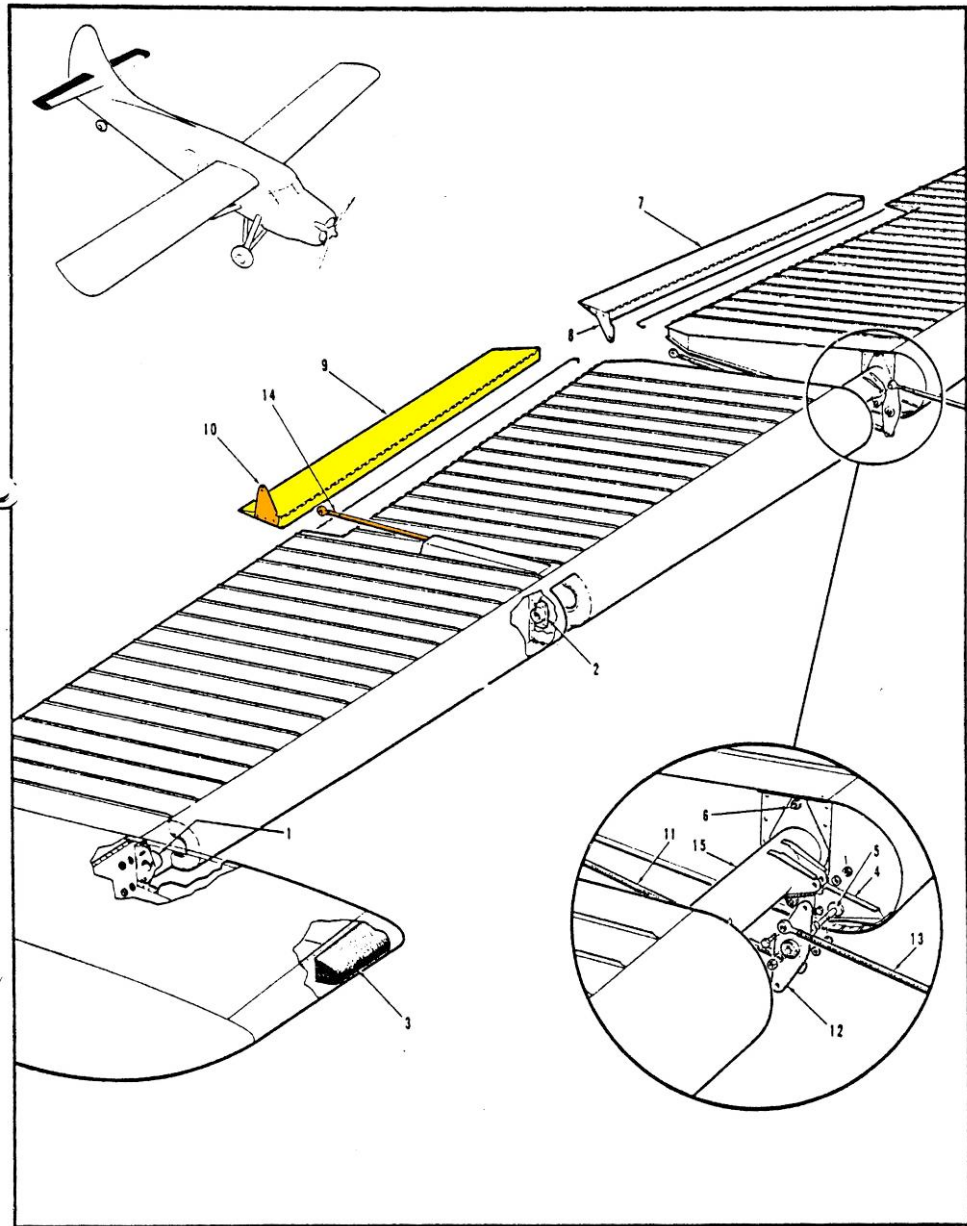
Figure 1. Depiction of the DHC-3 elevator assembly, showing the servo tab (yellow) and control rod and horn (orange)

The DHC-3 servo tab was an unbalanced<sup>4</sup> secondary control surface, hinged along the full length of its forward upper edge, and interconnected with a single rigid actuator rod via an upward facing control horn (Figure 1). The tab design had the control horn affixed directly to the outboard-facing end of the section with three solid-section rivets. The rivets extended through a composite filler block and were affixed to an internal flange plate.
