ATSB TRANSPORT SAFETY INVESTIGATION REPORT

Technical Analysis Occurrence Report – 200601173

Microlight Structural Analysis
Airborne Edge
Aircraft Registration: 32-4456 and 32-4388

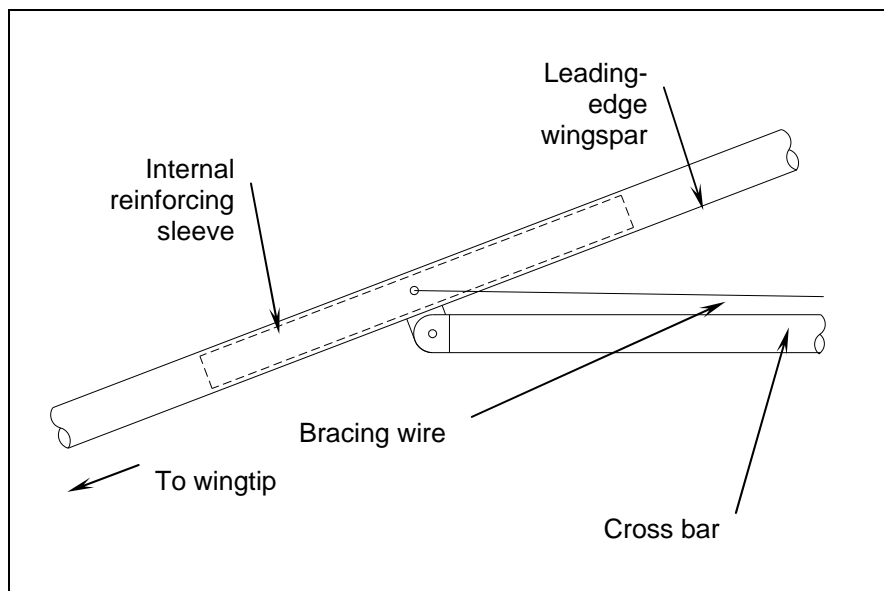
Figure 2: Leading-edge wingspar with reinforcing sleeve.

The wire bracing extended out to the intersection of the cross bar and leading-edge wingspar. At this point, the leading-edge wingspar had been reinforced by an internal sleeve of tubular aluminium alloy, see figure 2.

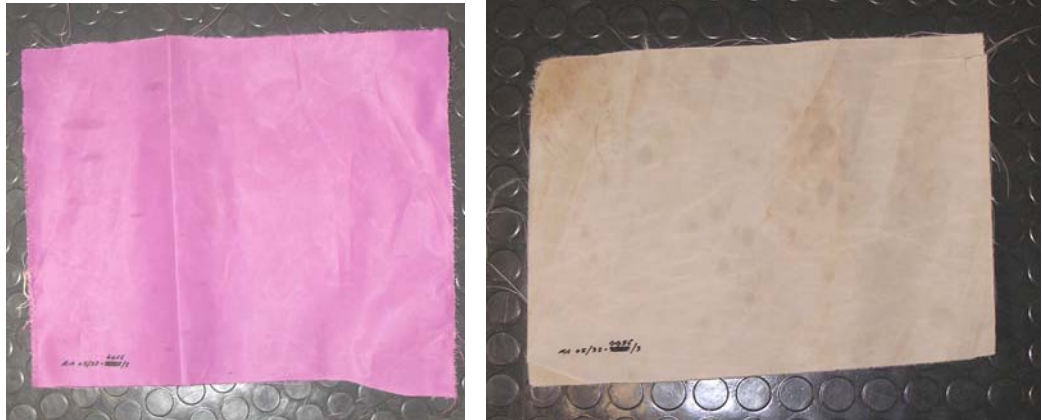
Figure 13: Purple and off-white fabric sample taken from the microlight canopy.

Two sections had been taken from the 32-4456 microlight canopy for analysis, see figure 13; a sample of the leading-edge fabric (purple), and a sample from the top surface of the wing, back from the leading edge to the trailing edge (off-white). The purple sample was relatively unsoiled, while the off-white fabric sample included a number of unidentified stains.
