ATSB TRANSPORT SAFETY INVESTIGATION REPORT

Aviation Occurrence Investigation – 200601640

**Loss of control
4 km ENE Archerfield Airport, Qld
31 March 2006
VH-BST
Amateur built Lancair 320**

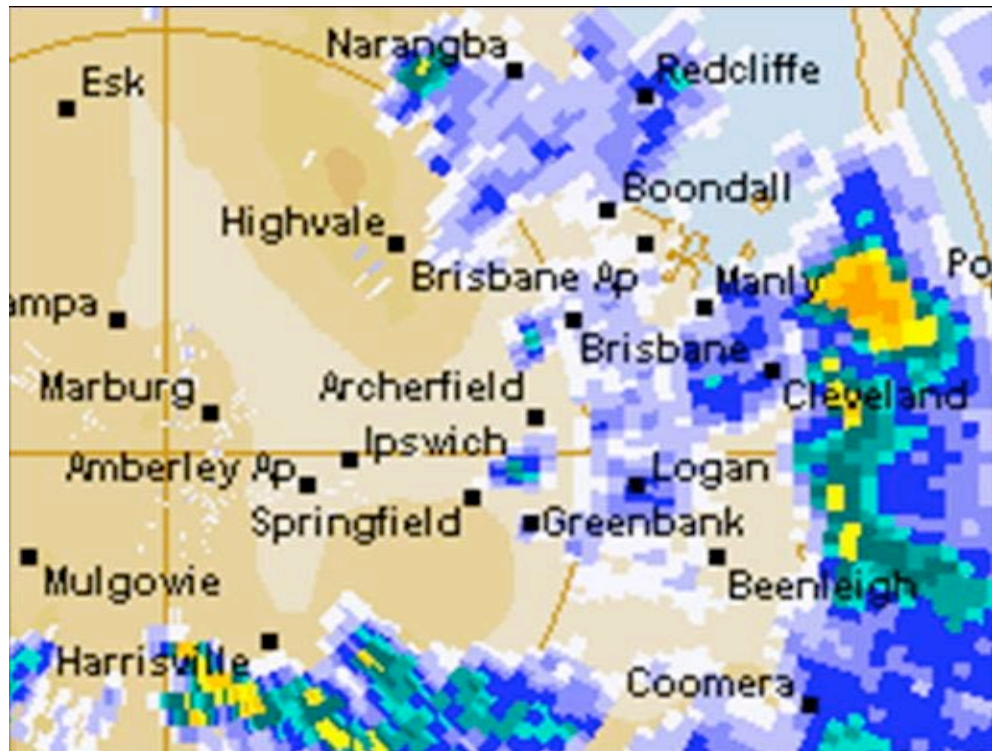
Figure 5: Weather radar image at 1050

Weather radar information provided by the BoM showed that a narrow band of rain and showers moved over Archerfield from the west at about 1040, and had cleared to the east by 1100. At the time of the accident, the weather radar showed areas of light rain to the east of the airport (Figures 5 and 6).

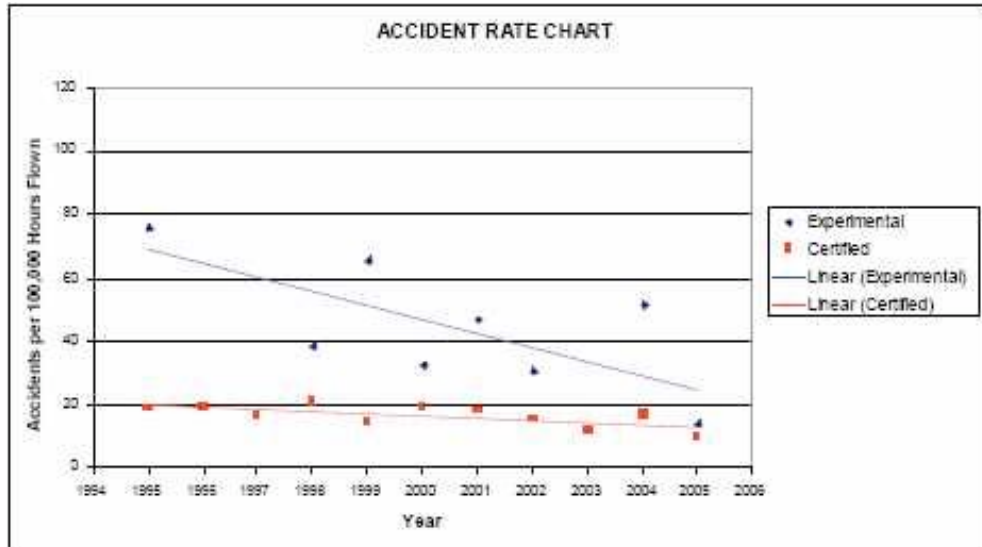
Figure 7: Amateur-built experimental aircraft accident rate chart

The annual accident rates between 1995 and 2005 for amateur-built experimental and comparable type-certificated fixed-wing single-engine aircraft indicated that the accident rates for the two aircraft types were converging (Figure 7).
