ATSB TRANSPORT SAFETY INVESTIGATION REPORT

Aviation Occurrence Report – 200604514

**Engine failure
5 km W Archerfield Aerodrome, Qld
8 August 2006
VH-WNR
Cessna Aircraft Company 182P**

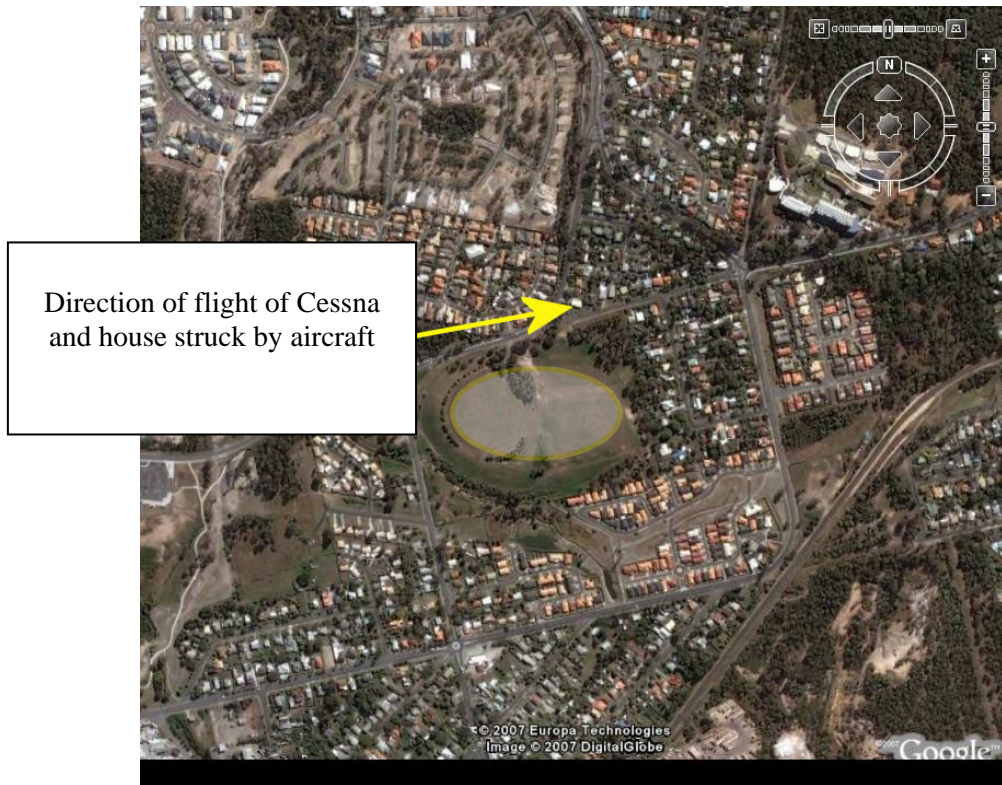
Figure 1: Google Earth image showing intended landing area (shaded) and house location

At that time (1121), the aircraft was approximately 5 km west of Archerfield Aerodrome at 1,000 ft altitude. The pilot transmitted a distress message to air traffic control that he was attempting an emergency landing and that the aircraft engine had failed. He reduced the engine throttle setting and attempted to position the aircraft for a landing in the only area he could see that appeared suitable for an emergency landing (Figure 1).
