Aviation Occurrence Report –200605133

Loss of control - Mt Vernon Station, WA

VH-RIL

Cessna 172L

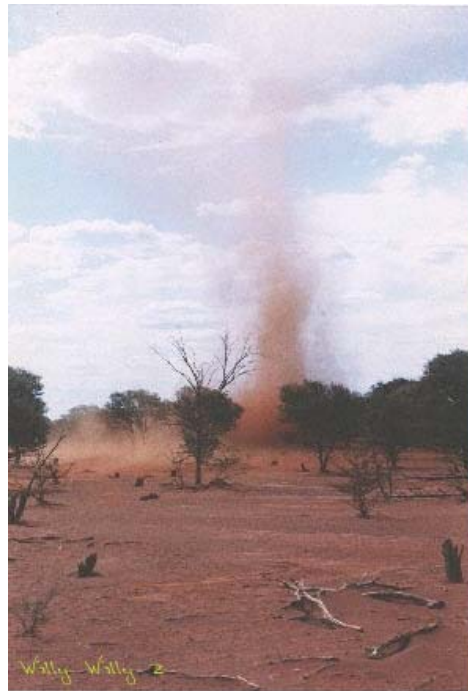
Figure 3. A Willy-willy

Willy-willies occur as a result of hot air at ground level expanding, becoming less dense, and rising rapidly. Sideways movement (such as a light wind) in the initial upward surge of the air, establishes a vortex and a twisting, rising column is formed. Willy-willies are only seen by the naked eye when dust or debris is picked up within the vortex (Figure 3). As a result, not all Willy-willies are visible.

Willy-willies are capable of vertical development in excess of 1,000 feet above ground level, with reports of grass lifted in Willy-willies being observed at 8,000 feet in Western Queensland. The air within Willy-willies is very unstable with rapid rising thermals and downdrafts created.

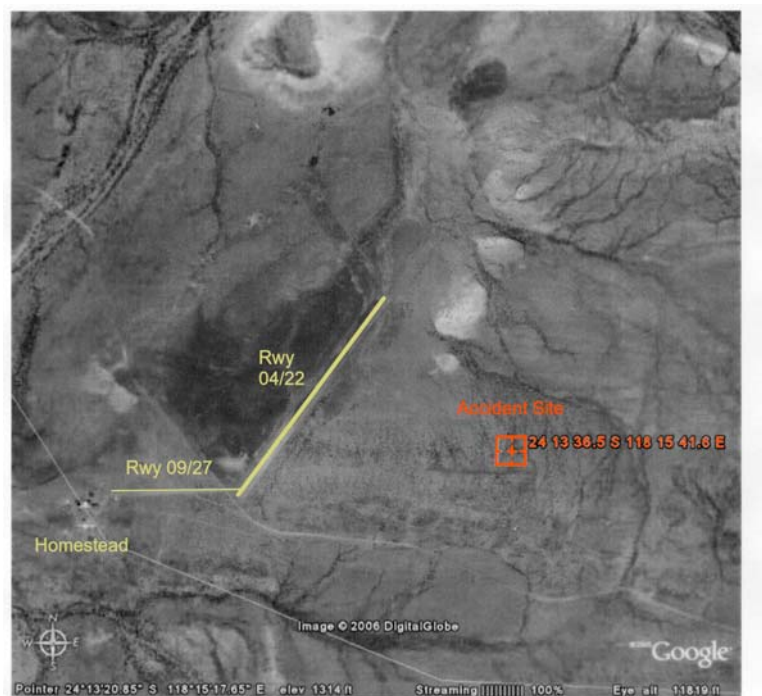
Figure 4. Aerial view of airstrip

The pilot had elected to join on the final leg and make a straight-in approach for the secondary airstrip, runway 27 (Figure 4). That was intended to place the aircraft into wind for the landing. The pilot reported being on a normal approach profile with flap extended to about 20 degrees, although he was not sure how much flap he had selected.
