ATSB TRANSPORT SAFETY INVESTIGATION REPORT

Aviation Occurrence Investigation – 200605620

In-flight engine malfunction and air turn-back

VH-TJI, Boeing Co. 737-476

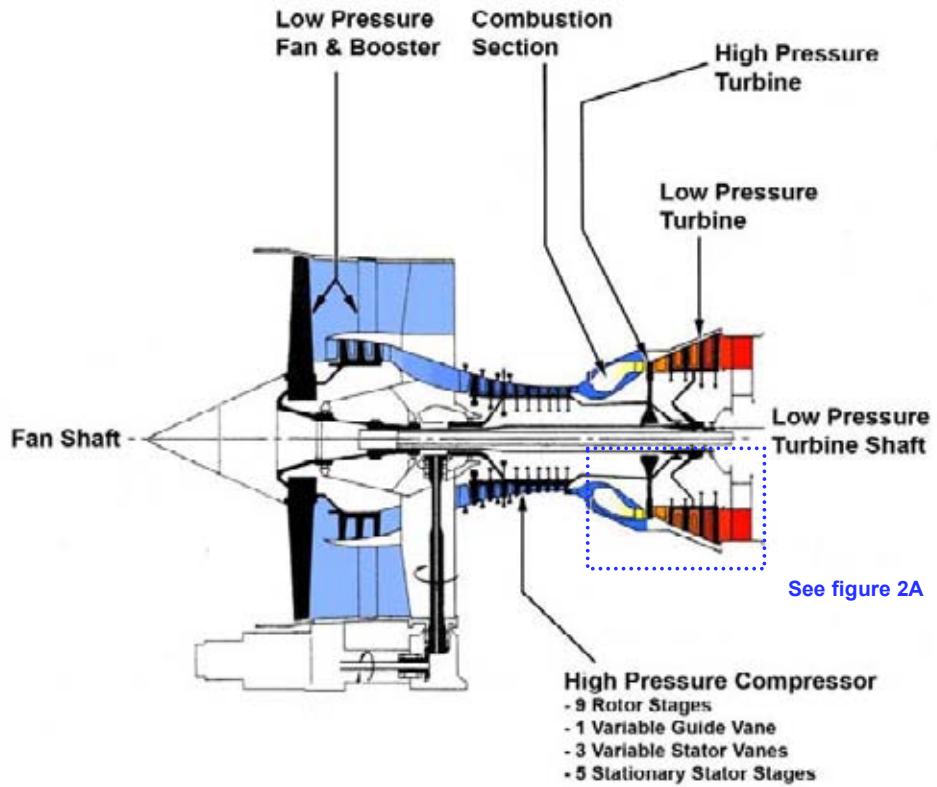
Figure 2: Schematic cross-section of the CFM56-3 series engine. The turbine section is shown in greater detail in figure 2A

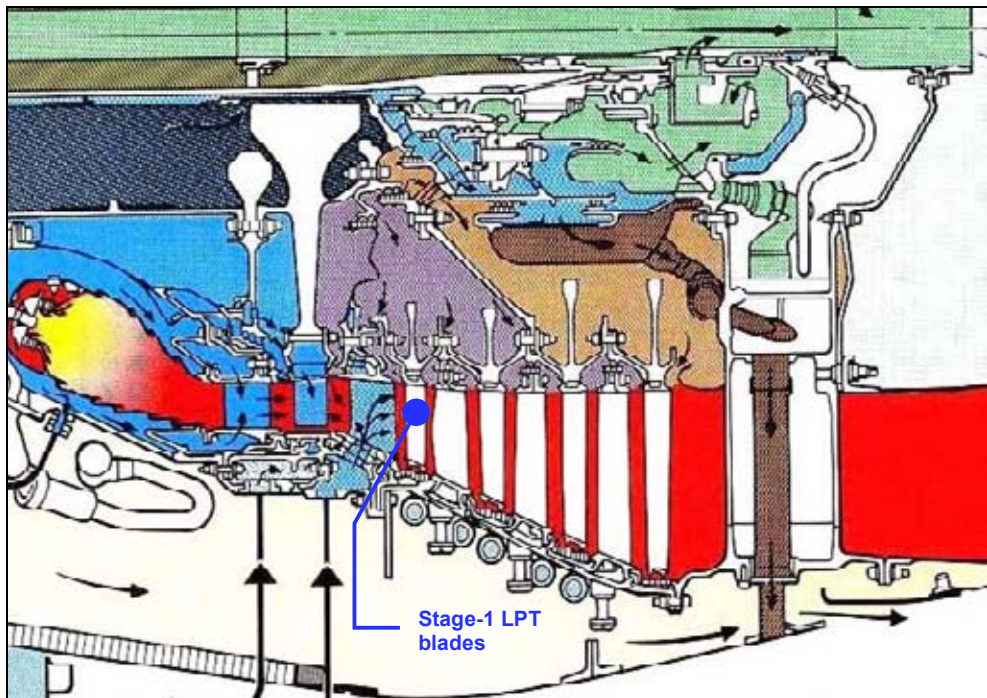
The region of failure was confirmed as the low-pressure turbine (LPT) section of the engine (Figure 2A), with all first-stage LPT blades having fractured through the aerofoil section between the blade platform and mid-span (Figures 3 and 4). Several of the remnant blade sections showed a degree of axial twisting and in-plane curvature opposite the direction of rotation (Figure 5), with the majority also showing random mechanical nicks, cracks and indentations associated with multiple and repeated impacts against the liberated debris. Evidence of prior repair and re-work blending was noted along the leading edges of some blades (Figure 6). However, there was no evidence of a correlation between the planes of fracture and the areas of re-work. The LPT stage-1 air seals and adjacent guide vanes had sustained extensive damage associated with the LPT blade rupture.

Figure 2A: Detailed view of CFM56-3 turbine section. Location of the stage-1 LPT is shown

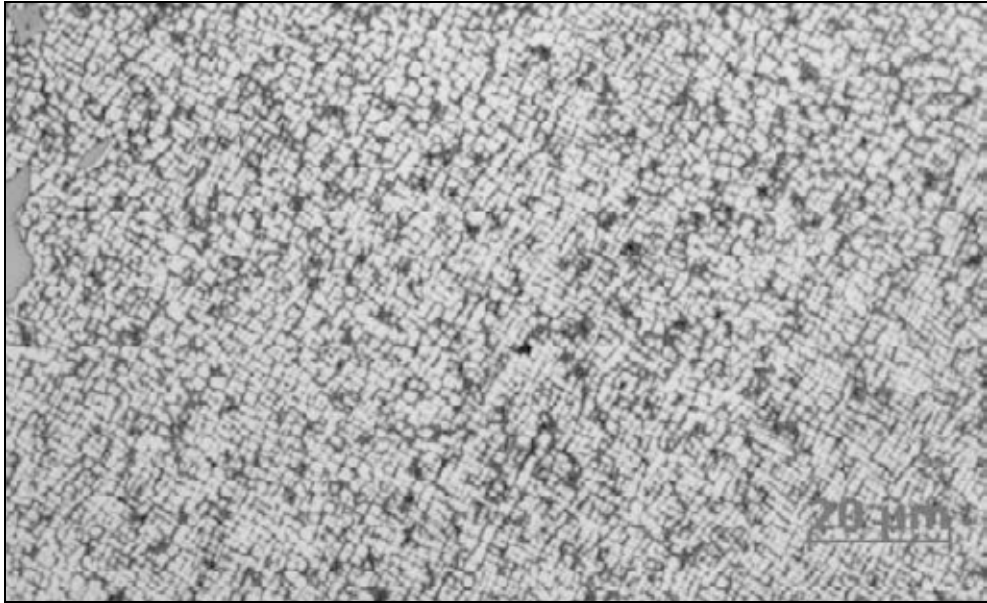
Reports received from both Lufthansa Technik and CFM International⁷ both indicated the absence of any evidence of tertiary microstructural creep⁸ damage within the examined blade sections. The persistence of sigma phase beneath the blade surface coating was cited as evidence that the blades had not experienced temperatures above 1050°C.

Figure 8: Characteristic microstructure of the stage-1 LPT blade material

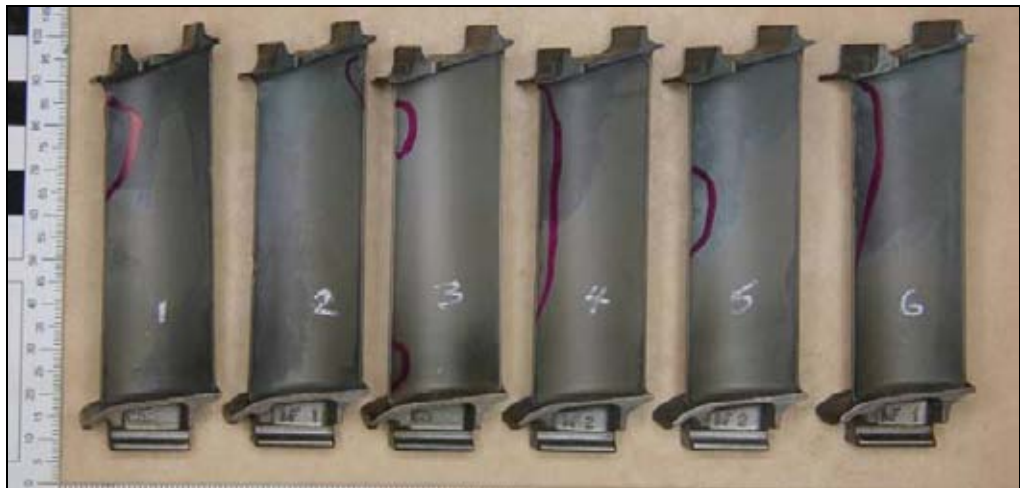
A selection of 17 stage-1 LPT blades from the operator's unserviceable stock was obtained by the ATSB for metallurgical characterisation (Figure 10). The thermal / operational histories of the blades were unknown, however the part number (301-330-114-0) was the same as the blades installed in engine 722113. Three of the blades were selected for examination, with sections cut and polished axially through the blade root and transversely through the aerofoil mid-chord position.

Figure 10: LPT blades received for examination

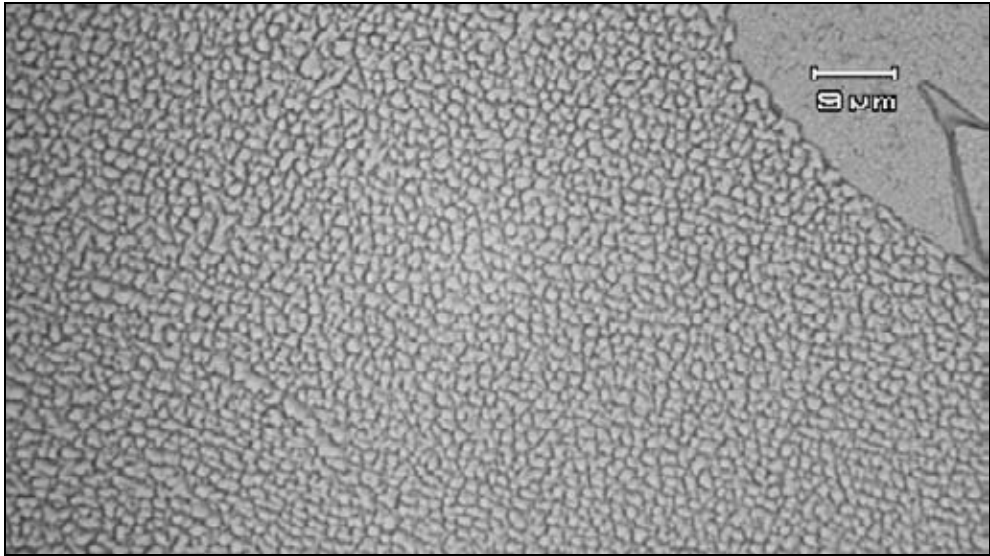
The three blades examined were comparable in respect of the level of thermally-induced changes within the gamma-prime microstructure. When compared against baseline structures within the root of the blades (Figure 11), the gamma-prime phase clearly showed a coalescence effect (Figure 12). However, when examined against representative structures for similar nickel-superalloy materials, the degree of coalescence and phase growth was considered to be within the ranges expected for normal blade operation. As such, the blades did not present any direct evidence of overheating. The clear presence of remnant sigma phase that is formed within the base metal immediately beneath the surface coating layer when the coating is first applied, was evidence that the blade temperatures had not exceeded 1050°C (Figure 13). At temperatures above 1050°C, the sigma phase rapidly breaks down and solutionises within the gamma matrix, and is thus an indicator of transient overheating events.

Figure 11: Typical baseline structure of the exemplar LPT blades (Kalling's etch)
