**ATSB TRANSPORT SAFETY INVESTIGATION REPORT**

Aviation Occurrence Investigation – 200605843

**In-flight break-up  
20 km NE Bathurst, NSW  
5 October 2006  
BAC 167 Strikemaster, VH-AKY**

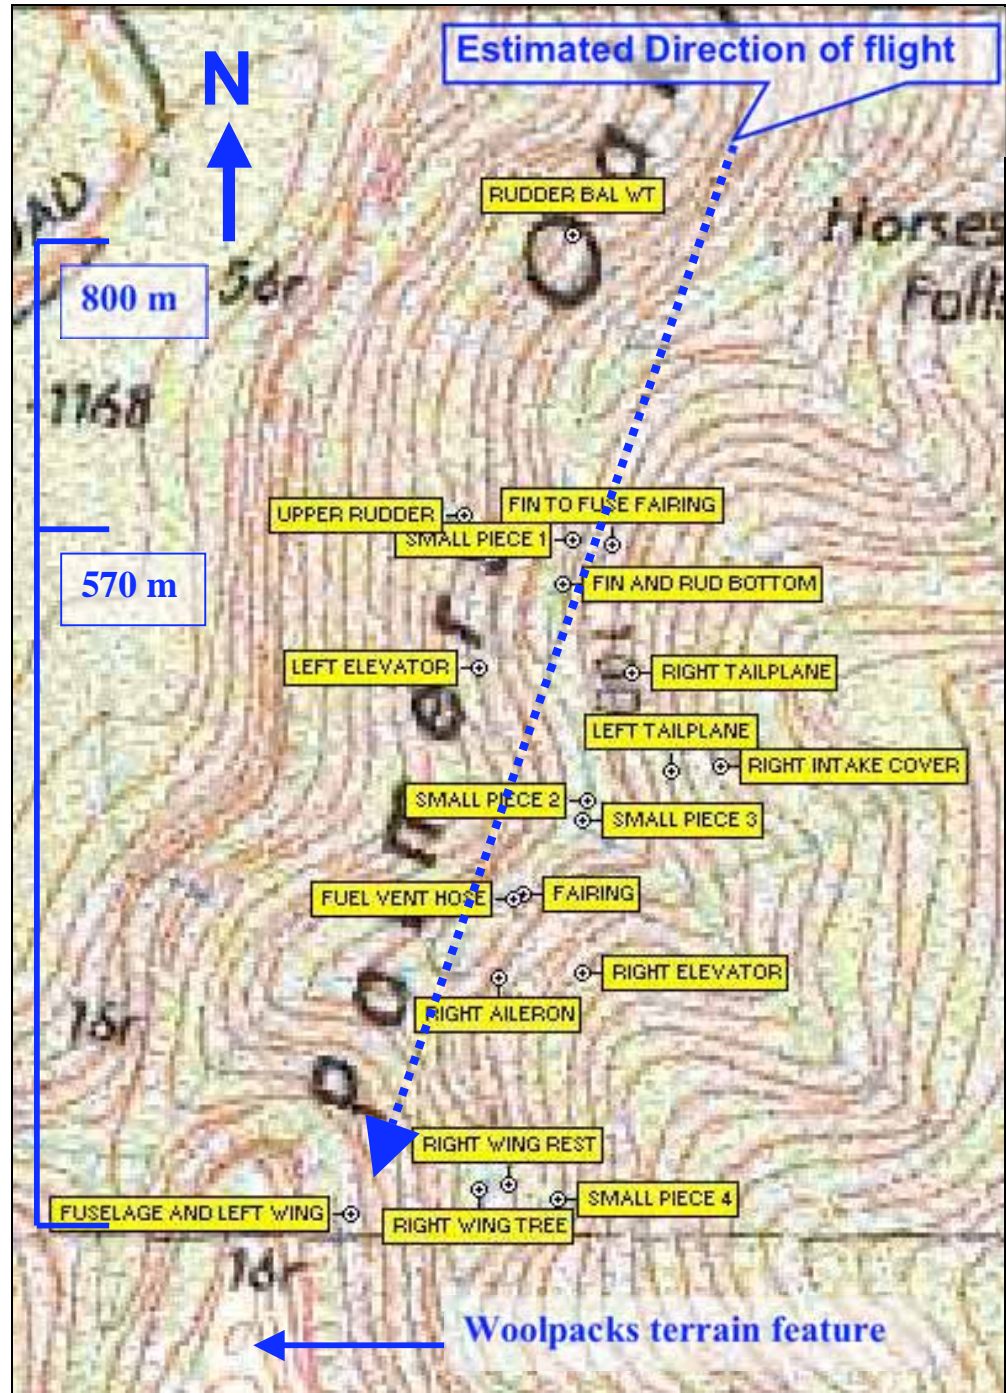
**Figure 4: Wreckage distribution**

The aircraft wreckage was located on the north-eastern side of the Woolpacks feature and in the valley floor, distributed over about 800 m of sloping, treed, terrain (Figure 4). The main wreckage, which consisted of the fuselage, engine and left wing, was located about halfway up the north-eastern side of the Woolpacks feature, and was mostly destroyed by impact forces and the subsequent post-impact fires (Figures 5 and 6). Witness marks on trees in the vicinity of the main wreckage indicated a downward impact angle of about 50 degrees. The right wing, tailplane, tail fin, elevators and rudder had separated from the fuselage in flight prior to impact with terrain. Other items of wreckage were damaged to varying degrees by impact with the ground and trees, and by the bushfire. The rudder mass balance weight, attached to part of the upper rudder, was the first item found in the wreckage trail, and was located about 120 m from other empennage items<sup>3</sup>.

The majority of the aircraft was identified at the accident site. The left flap and speed brake were not identified; however it is probable that they were destroyed with the left wing by the intensive post-impact fire.

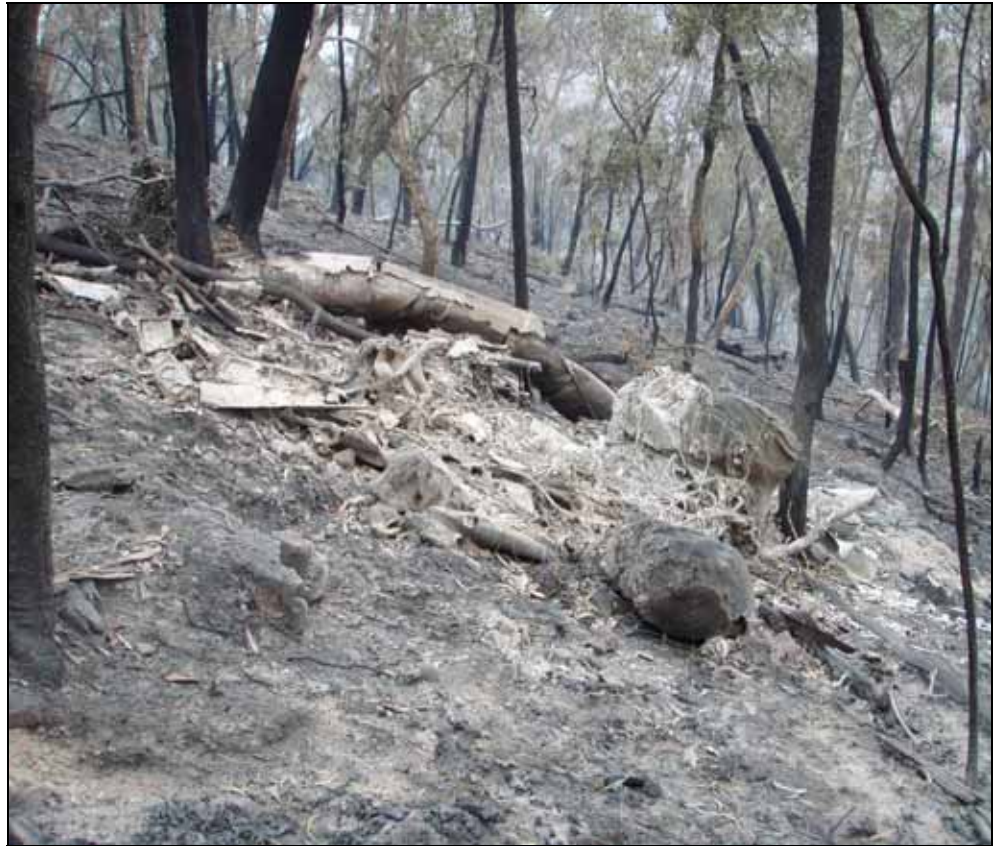
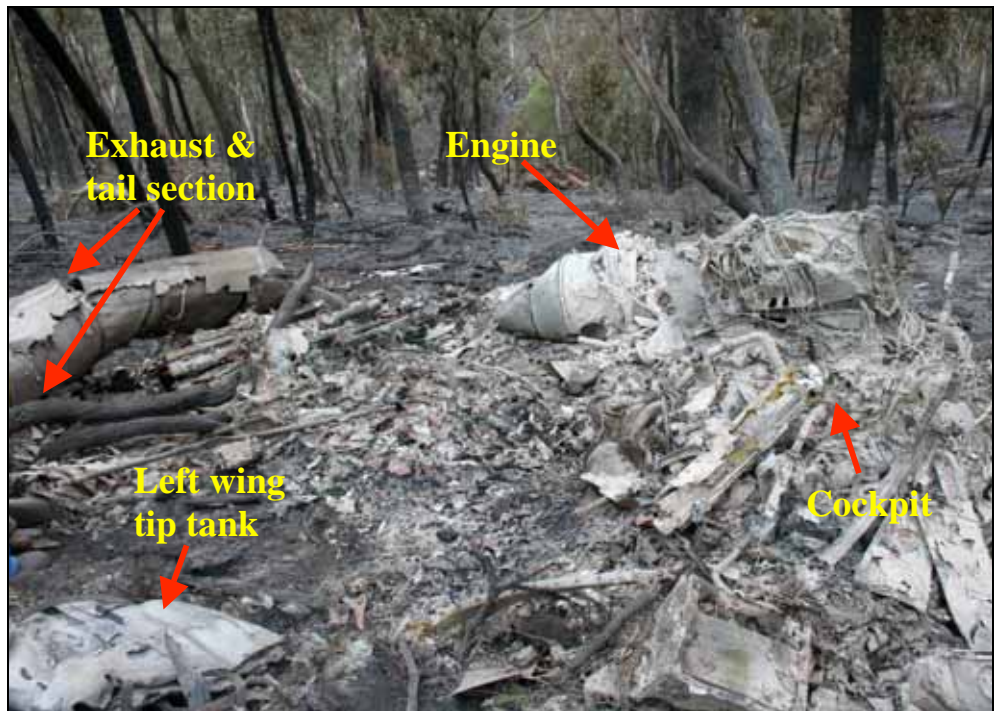
**Figure 5: Main aircraft wreckage**

**Figure 6: Main aircraft wreckage**

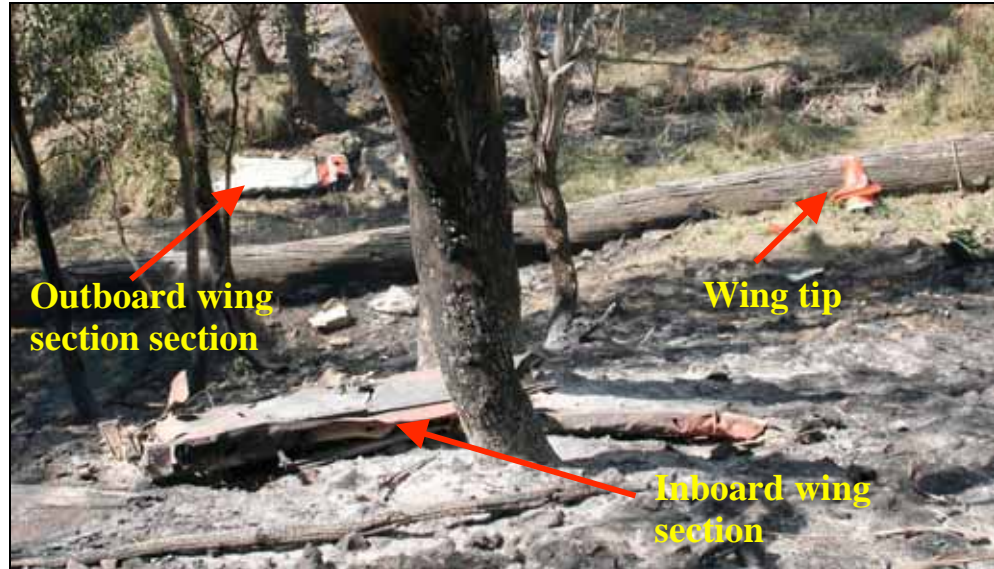
**Figure 9: Right wing**

The right wing had separated from the fuselage in flight and was largely intact prior to impact with a large tree, at which point it broke into a number of pieces (Figure 9). It was located about 150 m from the fuselage. Marks on the tree indicated a break-up trajectory of about 200 degrees magnetic (Figure 10).

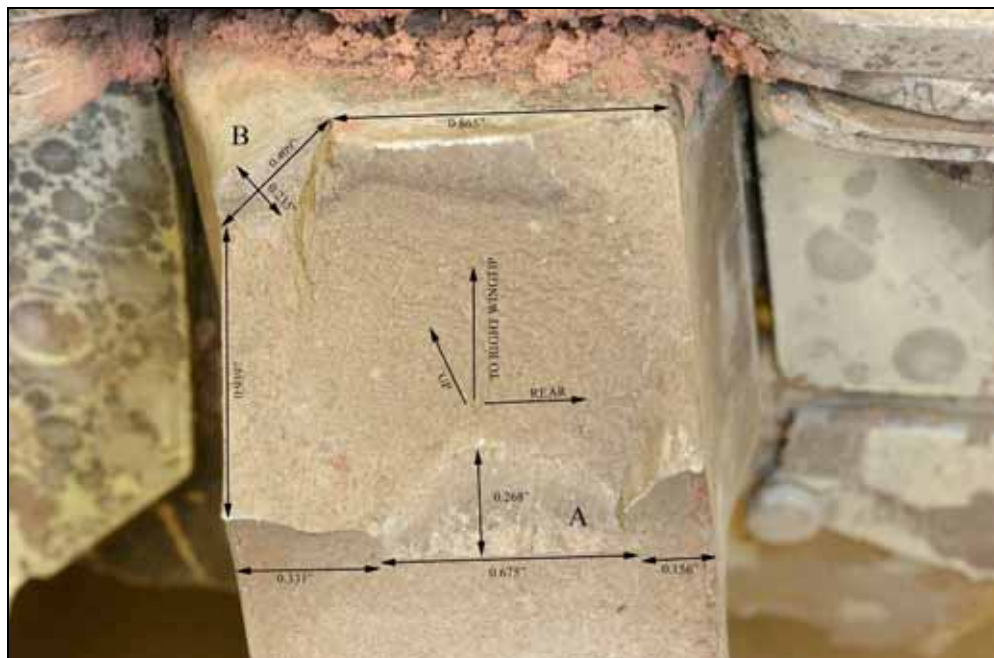
**Figure 12: Fracture surface and dimensions**

The right wing had separated from the aircraft under a single downward bending over-load that fractured the upper main spar attachment lug (Figure 11), then progressed down through the main spar web and finally fractured the lower and rear spar attachments. The investigation identified two areas of pre-existing fatigue cracks in the upper wing attachment lug, identified as positions A and B (Figure 12). Area A was the larger of the two cracks, with an origin at the lug bore surface. Area B had initiated from an area of prior surface/corner blending, which had been carried out for previous defect removal purposes. The attachment point and a section of its surrounding structure were retained for technical analysis at the ATSB's laboratory (Appendix B).

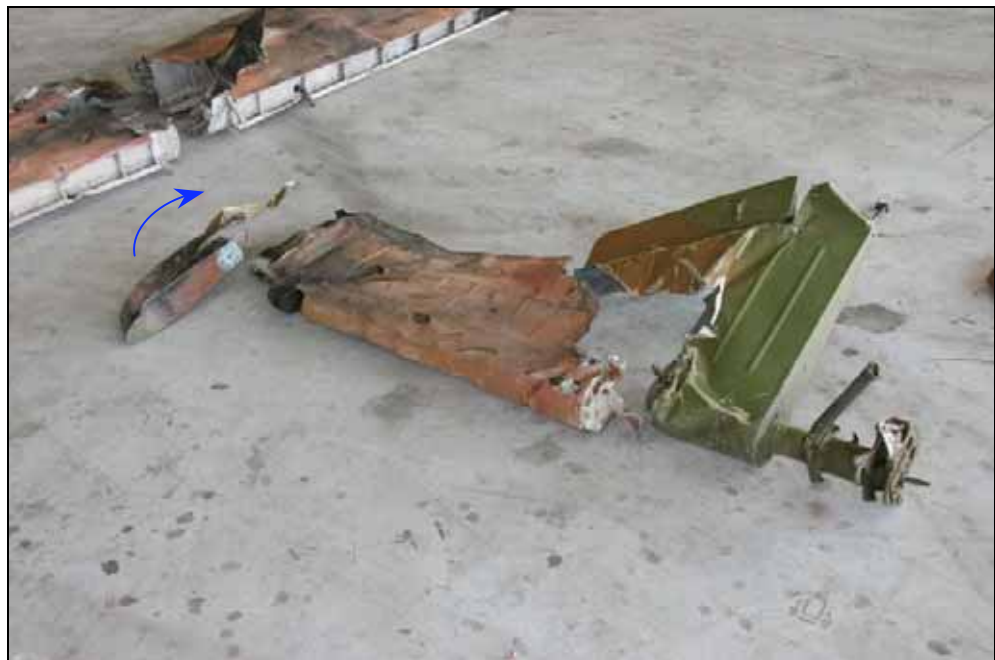
**Figure 18: Rudder pieces (note horizontal stabiliser in background)**

The aircraft rudder had broken into three pieces, comprising the mass balance weight, upper rudder section and lower rudder section (Figures 17 and 18). The mass balance weight had separated from the upper rudder in a manner such that the forward tip was pried over the top of the rudder (blue arrow in Figure 18), producing localised trailing edge buckling and tearing at the corners of the upper hinge cut-out.

Note: The blue arrow indicates the direction of mass balance separation from the vertical stabiliser.

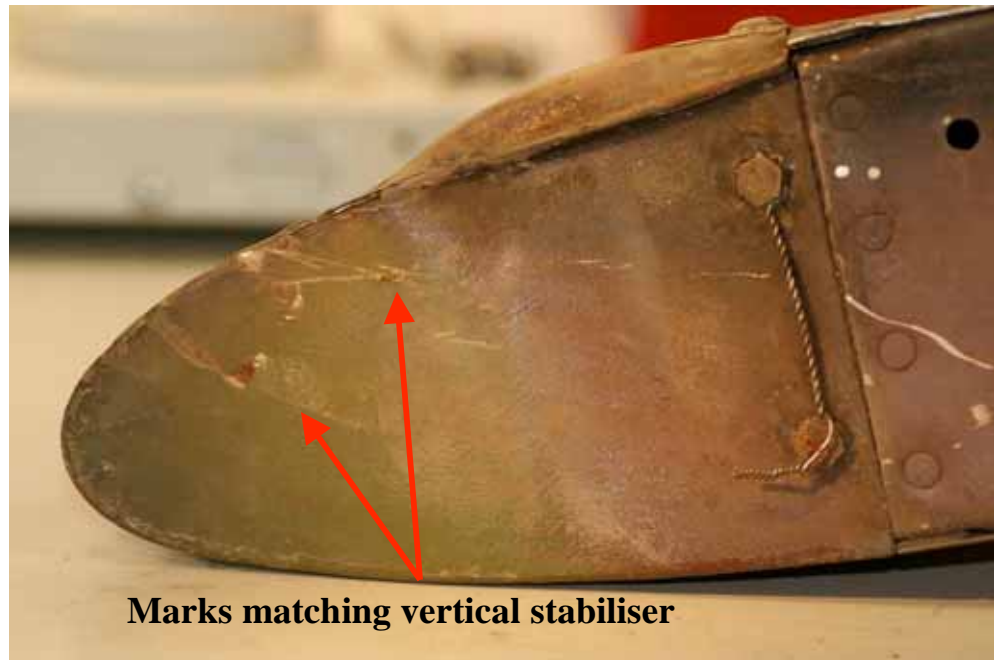
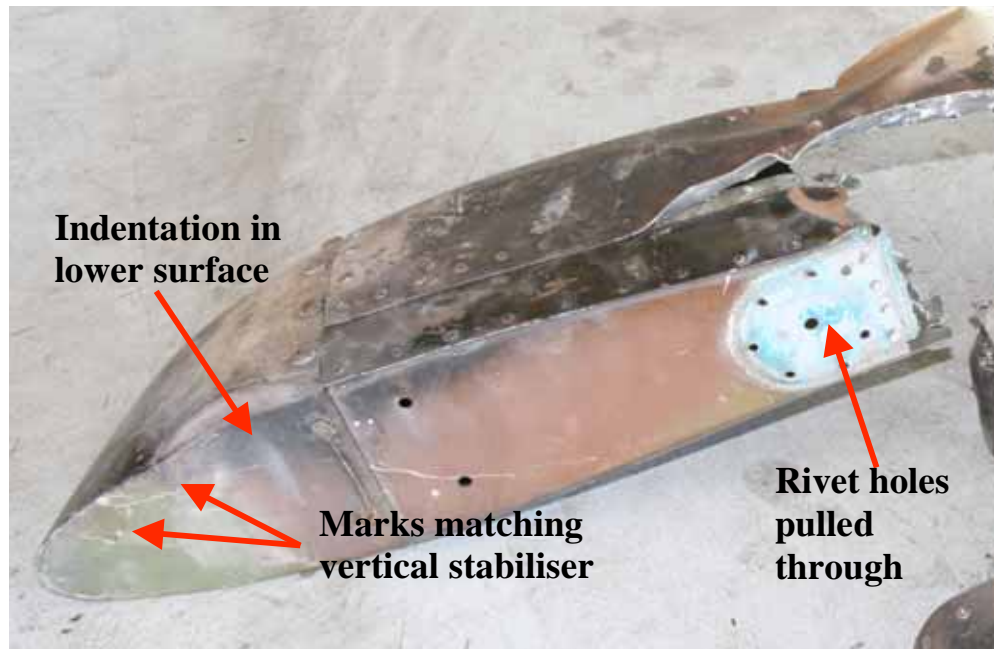
The lower surface of the mass balance weight had several marks of a shape and profile consistent with multiple impacts against the upper surface of the vertical stabiliser (Figures 19 and 20). An indentation in the lower surface of the mass balance weight, collocated with the other marks, suggested an impact with a blunt object. There was no corresponding mark on the vertical stabiliser to indicate that it was the origin of the impact.

**Figure 19: Lower surface of rudder mass balance**

**Figure 20: Lower surface of rudder mass balance**

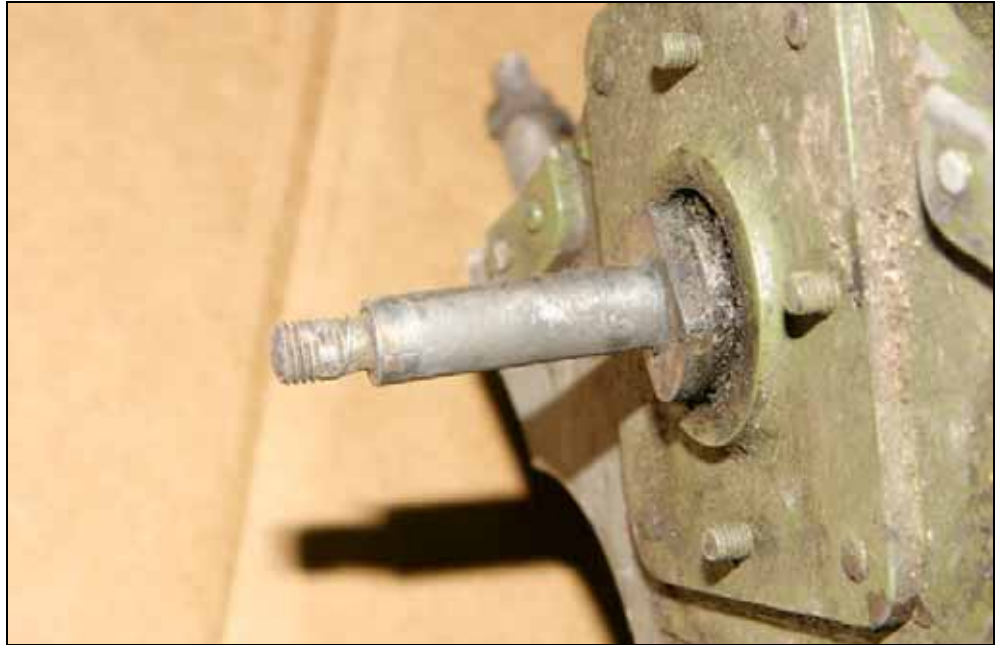
**Figure 24: Rudder lower hinge pin**

The lower section of the rudder included the rudder torque tube, rudder control bellcrank and elevator control bellcrank. The rudder control bellcrank contained the lower hinge pin, which normally attached it to the fuselage structure (Figure 24). The thread on the lower hinge pin contained thread remnants from the retaining

nut<sup>4</sup> (Figure 25). Examination of the hinge pin threads indicated that the nut thread had failed in a shear overload mode (stripping).

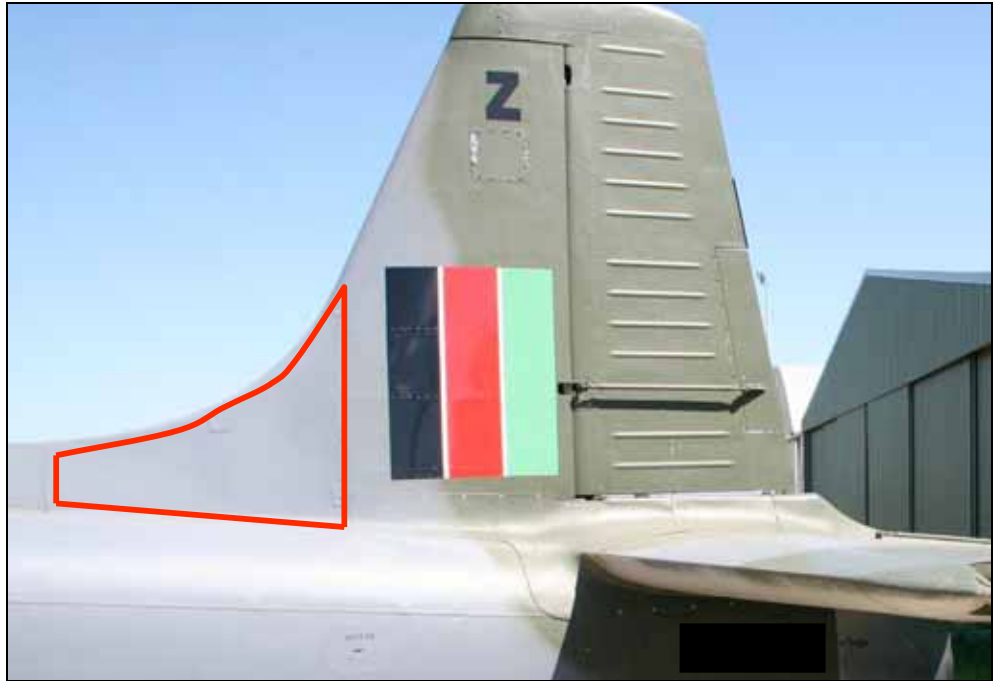
**Figure 28: Location of fin-to-fuselage fairing (outlined)**

The fin-to-fuselage fairing had failed in overload and was bent from right to left relative to the longitudinal axis of the aircraft. That was also consistent with the deformation of the vertical stabiliser (Figures 27 and 28).

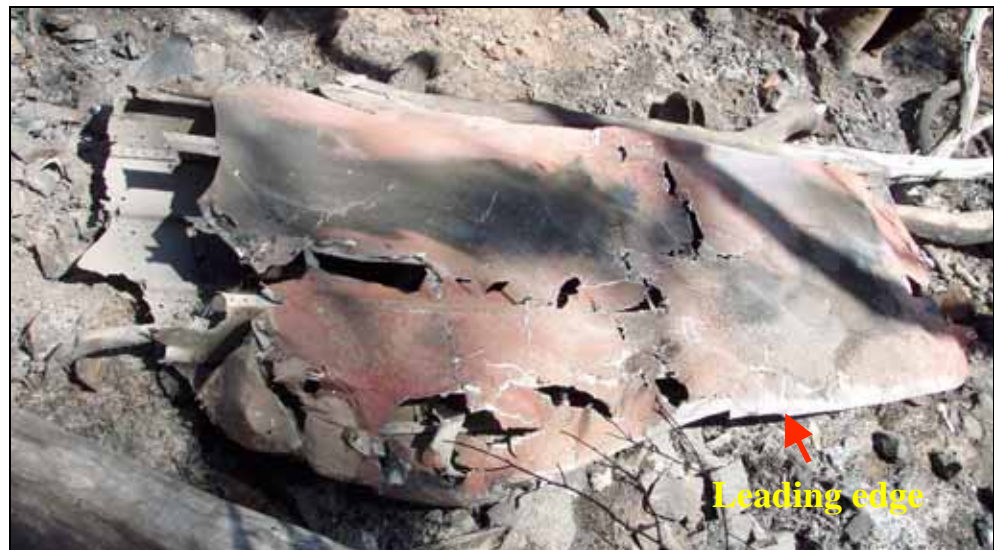
**Figure 31: Left section of tailplane**

The deformation and fracture of the tailplane primary load-bearing structures (main and rear spars) was consistent with exposure to upward bending forces that exceeded the structural capability of the assembly. However, there was some evidence of compression in some of the lower surface secondary structure (or stringers), which suggested that the tailplane had also experienced a large

downward bending load. All fractures had occurred due to overload (Figures 30 to 32).

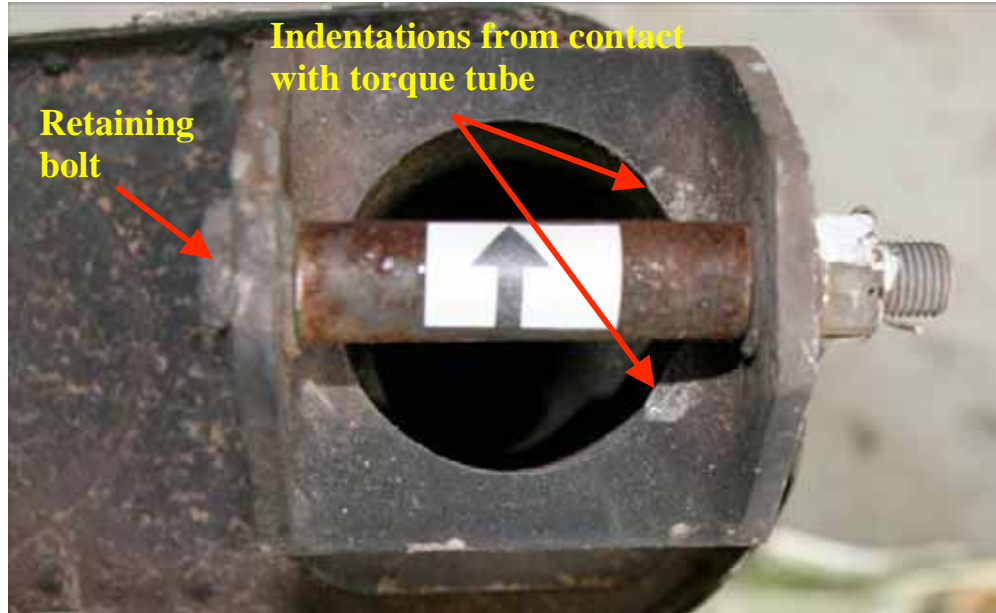
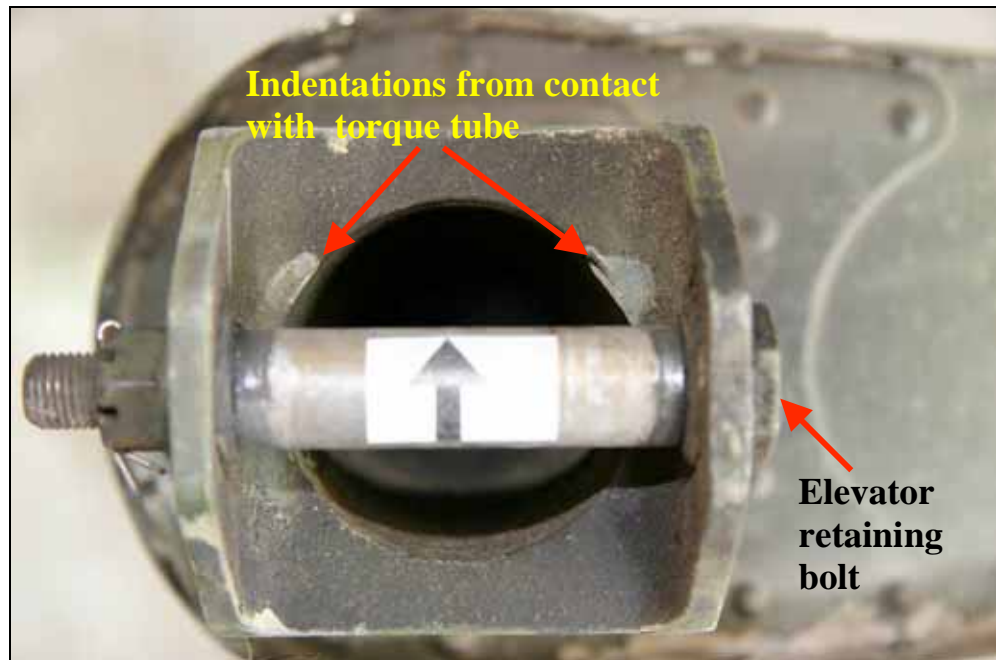
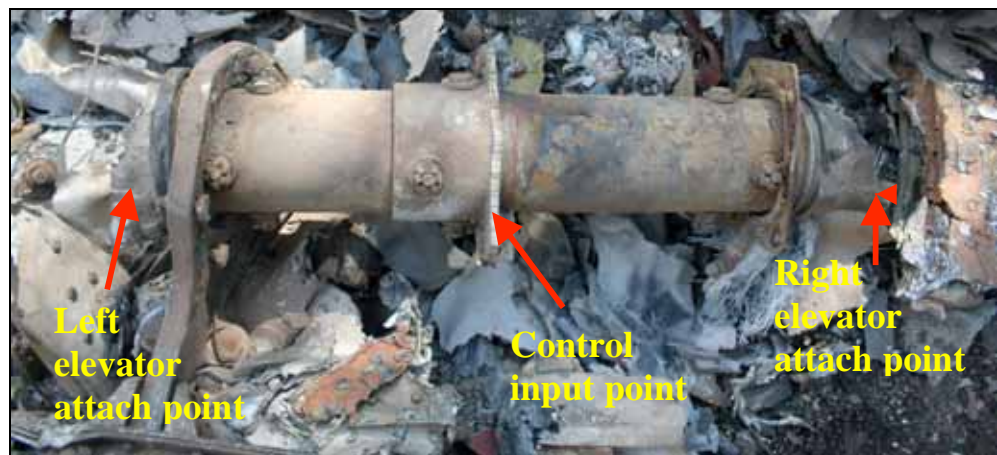
Both left and right horizontal stabilisers had separated from the aircraft in upward bending. Both elevator torque tube connections exhibited evidence of an upward deflection of the left and right sections of the horizontal stabiliser (Figures 34 to

36). Some structural elements of the left horizontal stabiliser also exhibited evidence of a downward deflection. There were no pre-existing defects identified within the stabilisers or elevators.

**Figure 34: Left elevator inboard attachment point**

**Figure 35: Right elevator inboard attachment point**

**Figure 36: Elevator torque tube as found**

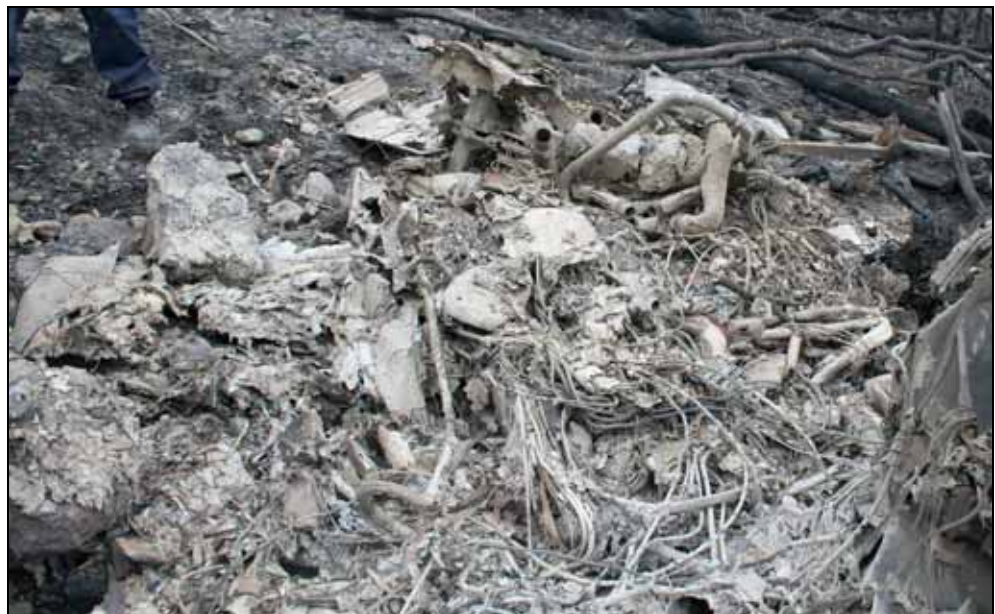
**Figure 37: Cockpit area**

Due to the destruction of the cockpit by impact forces and the post-impact fire, no readings or observations could be made (Figure 37).

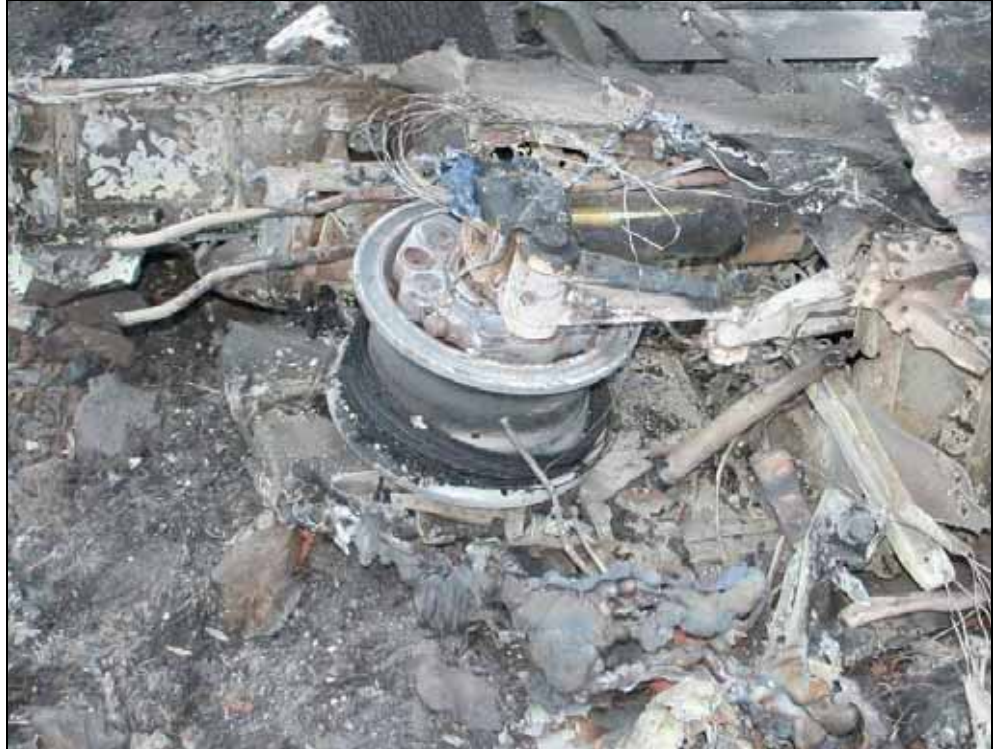
**Figure 38: Right main landing gear**

The retractable tricycle landing gear was in the retracted position (Figure 38).

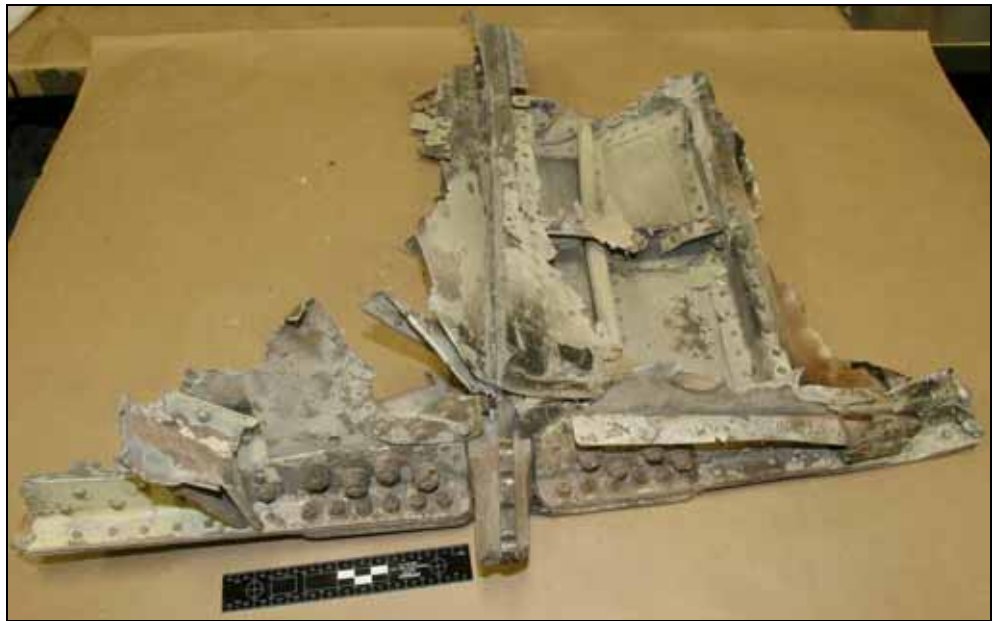
**Figure 4. Right wing spar boom - upper**

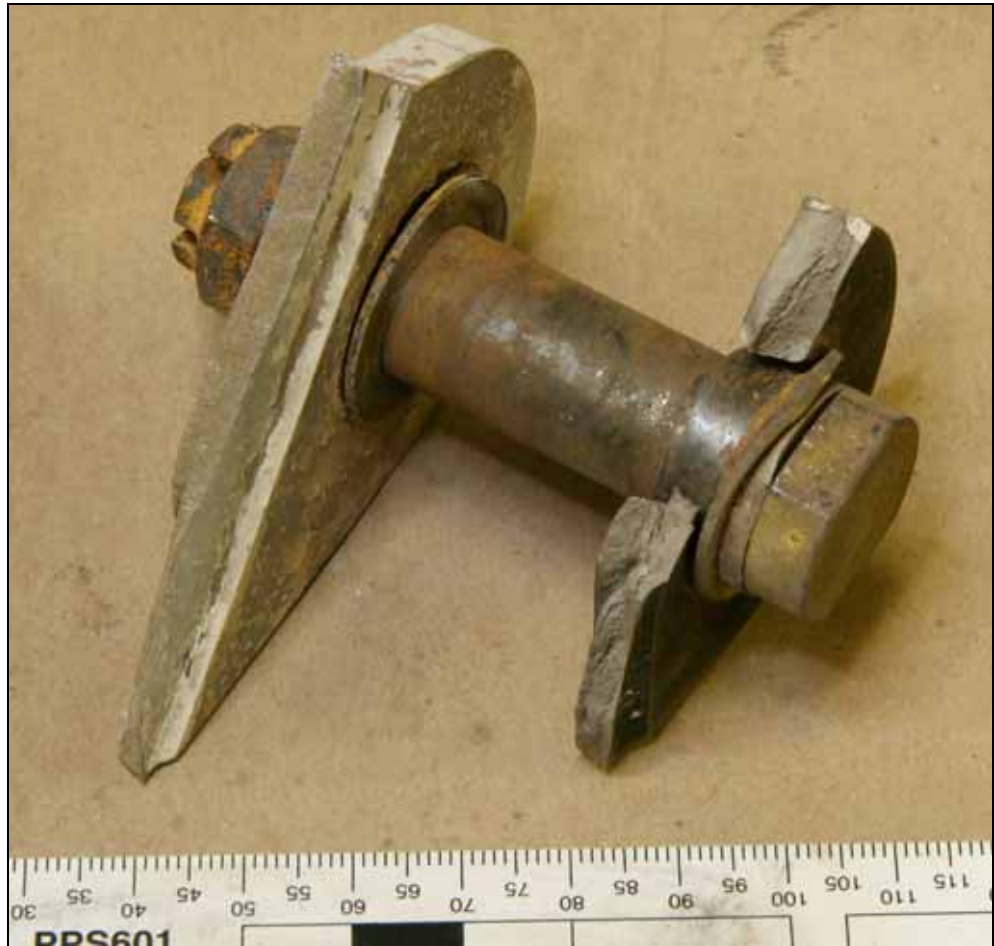
Both flanges and the pin from the right wing rear yoke connection were also recovered; the flanges having fractured away from the fuselage fitting.

**Figure 5. Right wing rear attachment yoke**

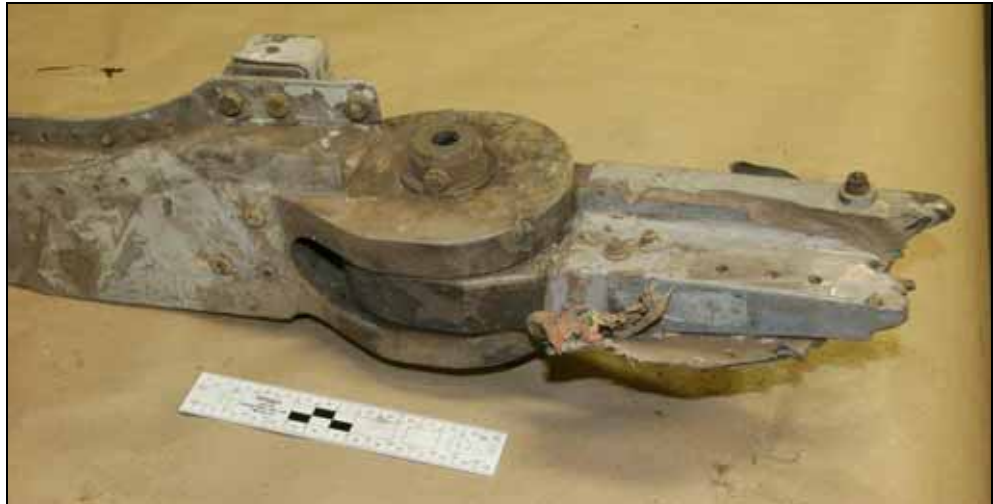
**Figure 15. Right wing spar lower lug and yoke engaged (as-recovered)**

The right wing lower main spar had separated from the fuselage by transverse fracture of the spar boom, approximately 200 mm (8") outboard from the horizontal lug centreline. The lug had remained engaged and secure within the fuselage yoke (Figure 15). The spar boom vertical web had fractured axially, with surface markings indicating fracture progression from the inboard end of the web. Cleaning and stereomicroscopic examination of the fractures found no evidence of pre-existing defects, fatigue cracking or other anomalous features. The surface morphology in all areas was typical of rapid ductile fracture under tensile or combined tensile/bending loads. Plastic deformation associated with the fractures and the bending of a fastener along the plane of separation (Figure 16) suggested failure under downward bending loads – thus correlating with the upper lug observations.

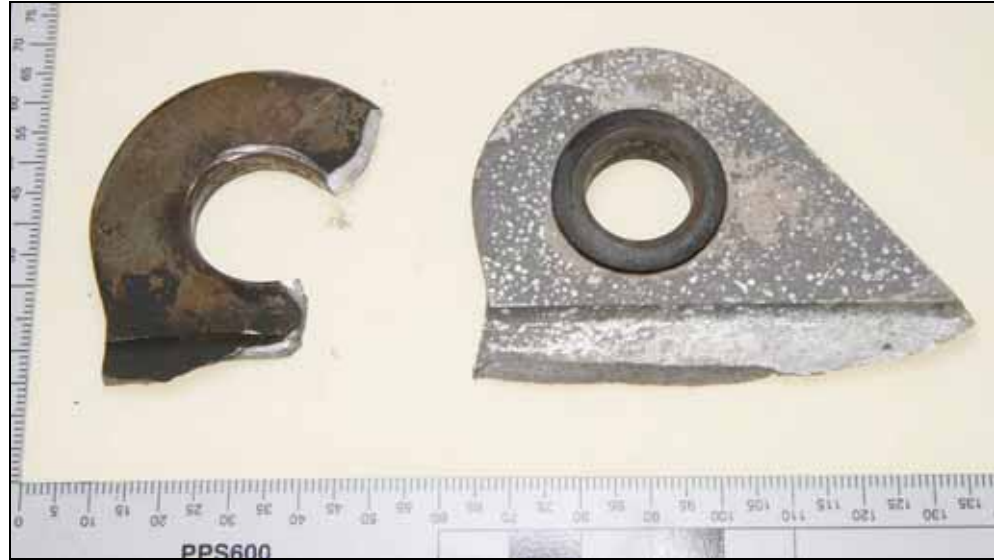
**Figure 17. Right wing rear attachment yoke flanges**

Both flange sections from the fuselage yoke presented fracture features typical of ductile tensile overstress, with no evidence of pre-existing anomalies that might have predisposed the fitting to premature failure. The flanges had failed in an asymmetric fashion, with the forward flange tearing through the body to intersect the pin hole; the rear flange tearing along the reduced section immediately behind the yoke faces (see Figure 17).
