**ATSB TRANSPORT SAFETY INVESTIGATION REPORT**

Aviation Occurrence Investigation – 200606542

**Engine failure – Townsville Airport, Qld  
1 November 2006  
VH-UBX  
Cessna Aircraft Company 207**

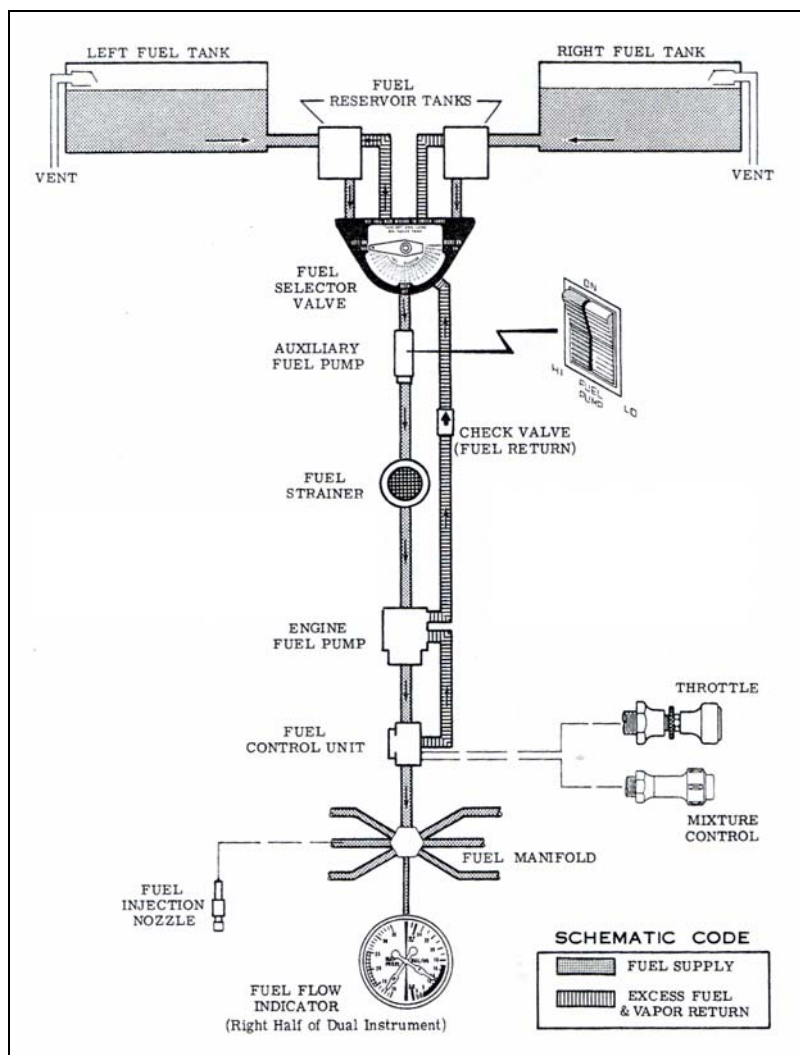
**Figure 1: Fuel system schematic**

In normal operation, fuel is gravity fed from the C207's main fuel tanks (located in the left and right wings) to the respective fuel reservoir tank, through the tank selector valve (selector valve selected to left – fuel is fed from the left fuel tank, selector valve selected right – fuel is fed from the right fuel tank). Fuel then travels through the auxiliary fuel boost pump (normally OFF, but selected ON in the event of an EFP failure), through the main fuel filter, then to the EFP. The EFP pumps fuel to each of the cylinders in a metered amount via the fuel control unit (FCU) and a fuel manifold. Fuel pressure indication is measured at the fuel manifold. Excess fuel (as a result of the metering function) is returned from the FCU to the

EFP and from there, returned to the reservoir tank via the EFP ejector valve (Figure 1).

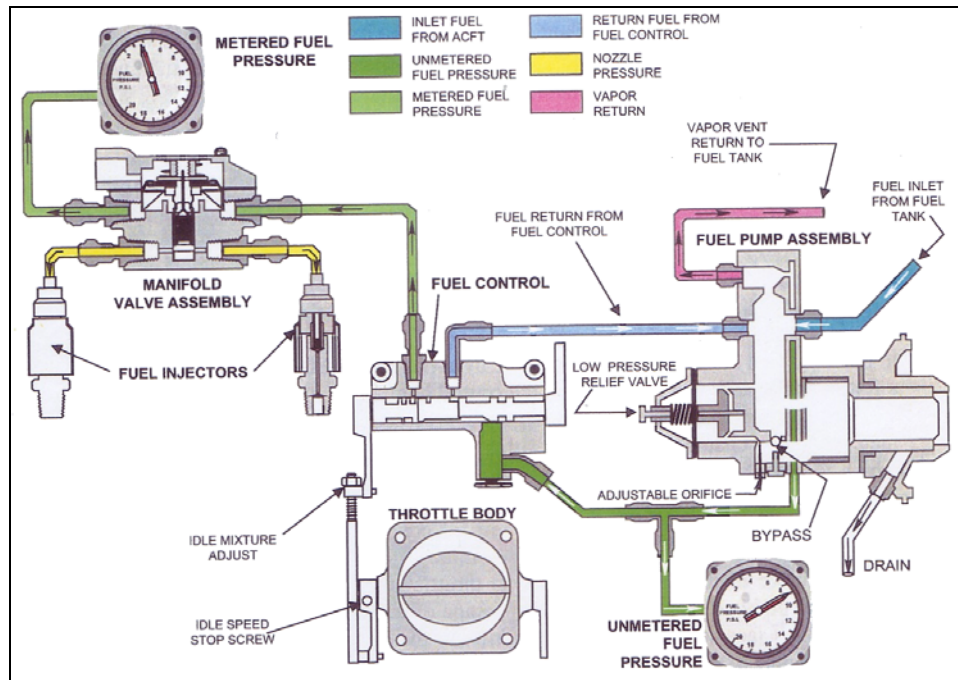
Figure 4: Engine fuel system schematic

The ejector valve (Figure 3) was removed and was found to be blocked with rubber-like debris. The ejector valve operates on a vacuum principle through a venturi that ejects any air that accumulates in the swirl chamber. Excess fuel from the EFP is also returned to the swirl chamber. Excess fuel is then returned to the respective fuel reservoir tank through the same ejector valve (Figure 4). With the ejector valve blocked, excessive fuel from the EFP could not return to the reservoir tank.

The manufacturer advised that if the ejector valve was blocked, the EFP would run 'rich'; that is, there would be a high fuel to air mixture.
