**ATSB TRANSPORT SAFETY INVESTIGATION REPORT**

Aviation Occurrence Report – 200607478

Preliminary

**Collision with terrain – Collymongle, NSW  
09 December 2006  
VH-CJZ  
Air Tractor AT-802A**

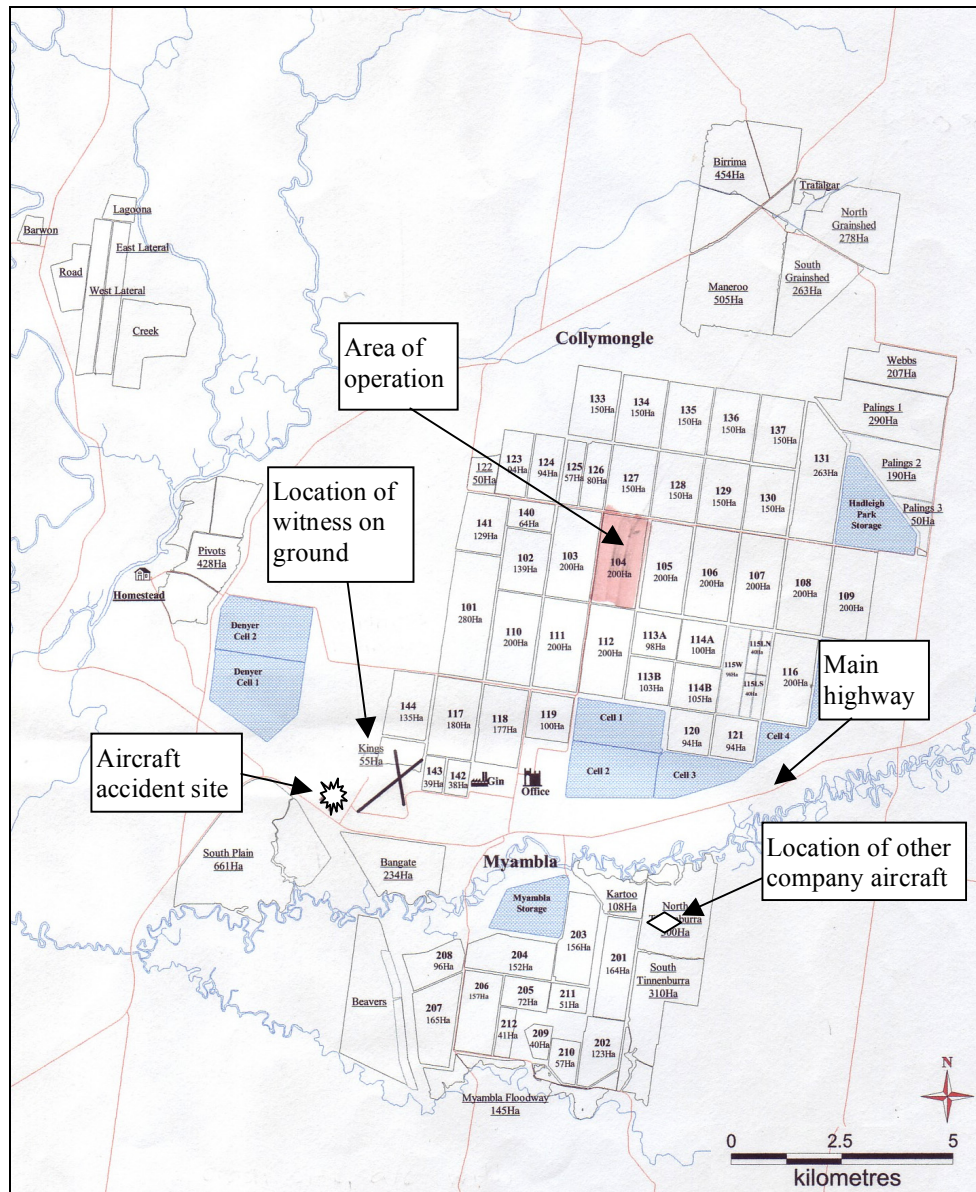
**Figure1: Accident site and surrounding area**

Witnesses on the ground saw the aircraft overfly the airstrip heading in a south-westerly direction (figure 1). The pilot of the other aircraft was at an altitude of approximately 200 ft above ground level and about 10 km south-east of the accident aircraft (figure 1) when he saw a bright light in a steep dive towards the ground, followed by a fireball. The pilot initially thought he may have seen a shooting star. He reported that he then realised that it was the other aircraft and then he flew to, and over the accident site to see if he could assist. On overflying the accident site he saw the crashed aircraft was on fire. He returned to Collymongle airstrip to assist ground staff.
