**ATSB TRANSPORT SAFETY INVESTIGATION REPORT**

Aviation Occurrence Investigation – 200607801

**Wirestrike - Nelson, Vic. - 24 December 2006**

**Auster Aircraft Co. J1/A1**

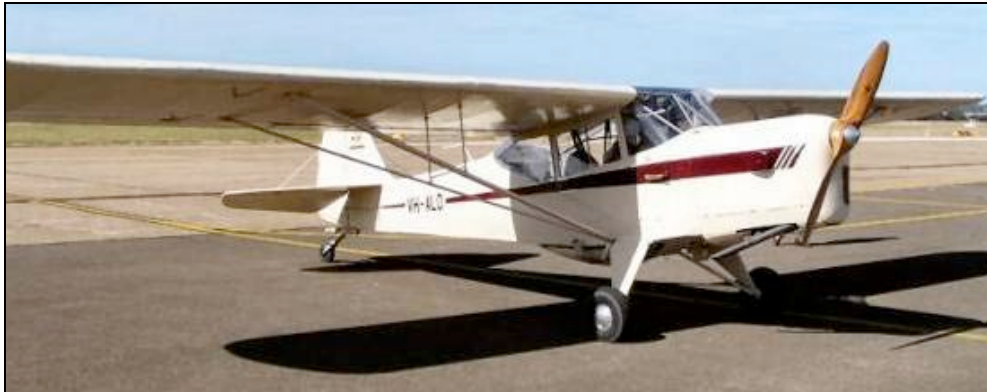
**Figure 4: VH-ALO**

The aircraft was a high-wing monoplane with a normally aspirated 4-cylinder engine and a fixed-pitch laminated timber propeller. Its main structure consisted of welded steel tubing and timber, which was wrapped in a resin impregnated fabric forming the outer skin surface. The aircraft had a seating capacity of three, two in the front and one in the rear (Figure 4).
