**ATSB TRANSPORT SAFETY INVESTIGATION REPORT**

Aviation Occurrence Investigation – 200700357

**Engine failure – 28 km WSW of Warialda NSW**

**VH-HRT Bell Helicopter Company 407**

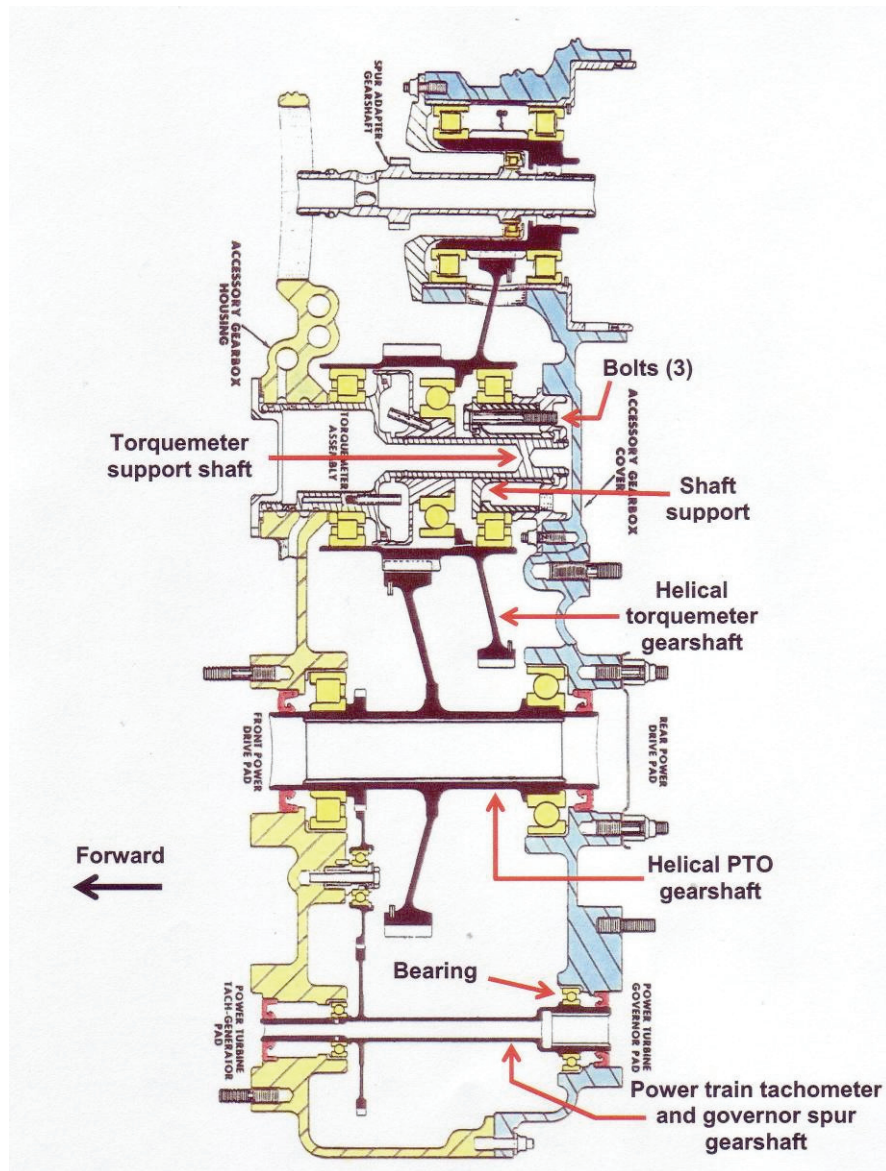
Figure 7: Schematic of engine gearbox gears

The engine gearbox assembly consisted of a gearbox housing, gearbox cover, gas producer (N1)<sup>15</sup> gear train, power turbine (N2)<sup>16</sup> gear train, oil pump assembly, oil filter assembly and the necessary oil tubes to provide pressure and scavenge oil as required by the lubrication system. Some of the gears in the gearbox, including the helical torquemeter gear, were compound gear assemblies. A compound gear assembly consisted of one gearshaft with two gears on it (Figure 7).

The helical torquemeter gear was a 42-tooth gear, which rotated at 10,026 RPM at 100 % N1 within the gearbox. It drove the helical power take-off gearshaft, which delivered power to the output pads located on the front and rear of the gearbox. The front output pads delivered power to the input of the main transmission assembly and the rear output pad to the tail rotor driveshaft.
