ATSB TRANSPORT SAFETY INVESTIGATION REPORT

Aviation Occurrence Investigation – 200700358

**Engine power loss
15 km SE Gold Coast Airport, Qld
4 February 2007**

VH-DIC

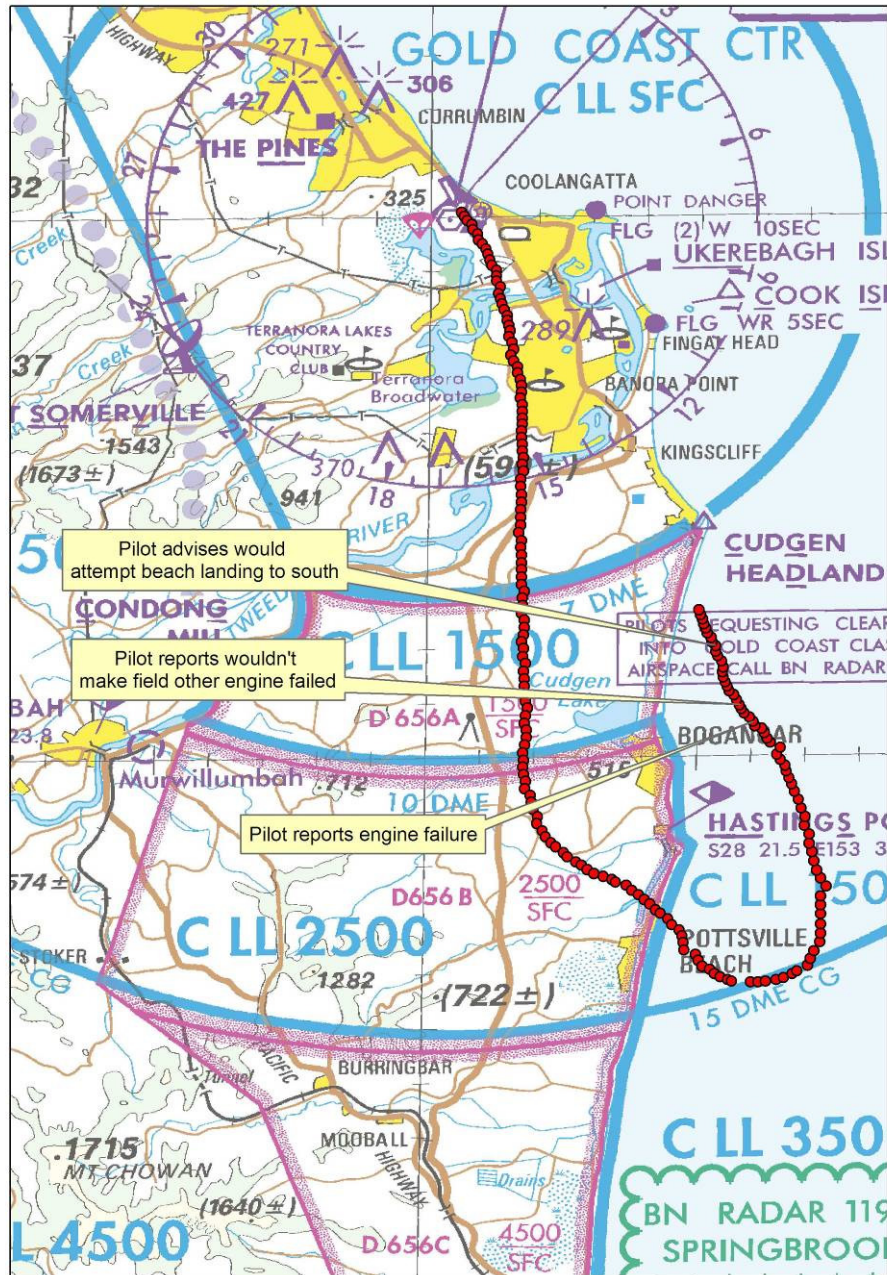
Figure 1: Radar track of aircraft's flight

Recorded radar data showed that after takeoff, the aircraft had tracked south towards the flying training area, reaching groundspeeds of up to 138 kts. At 1617:56 the aircraft turned towards the south-east and at 1619:56 the aircraft turned to the north-north-west towards the Gold Coast Airport. After that turn, the radar data showed that the aircraft maintained 1,500 feet above mean sea level (AMSL) with a groundspeed of about 160 kts. From 1621:25 to 1622:20, the groundspeed reduced to below 100 kts. After 1621:35, the aircraft descended at about 650 ft/min, which continued until it was below radar coverage (Figure 1). The last radar derived groundspeed was 89 kts (see Appendix A for further details concerning recorded radar data).
