ATSB TRANSPORT SAFETY INVESTIGATION REPORT

Main rotor blade skin separation

VH-HPI

Robinson Helicopter Company R22 Beta II

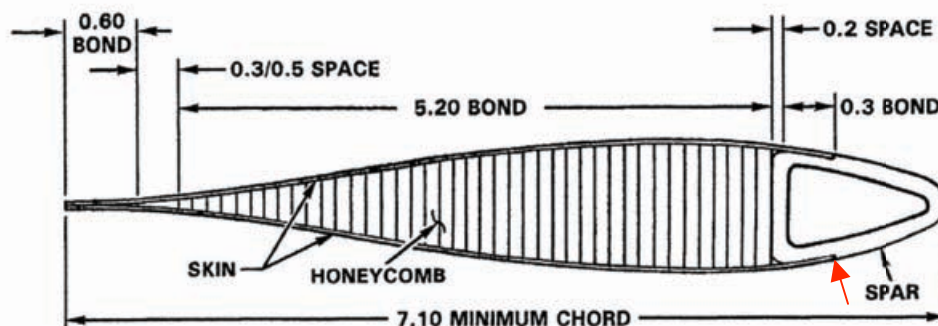
The A016-4 main rotor blade design consisted of a single piece leading-edge hollow D-spar, with the aerofoil section comprised of an expanded aluminium honeycomb core overlayed on the upper and lower surfaces with an adhesively-bonded stainless steel skin (Figure 2). The aerofoil section skin was lap-bonded to a recessed surface at the rear of the leading-edge spar, with any small gaps between the skin edge and recess corner being filled with adhesive that presumably extruded from the joint during manufacture. The entire length of the upper and lower skin-spar joints was coated with primer and polyurethane enamel paint, with the leading edges also having a supplementary black polyurethane enamel paint coating, extending over and beyond the external skin-spar bond lines.

Figure 2: Typical construction of the part number A016-4 R22 main rotor blade aerofoil section - under surface 'bond line' shown at red arrow
