ATSB TRANSPORT SAFETY INVESTIGATION REPORT

Aviation Occurrence Investigation – 200702219

**In-flight engine failure
9km NE Wagga Wagga, NSW
de Havilland Canada Dash 8, VH-TQY
11 April 2007**

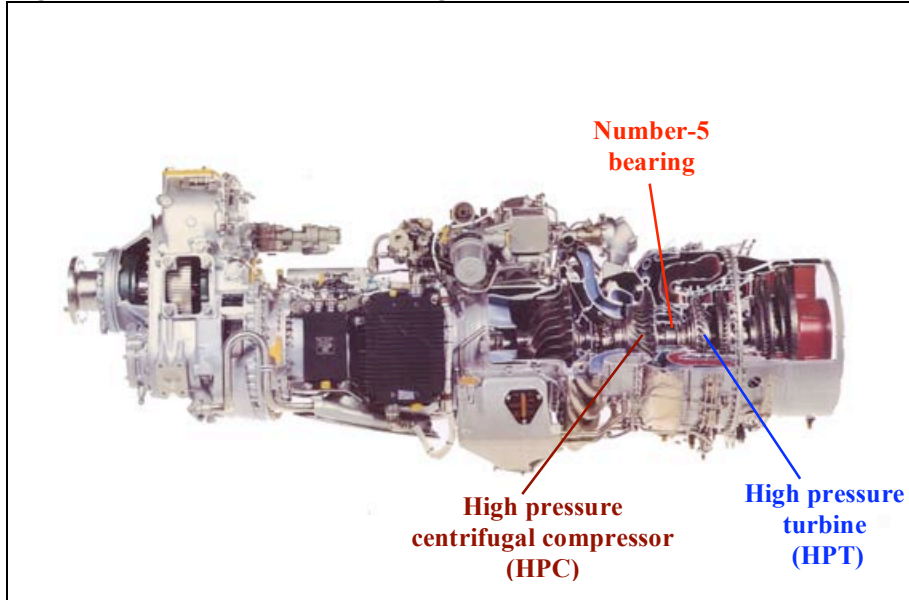
Figure 1: PW100 series engine

The engine (Figure 1) was disassembled and examined on behalf of the Australian Transport Safety Bureau (ATSB), at the manufacturer's facility in Quebec, Canada,
