Aircraft control cable terminal fittings – ATSB technical examination

ATSB Transport Safety Report
Aviation External Investigation
AE-2012-028
Final – 9 April 2013

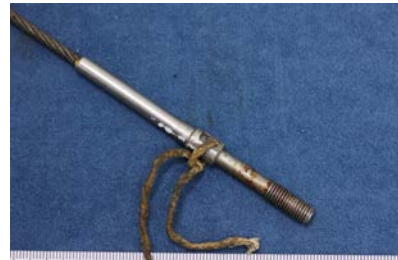
Sample cable terminal fitting

While several of the 54 submitted cable terminals showed evidence of surface pitting corrosion, none revealed any evidence of SCC when examined visually and using non-destructive testing techniques.

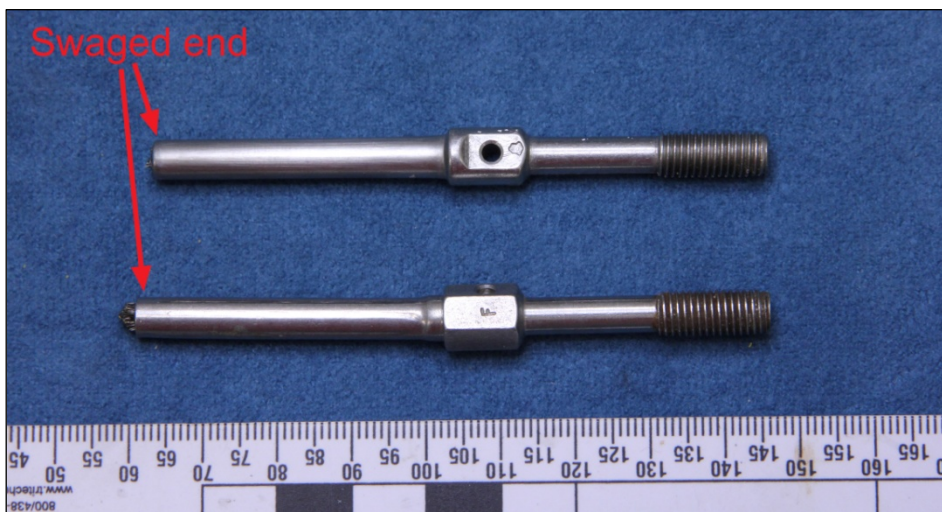
Figure 1: Sample of cable terminals submitted to the ATSB

The terminals (Figure 1) were designed so that one end could be swaged¹ onto a wire rope cable, while the opposite end contained threads that were inserted into a turnbuckle for tensioning the cable. The terminals contained a hole through the centre wrenching flats for securing the assembly with lock wire.

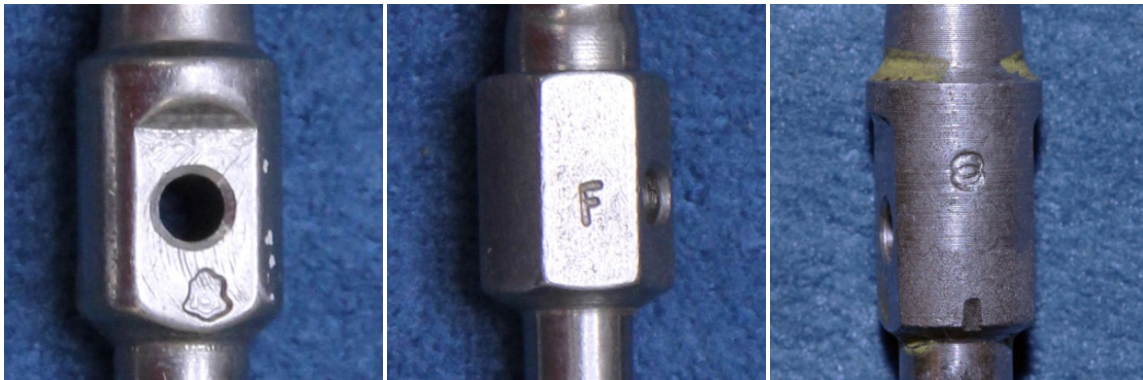
Figure 2: Manufacturer markings observed on the submitted terminals (from left to right; bell, F and OO)

Slight differences were observed in the design of the terminals received, but they were essentially the same component. The primary difference was in the centre section that included a hole for safety wire installation; one population exhibited a hexagonal form (Figure 1 bottom) while the other exhibited a rounded mid-section with wrench flats (Figure 1 top). The terminals also exhibited three different manufacturing markings which included 'bell', 'F' or 'OO' (Figure 2).

The terminals marked with an 'F' were all of the type with the hexagonal centre section, while the 'bell' and 'OO' samples were round. Additionally, all the 'bell' and 'OO' items were identified as part number AN669, while approximately half the 'F' terminals were part number AN669 with the other half being part number MS21260⁴. The two part numbers were consistent with those identified in the CASA AWB.
