**ATSB TRANSPORT SAFETY REPORT**  
Aviation Occurrence Investigation AO-2009-004  
Final

**Operational event**  
**89 km south-east of Townsville**  
**Aerodrome, Queensland**  
**2 February 2009**  
**VH-ESH**  
**Agusta Westland AW139**

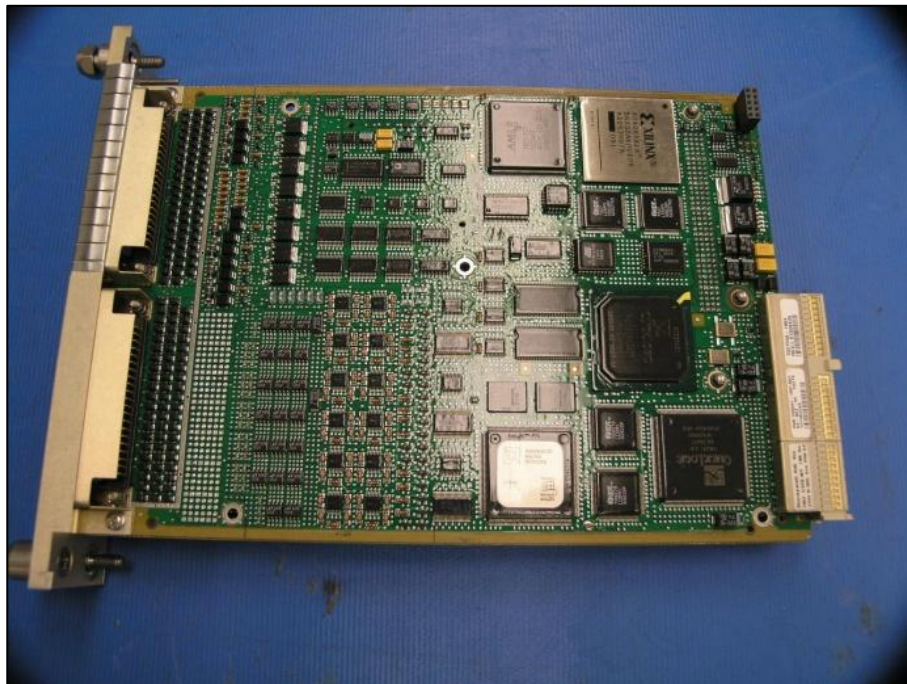
**Figure 6: MAU module**

Each MAU consisted of a cabinet containing a number of slots within which several replaceable electronic modules (Figure 6) were housed.

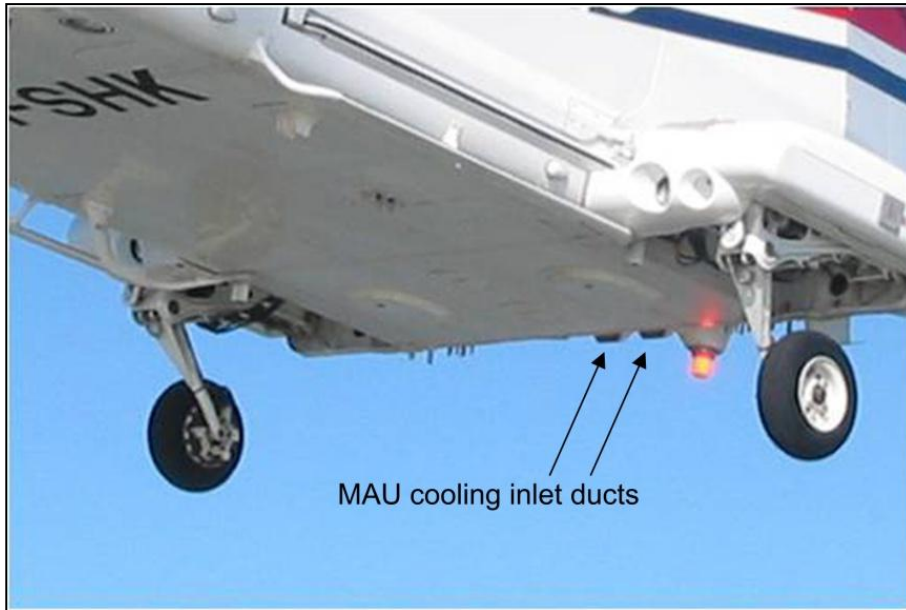
**Figure 7: MAU cooling inlets**

Cooling of the MAUs was achieved using outside air that was separately ducted to each MAU cabinet from two air inlets located on the underside of the fuselage (Figure 7). The cooling air was not filtered or conditioned and, in the case of MAU2 (right side) the vent was located underneath the cabinet (Figure 8).

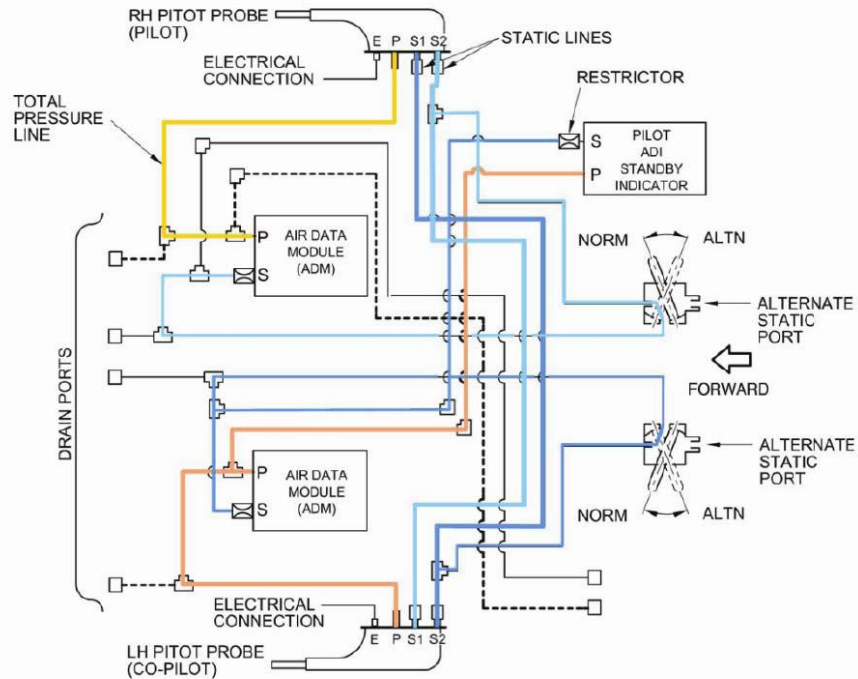
**Figure 9: Air data system**

The air data system is a subset of the avionics system comprising dual pitot/static probes, air data modules (ADM), outside air temperature (OAT) probes and alternate static sources (Figure 9).

Each ADM converts the dynamic and static pressures measured by the pitot/static probes to digital signals which, together with the measured OAT values, are used by the MAUs to generate air data parameters such as airspeed, altitude and vertical speed. In the event of erratic airspeed and altimeter indications, two alternate static sources within the aircraft cabin are available to restore normal operation. In the event that the altitude generated by each of the MAUs varied by more than 150 ft, an amber altitude mis-compare alert would be displayed on both altimeters (Figure 10).

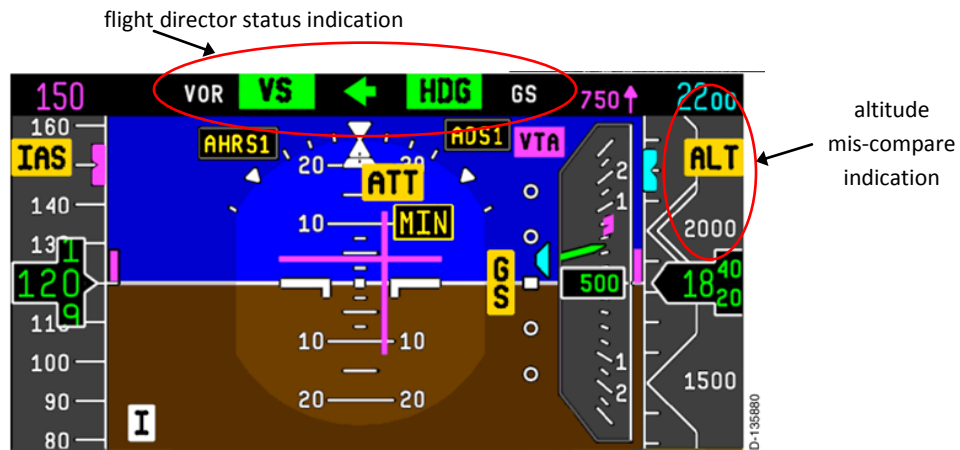
**Figure 10: Flight director mode information**

The AW139 has an automated flight system that is capable of controlling the helicopter’s movement in a number of modes, including the capture and maintenance of a defined flight path or flight parameters such as altitude or airspeed. This system, known as a flight director, incorporates a chime to identify both routine flight director mode changes to the crew and also to alert the crew of an unintended change in the automated control of the helicopter. In addition to the chime, the status of the flight director, including mode changes, is displayed on the top section of both PFDs using a combination of colour coded and flashing identifiers (Figure 10).
