Powerplant/propulsion event Launceston aerodrome – 20 August 2009

Abstract

The left engine was a CFM International (CFMI) CFM56-7B24, high bypass ratio turbofan (Figure 1), serial number 888952.

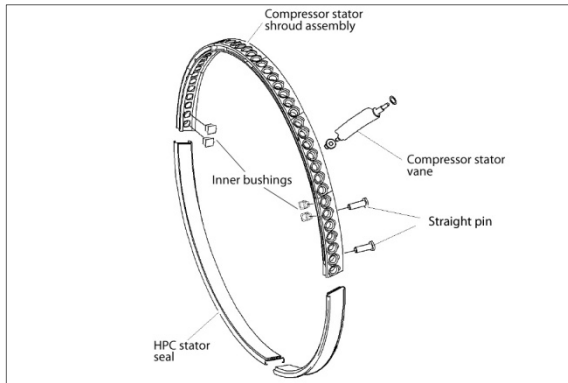
Figure 5: Shroud assembly schematic (from SB 72-0515).

Further examination of the HPC revealed that the stage-1, 2 and 3 inner shroud segments were loose, and the bushings exhibited heavy wear. All straight pins were accounted for. Refer to Figures 5 and 6 for a diagram showing the HPC VSV shroud assembly.

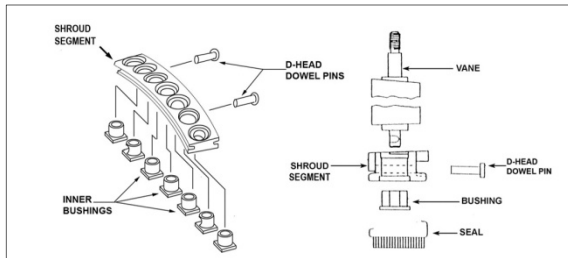
Figure 6: VSV assembly.

Although loose, the stage 1 and 2 inner shroud segments were intact and the honeycomb seals had not rotated. However, the stage-3 honeycomb seal segment located in the 9 - 12 o'clock position looking forward was missing, and the adjacent 12 - 3 o'clock segment had been displaced about 4 inches (102 mm). Two small pieces consistent with the missing seal segment were found in the debris recovered from the engine (Figure 7).

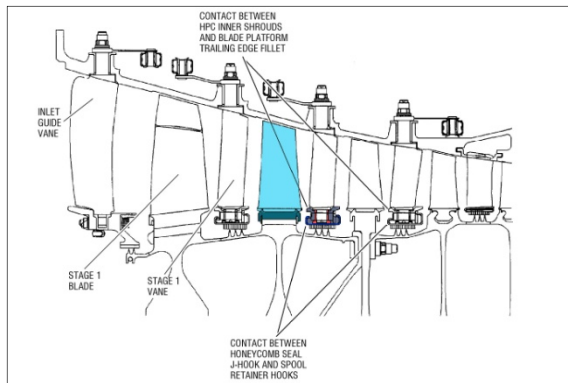
Figure 10: Overview of blades and vanes (from SB 72-0515).

standards for a borescope inspection (BSI) on high time since new (TSN) CFM56-7B engines in order to detect and monitor wear or rotation of inner shroud J-hooks'. The bulletin stated that wear of the VSV inner bushings allows the HPC inner shrouds to move forward, which in turn allows the vanes and inner shrouds to rotate forward into the rotor hardware (Figures 10 and 11).

The bulletin recommended a borescope inspection after 24,000 hours TSN, or 24,000 flight hours since the HPC inner and outer VSV bushing and outer washers had been replaced with new parts.
