Pilot incapacitation while operating a Robinson R44 Helicopter, VH-HCA

180 km SSW of Newman, Western Australia | 3 September 2011

ATSB Transport Safety Report
Aviation Occurrence Investigation
AO-2011-109
Final

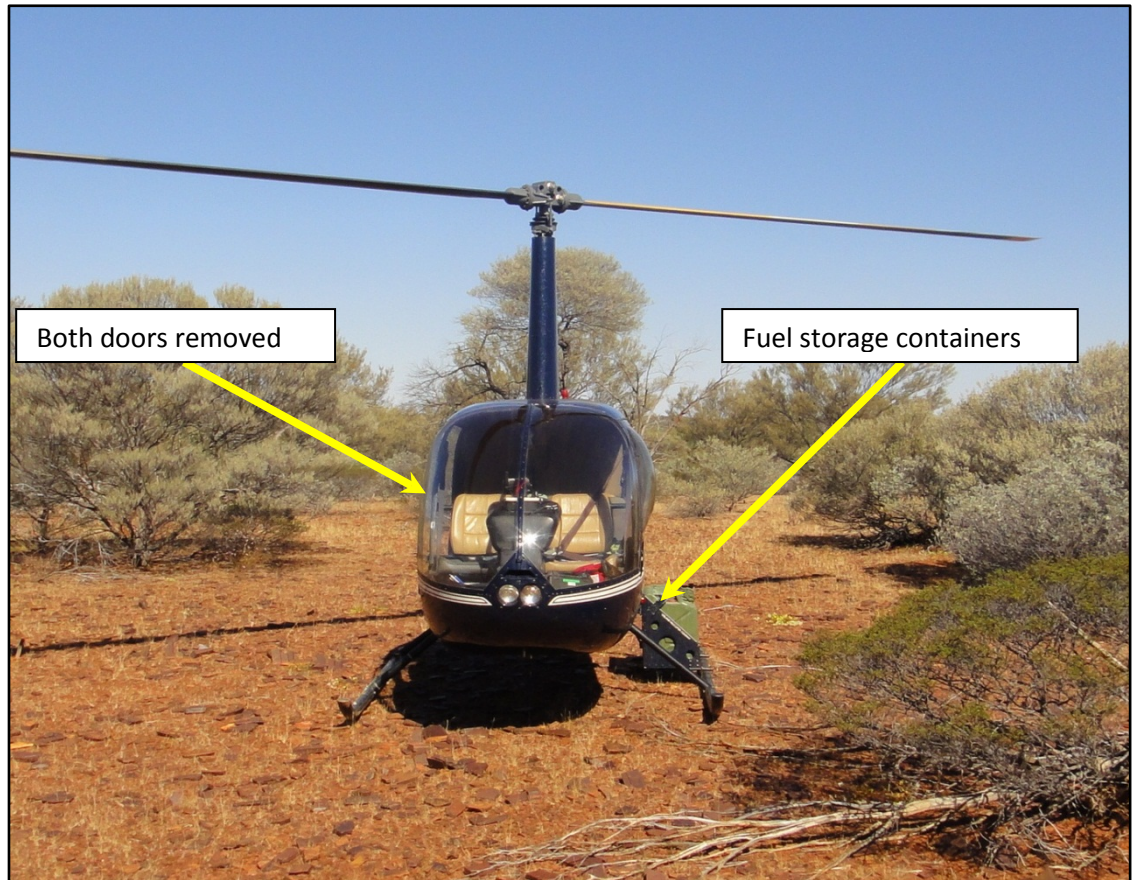
Figure 2: VH-HCA

The Robinson R44 is a single-engine helicopter with a semi-rigid, two bladed main rotor and skid-type landing gear. Seating was provided for four people, including the pilot. HCA had the left-rear passenger seat base cushion removed and replaced with a thin piece of high density foam to protect and allow the storage of the geophysical equipment when transiting between landing nodes. Additionally, both the right pilot door and right-rear passenger door had been removed for operational purposes (Figure 2).

The helicopter was reported to have been fully refuelled at the end of the previous day's flying activities. This included an additional three 20 L fuel storage containers that were filled with aviation fuel and secured in a pannier-type mount located along the left side of the helicopter (Figure 2). This additional fuel enabled the helicopter to operate for an extended period of time away from a refuelling facility.
