Loss of control involving Eurocopter AS350BA, VH-RDU

93 km N of Rockhampton Airport, Queensland | 8 September 2011

ATSB Transport Safety Report
Aviation Occurrence Investigation
AO-2011-110
Final – 5 September 2013

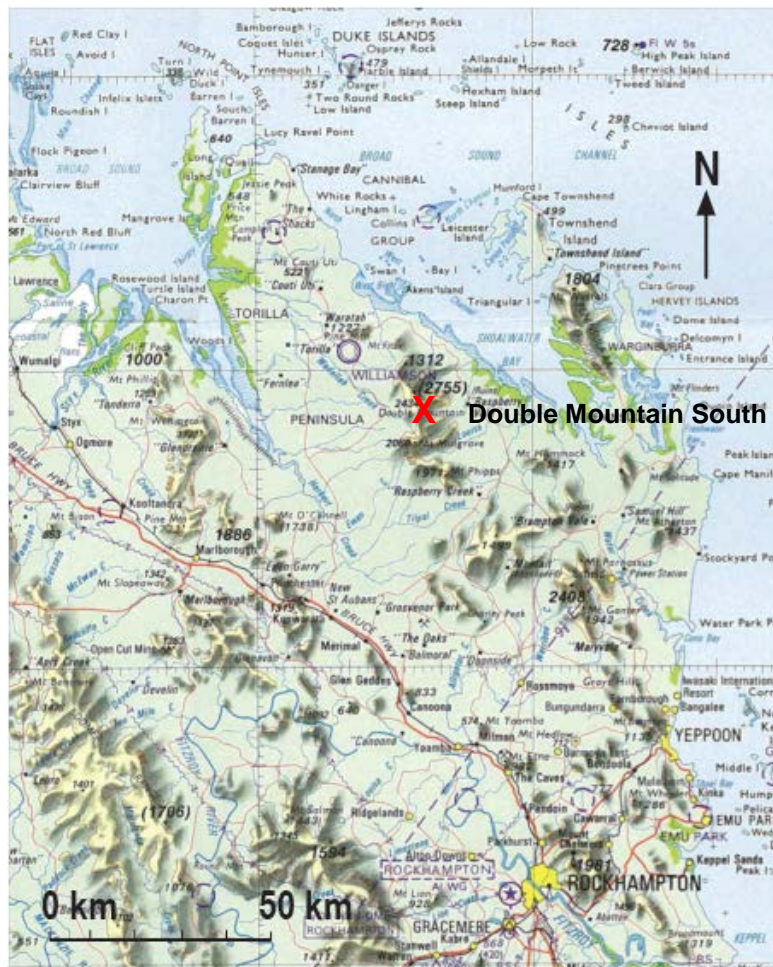
Figure 1: Locality map

At 0947 Eastern Standard Time¹ on 8 September 2011, a Eurocopter AS350BA helicopter, registered VH-RDU, departed from an airfield in the Shoalwater Bay military training area, Queensland (Qld) with a pilot and two passengers on board. The aircraft was under charter from a Cairns operator and was being flown under the Visual Flight Rules to assist in helicopter landing site (HLS) maintenance in the area. Initially the crew flew to an HLS associated with a communication tower in the eastern sector of the training area. The tower was on a low hill at an elevation about 700 ft. After an hour of maintenance work at that HLS, they departed for another HLS that was located on the western peak of Double Mountain South at an elevation of about 2,421 ft (Figure 1).

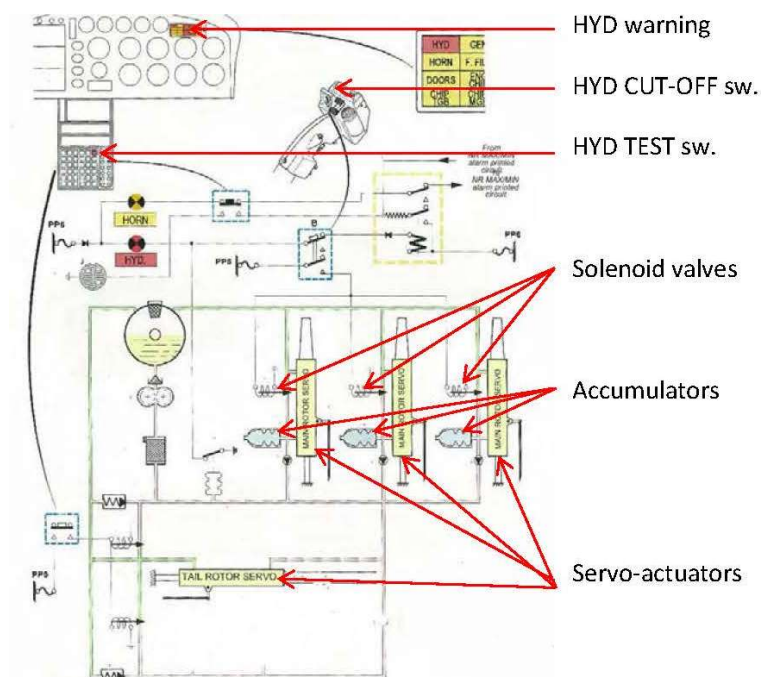
Figure 3: AS350BA hydraulic system diagram

The hydraulic flight control system consists of an engine-driven pump (via a flexible drive belt from the engine-to-main rotor gearbox power drive shaft), filter, hydraulic fluid reservoir, and three main rotor and one tail rotor hydraulic servo actuators with associated electrically operated warning and emergency systems (Figure 3). Hydraulic accumulators are fitted to each of the three main rotor servo actuators. There is no accumulator on the tail rotor servo actuator.

Each accumulator provides its actuator with a small reserve of pressurized hydraulic fluid so that, in the event of loss of system hydraulic pressure, the pilot can establish the helicopter in a safe speed range, where the feedback forces without hydraulic assistance are controllable. The solenoid valves (also called electro-valves) are electrically actuated devices that, when selected by the pilot relieve the hydraulic pressure in the main rotor servos simultaneously.

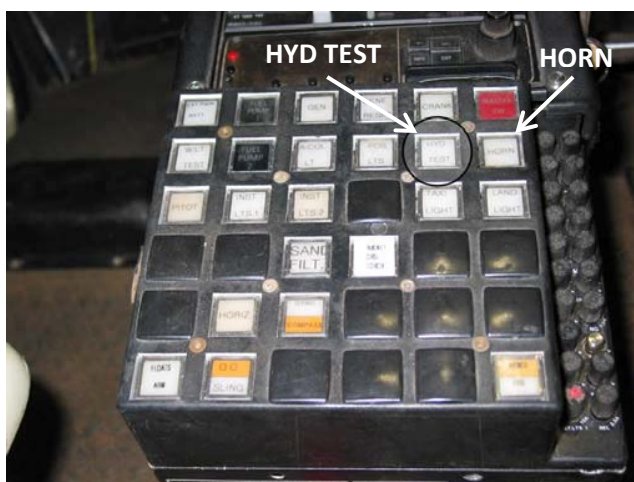
Figure 4: Hydraulic test (HYD TEST) and horn mute (HORN) switches on the centre console switch panel

The hydraulic system is controlled by the pilot using two switches: the hydraulic cut-off (HYD CUT OFF) switch mounted on the collective lever and the hydraulic test (HYD TEST) switch mounted in the centre console switch panel (Figure 4). The HYD CUT OFF switch is a guarded toggle switch with two positions: ON or OFF. The guard protects the switch from unintentional OFF selection that could lead to potential control problems.

The HYD CUT OFF switch is normally set to the ON (forward) position, allowing the servos to be powered when the hydraulic system is functioning correctly. When the pilot selects the HYD CUT OFF switch to the OFF (rear) position, the three main rotor servos are simultaneously depressurized by opening each servo's electrically operated valve (electro-valve): 'dumping' the hydraulic pressure in the respective servo actuators and immediately reconfiguring the helicopter controls from the hydraulically boosted mode to full manual flight control. Selecting the HYD CUT OFF switch to OFF also inhibits the low hydraulic pressure warning function of the warning horn.⁶

The HYD TEST switch is an illuminated, pushbutton switch mounted in the centre console switch panel (Figure 4), with two positions: TEST or OFF. Pushing the switch down to TEST opens the solenoid valve on the regulator unit, depressurizing the hydraulic system. The drop in hydraulic system pressure illuminates the red HYD warning lamp on the warning-caution-advisory panel and activates the hydraulic pressure warning function of the dual function warning horn.

When selected, a horn mute switch (HORN) on the centre console switch panel (Figure 4) silences the horn and illuminates the amber HORN caution lamp on the upper left corner of the warning-caution-advisory panel. This informs the pilot of the position of the horn mute switch. In this respect, if the mute switch is inadvertently left engaged during flight, and a loss of hydraulic pressure occurs, the horn would not sound. Despite this lack of an aural alert, the pilot would be alerted to the loss of hydraulic pressure by the red HYD warning lamp and the increased tail rotor pedal forces.

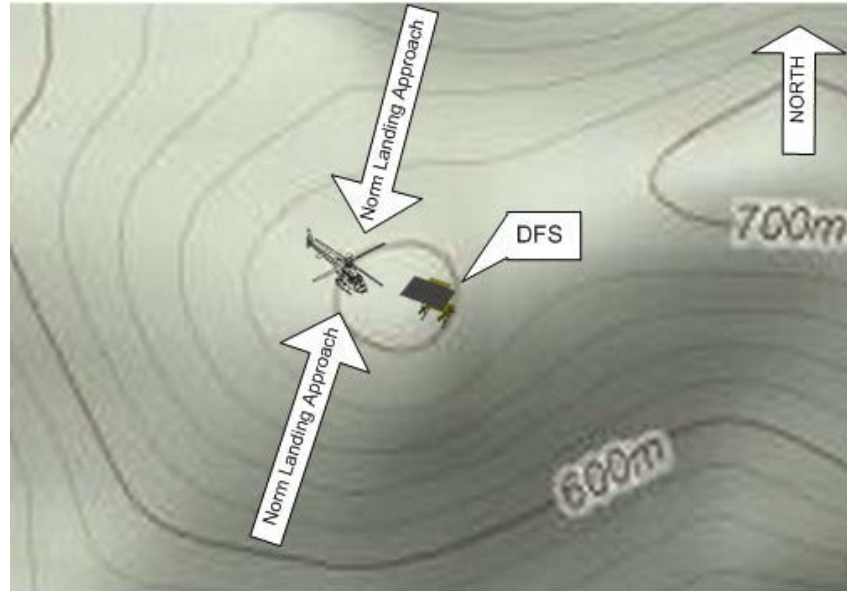
Figure 20 – Double Mountain DFS site

The Double Mountain sites consist of two separate communication sites within 1 Nautical Mile (Nm) of each other. Each location has its own landing pad. The vegetation at both Double Mountain sites requires some slashing with the brush cutter before treatment. Dominant vegetation species identified within the treatment areas include Rats Tail Grass, Parramatta Grass and Grass Trees. Trees surrounding the two sites may require coppicing to ensure maximum solar collection...

The contour map [Figure 20 in the original document] shows the normal landing and takeoff direction. For a helicopter, the most dangerous portion of the flights to/from the remote sites is during landing and take-off; it is during this period that the main and tail rotor is at risk of striking flora.

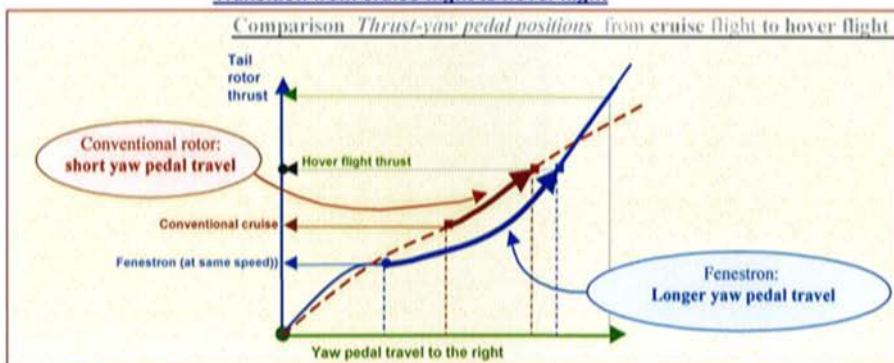
Transition from cruise flight to hover flight

With a Fenestron, when changing from cruise flight to hover flight, be prepared for a **significant movement of the foot to the right**.

Insufficient application of pedal would result in a leftward rotation of the aircraft during the transition to hover.

To stop rotation to the left, whether it is intentional or not, never hesitate to go up to the yaw pedal RH stop!

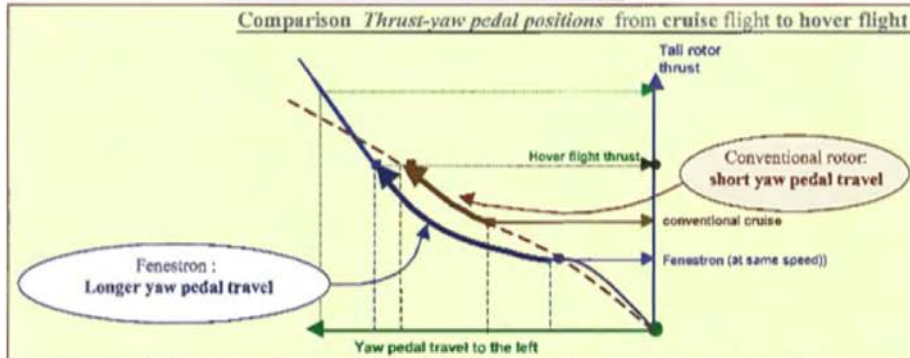
Comparison Thrust-yaw pedal positions from cruise flight to hover flight

With a Fenestron, when changing from cruise flight to hover flight, be prepared for a significant movement of the foot to the left.

Insufficient application of pedal would result in a rightward rotation of the aircraft during the transition to hover.

To stop rotation to the right, whether it is intentional or not, never hesitate to go up to the yaw pedal LEFT stop!
