Aircraft proximity event involving a Cessna 172S, VH-VMM and a Schweizer 269C-1, VH-FTR

9 km NE of Parafield Airport, South Australia, 1 September 2012

ATSB Transport Safety Report
Aviation Occurrence Investigation
AO-2012-115
Final – 21 March 2013

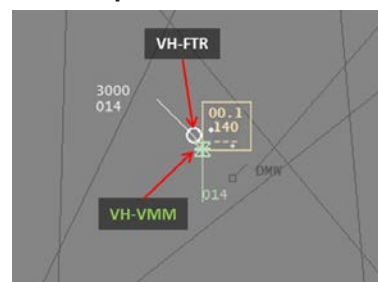
Figure 1: Inbound from the Dam Wall

On 1 September 2012, the flight instructor and student pilot of a Schweizer 269C-1 helicopter, registered VH-FTR (FTR), were conducting a training flight from Parafield, South Australia and return, via the ‘Dam Wall’, a visual flight rules (VFR) approach point (Figure 1).

At about the same time, a Cessna 172 aircraft, registered VH-VMM (VMM) was being operated on a solo training flight from Parafield and return, via the Dam Wall. When about 3-4 NM from the Dam Wall, at about 1,500 ft, the pilot was attempting to sight the Dam Wall when he observed a helicopter (FTR) in his 1 o’clock² position on a converging track. As a precaution, he reported conducting a 20° left turn and descending 100-200 ft. The turn could not be verified by Airservices Australia surveillance data. The pilot then temporarily lost sight of the helicopter as he became preoccupied with sighting the Dam Wall and preparing his inbound broadcast to Parafield Tower.

Aircraft positions at 1634:04
